# Investigation on Effects and Properties of Concrete Structure after Exposed to Fire

Prof. S. V. Dhoke<sup>1</sup>, Akshay Chikate<sup>2</sup>, Abhijit Andhare<sup>3</sup>, Anikesh Sable<sup>4</sup>, Ashish Gabhane<sup>5</sup>, Himanshu Bhabutkar<sup>6</sup>, Yash Gandhe<sup>7</sup>

*P.R.Pote (Patil) college of Engineering and Management, Amravati  
Sant. Gadge baba Amravati University – India*

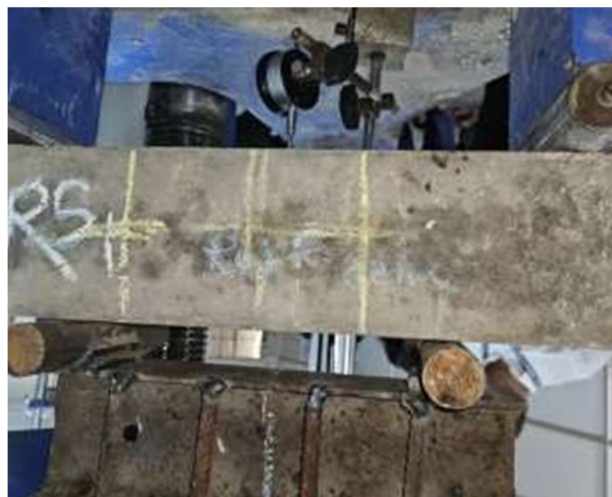
4.1.1 Reference Specimen one

This Reference specimen is use as reference point of view. This Reference specimen compare with the fired beam. Remaining beam are fire provided is different by using muffle Furnace after the testing of that beam all results compare RS1.

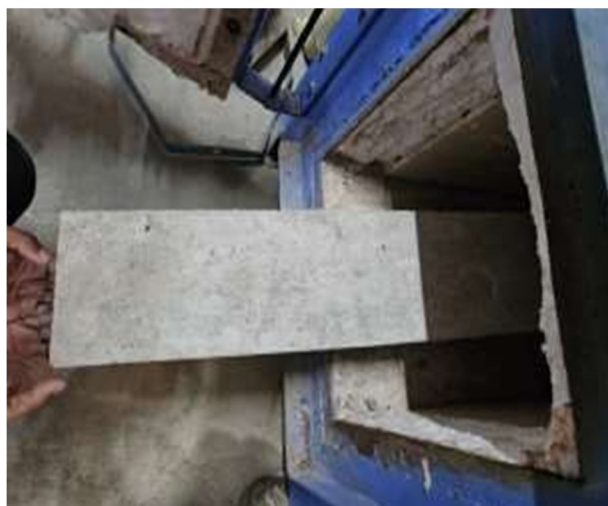
(a) Fired Process on Beam At (500°C)

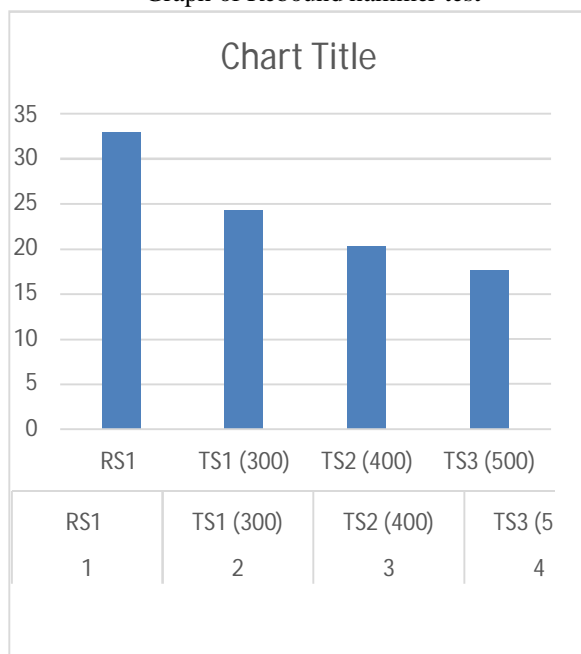
Graph of Rebound hammer test

REBOUND NO	Location-1	Location-2	Location-3	Average	Compressive strength	
36		32	31	33	25	Good
24		26	23	24.33333333	19.05	Fair
20		21	20	20.33333333	15.05	Fair

- 4) Rebound number and compressive strength decreases with increase in temperature.
- 5) Range from 300°C to 400°C the compressive strength decreases 20% to 80% with the increase in temperature.
