# Investigation on Effects and Properties of Concrete Structure after Exposed to Fire

Prof. S. V. Dhoke<sup>1</sup>, Akshay Chikate<sup>2</sup>, Abhijit Andhare<sup>3</sup>, Anikesh Sable<sup>4</sup>, Ashish Gabhane<sup>5</sup>, Himanshu Bhabutkar<sup>6</sup>, Yash Gandhe<sup>7</sup>

**Abstract:** *The integrity and strength of the materials used in reinforced concrete structures are highly influenced by their exposure environment. Exposing the building materials to high temperature changes their performance. The change in the performance is a result of the change in the material properties. When subjecting a building material to fire, the occurring damage depends on the severity of the fire in terms of the fire temperature and time of exposure.*

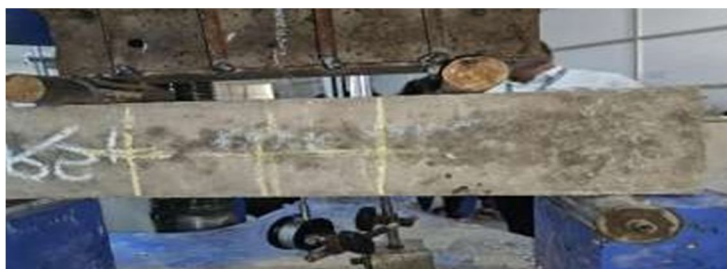
##### 2) Apply Load On (RS1)

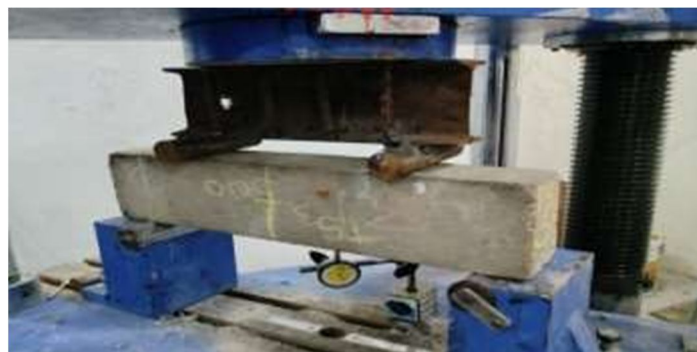
Apply Load On (RS3)

4) *Apply Load On (RS3)*
