# Prevention of Damages & Accidents in PSC I-Girders during Stressing & Erection Works

Abhijit Mangaraj<sup>1</sup>, Nitin Bobade<sup>2</sup>, Ananya P. Parida<sup>3</sup>

Department of Civil Engineering, Gandhi Institute For Technology Autonomous

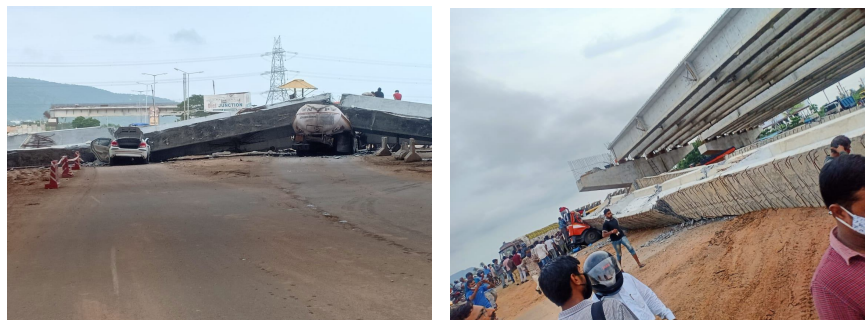
Fig 1.1:- Anakapalli AP NH-16 Flyover Girder Collapse On 6-Jul-2021

This is the major case of PSC girder failure in our country. About 80% of failures are falling in this category. The main cause of this type of failure is due to improper supporting arrangement below girder soffit and insufficient inclined/ cross supporting and due to no interconnections between 2 adjacent girders.

- a) negligence in supporting arrangement of girders,
- b) poor supervision during supporting,
- c) Improper temporary interconnections between adjacent girders.
- d) Entry & movement of unskilled workers in supporting area without Supervisor.
- e) Girder directly over bearings, with full load on Bearings.
- f) Machinery and equipment movement below & around the girders causing touch and vibrations to girder system.

- a) All supporting work shall be carried out under strict supervision and control of experienced Engineers, Supervisors.
- b) Not a single support shall be removed or relocate, unless the permission granted by Engineer-in-Charge. This is one of the main cause of girder toppling.
