# Prevention of Damages & Accidents in PSC I-Girders during Stressing & Erection Works

Abhijit Mangaraj<sup>1</sup>, Nitin Bobade<sup>2</sup>, Ananya P. Parida<sup>3</sup>

Department of Civil Engineering, Gandhi Institute For Technology Autonomous

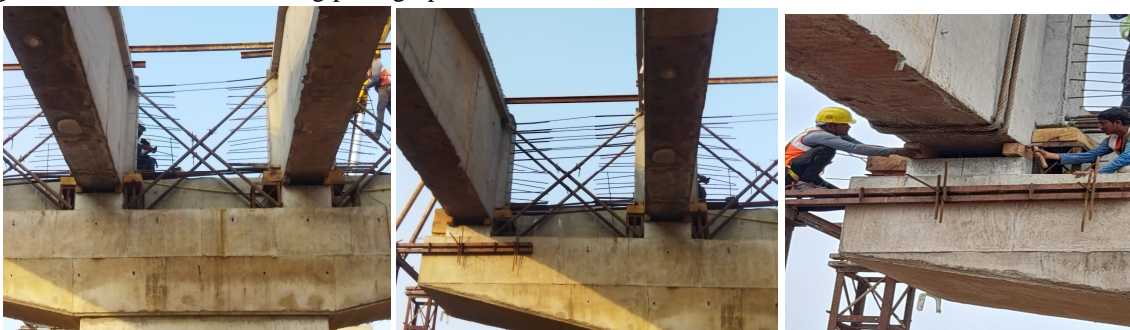
Fig 1.3:- Supporting arrangement of PSC Girdes (3 Photos)

- d) Method statement shall be strictly followed.
- e) All girders shall be firmly placed over wooden blocks. Wooden blocks placed below Girder soffit and diaphragm soffit. Even if girder placed over bearing, these wooden blocks packing required.

- f) Check the wooden blocks firmness by striking the ball pin hammer on blocks. After hammer striking ringing sound shall appear from the blocks.
- g) Till casting of diaphragm all girders shall be interconnected by connecting/ welding rods to dowels of diaphragm of adjacent girders.

- h) Placing and tack connecting the Steel Beam or Channel to shear connectors of the PSC girder and adjacent girder.
- i) Placing and fixing the inclined supports (Struts), forming a cross frame at location between girder end portion to girder tapering portion.
