# Repair, Retrofitting and Rehabilitation Techniques for Strengthening of Reinforced Cement Concrete Structures Along with Experimental Work

The main scope work included assessing structural condition of existing reinforced cement concrete (RCC) structure at the Project Construction Site, New Delhi through visual survey and non-destructive testing (NDT). During the meetings held with the contact officers, two phases of the project were made: (a) first phase: visual survey and NDT, and (b) second phase: only if requirement is felt from the first phase of the project, (i) structural analysis of the existing structure based on available drawings and data. For gravity as well as seismic loads by using structural analysis software such as SAP/ STAAD/ ETABS/ NISA, etc. (ii) suggestions and designing retrofitting scheme for the structure if it demands as per relevant Indian standard (IS) codes. Preparation and submission of detailed estimates, bill of quantities (BOQ), and specifications for retrofitting scheme.

### B. Second Phase: Structural Analysis And Design Assessment

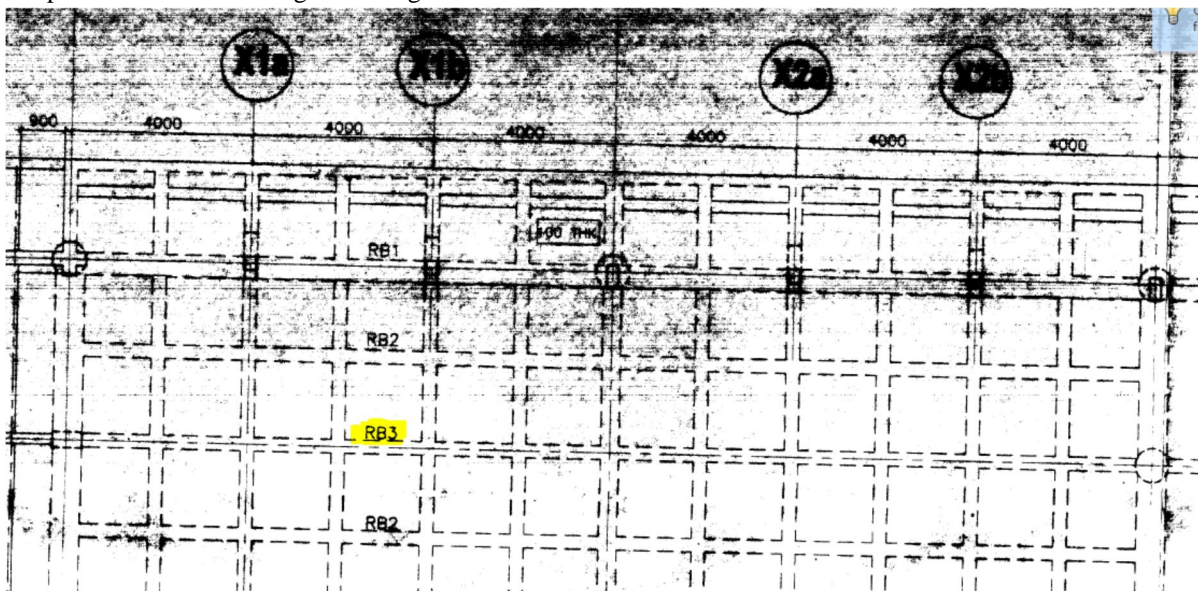
Fig. 1: Structural G.A. at 10.8 m Level, Drawing No. CEDZ-1743(S), Sheet 25/32, Dated 10-09-04.

In Banquet Hall, main portal having span of 24 m is analyzed in Staad Pro. The structural general arrangement (G.A.) drawing and the first-floor plan are as shown in Fig. 1 and Fig. 2.

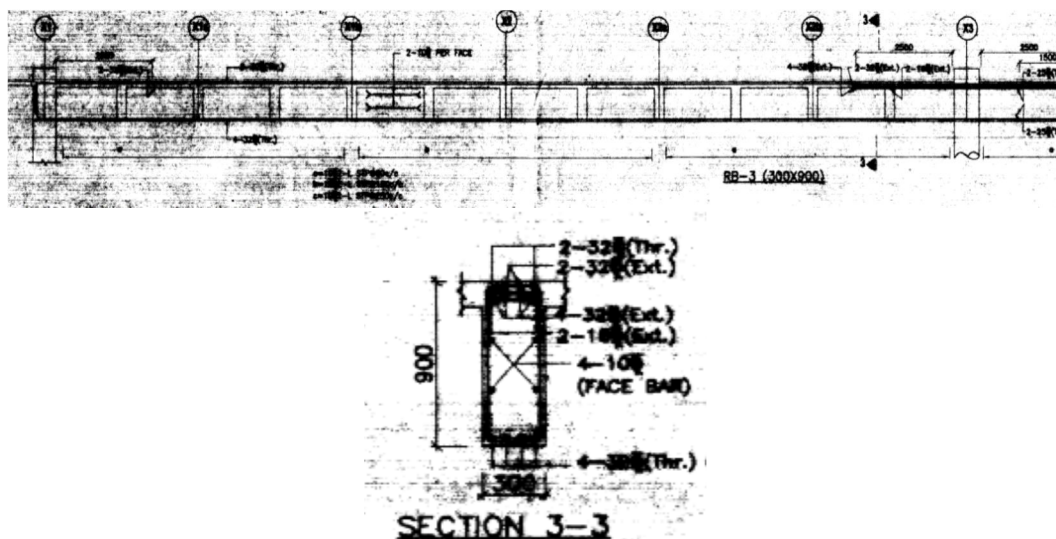
Fig. 2: Beam Details at 10.8 m Level, Drawing No. CEDZ-1743(S), Sheet 23/32, Dated 10-09-04.

Beam Size = 300 m × 900 m

Beam Span = 24 m

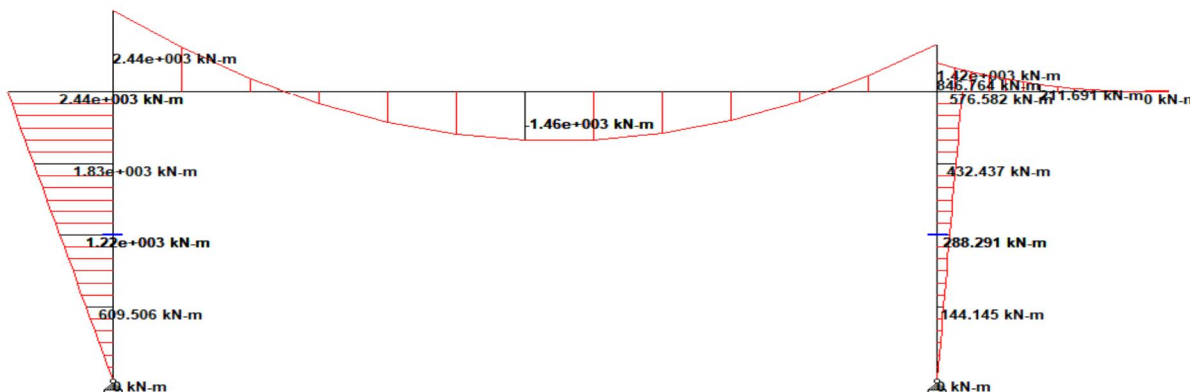
STAAD Analysis  
Bending Moment (BM) Diagram (Ultimate Load Case)

Position	Bending moment	Ast-required	Ast-provided
Top face @ support	2440 kN-m	7730 mm <sup>2</sup>	6834 mm <sup>2</sup> (T32 - 8 Nos. + T16 - 2 Nos.)
Bottom face @ mid-span	1460 kN-m	4560 mm <sup>2</sup>	3200 mm <sup>2</sup> (T32 - 4 Nos.)

Insufficient Flexural Reinforcement. Hence, Unsafe.

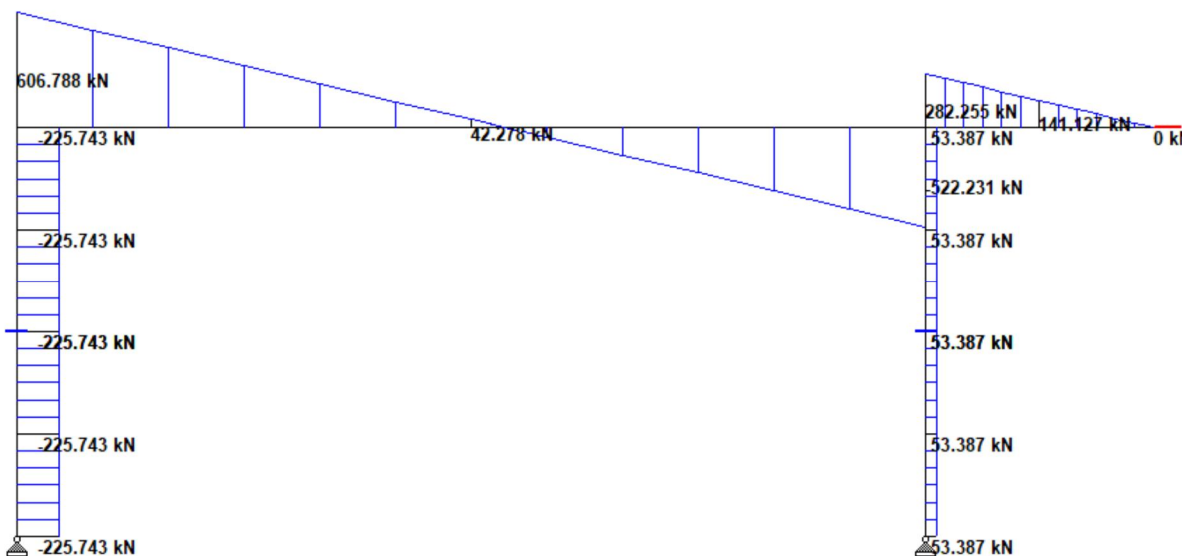
Shear Force (SF) Diagram:

Total Shear force = 607 kN

Shear taken by Concrete -  $0.7 \text{ N/mm}^2 = 178.5 \text{ kN}$

Shear to be taken by steel = 428.5 kN

Provided shear reinforcement = T10 @ 100 mm c/c

Actual shear carrying capacity = 580 kN

Although the simplified analysis shows sufficiency of the shear reinforcement, the grid action and the torsional effects may make it vulnerable in shear.

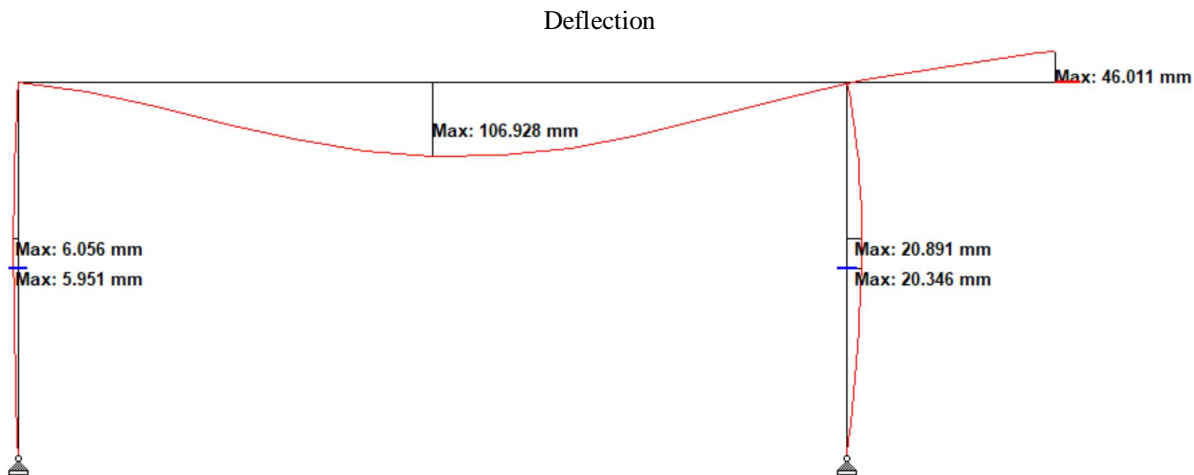
Maximum Deflection = 106.93 mm, as per analysis

Allowable Deflection = 96 mm for Span/250 as per Clause 23.2 Indian Standard (I.S.) 456: 2000

Unsafe in Serviceability Criteria of Deflection.

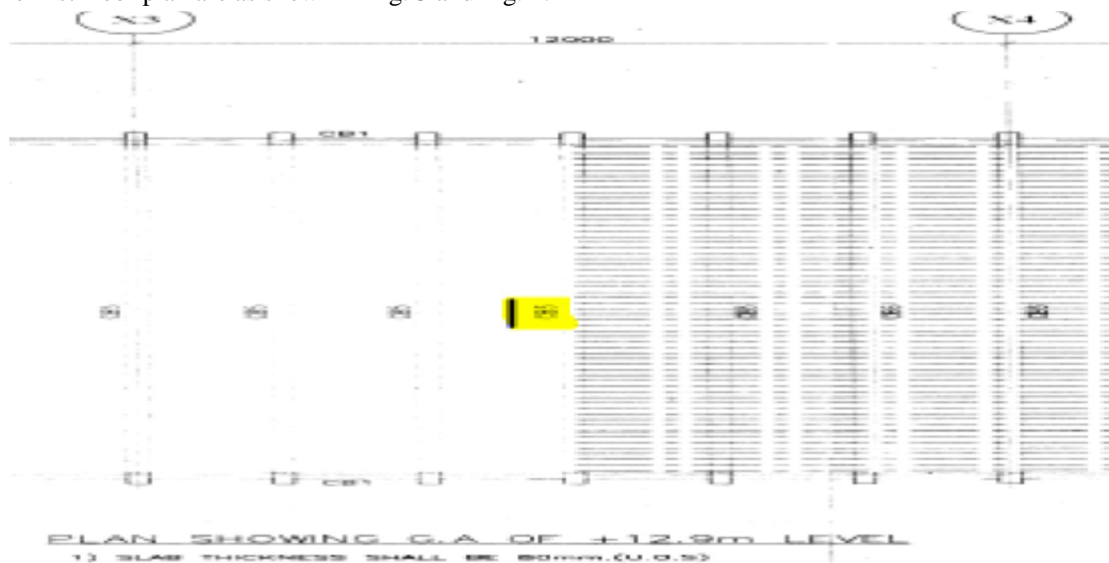
Fig. 3: Structural G.A. at 12.9 m Level, Drawing No. CEDZ-1743(S), Sheet 28/32, Dated 10-09-04.

In Entrance Lobby area, main portal having span of 18 m is analyzed in Staad.Pro. The structural general arrangement (G.A.) drawing and the first-floor plan are as shown in Fig. 3 and Fig. 4.

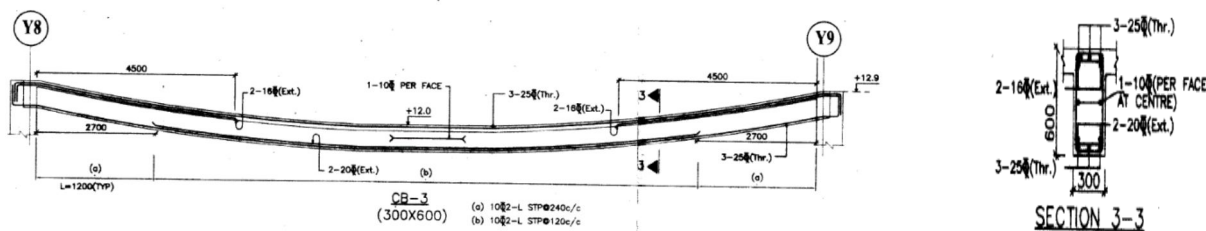
Fig. 4: Structural G.A. at 12.9 m Level, Drawing No. CEDZ-1743(S), Sheet 30/32, Dated 10-09-04.

Beam Size = 300 m × 600 m

Beam Span = 18 m

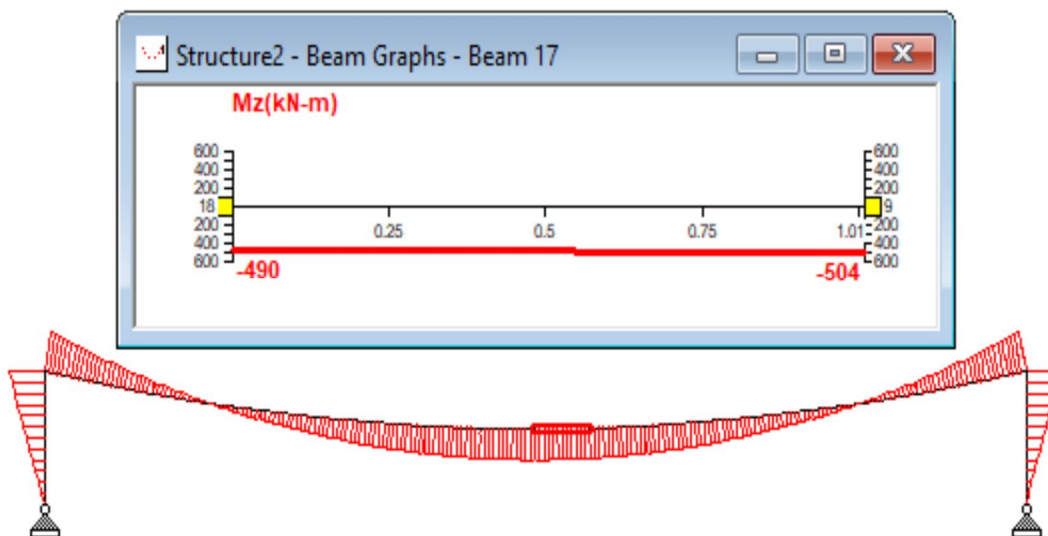
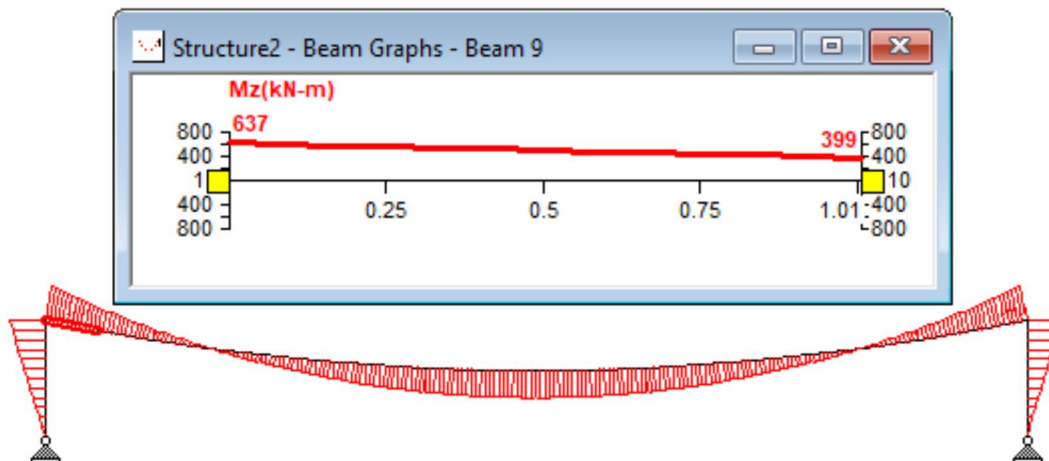
Bending Moment (BM) Diagram (Ultimate Load Case):

Position	Bending moment	Ast-required	Ast-provided
Top face @ support	637 kN-m	3080 mm <sup>2</sup>	1875 mm <sup>2</sup> (T25 - 3 Nos. + T16 - 2 Nos.)
Bottom face @ mid-span	504 kN-m	2440 mm <sup>2</sup>	2100 mm <sup>2</sup> (T25 - 3 Nos. + T20 - 2 Nos.)

Insufficient Flexural Reinforcement. Hence, Unsafe.

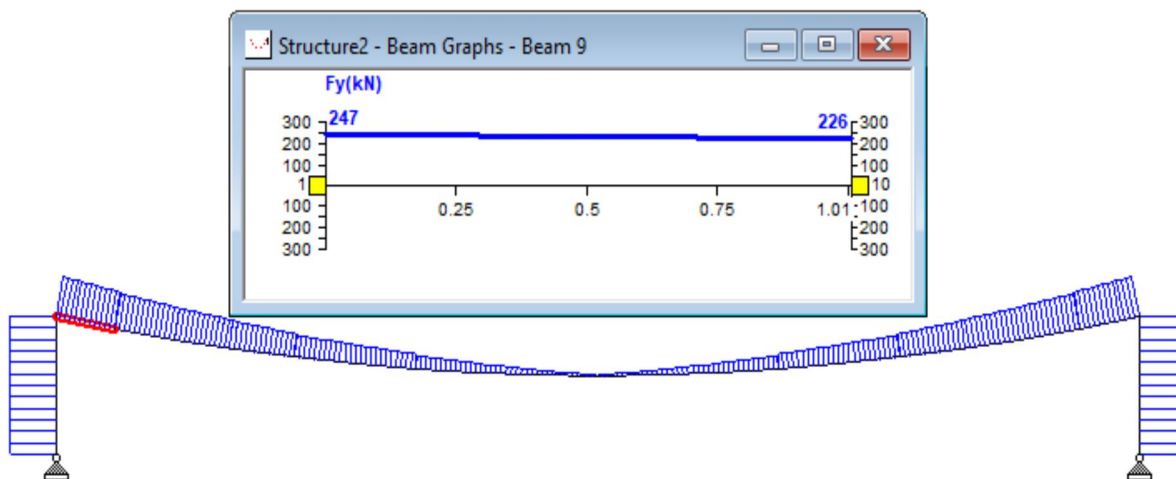
Shear Force (SF) Diagram

Total Shear force = 247 kN

Shear taken by Concrete - 0.7 N/mm<sup>2</sup> = 115.5 kN

Shear to be taken by steel = 131.5 kN

Provided shear reinforcement = T10 @ 120 mm c/c

Actual shear carrying capacity = 313 Kn

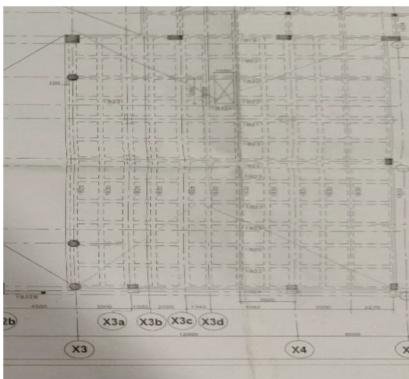
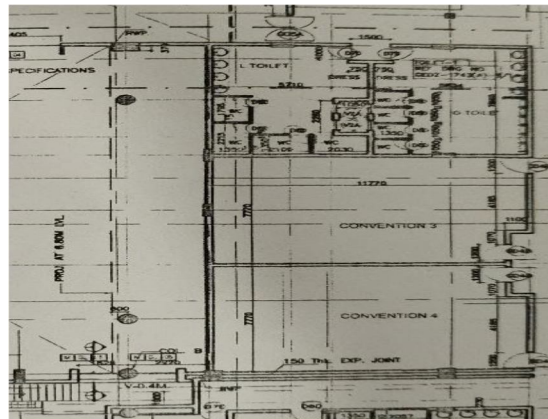
Fig. 5: Structural G.A. at 6.8 m Level, Drawing No. CEDZ-1743(S), Sheet 17/32, Dated 10-09-04.

Terrace Grid in Banquet Hall is analyzed in Staad Pro. The structural general arrangement (G.A.) drawing and the first-floor plan are as shown in Fig. 5 and Fig. 6.

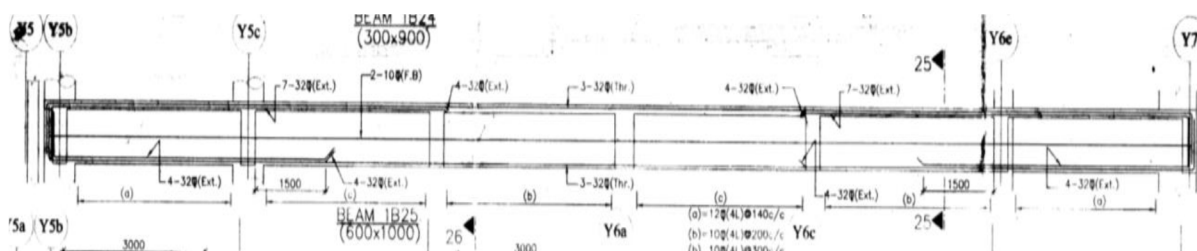
Fig. 6: Beam Details at 6.8 m Level, Drawing No. CEDZ-1743(S), Sheet 21/32, Dated 10-09-04.

Beam Size = 600 m × 1000 m

Beam Span = 16 m

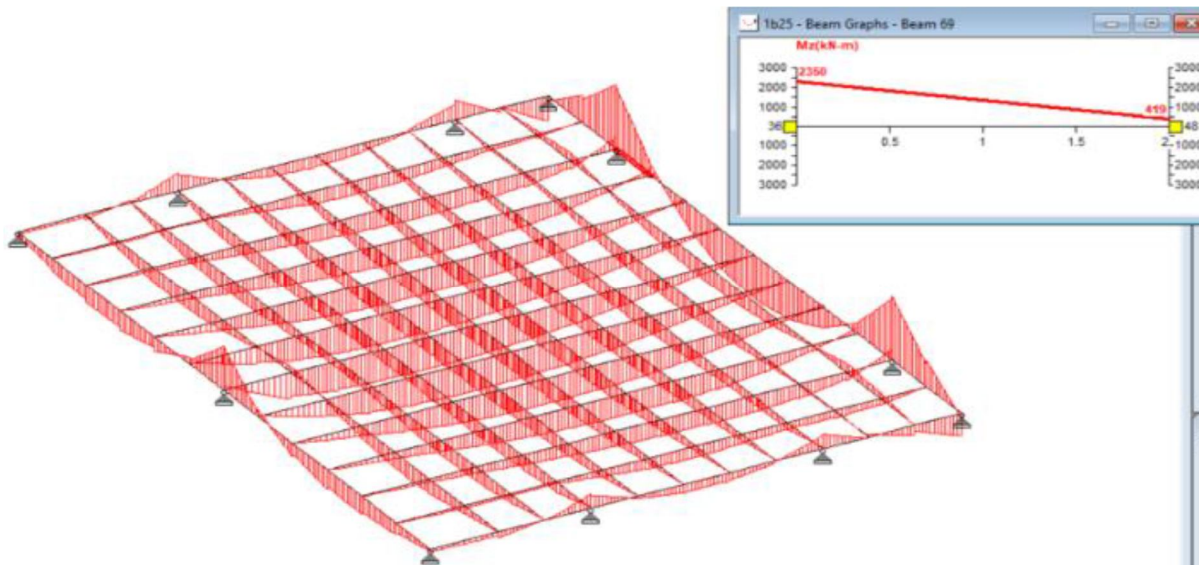
BM at support for 1B25

Position	Bending moment	Ast-required	Ast-provided
Top face @ support	2350 kN-m	7850 mm <sup>2</sup>	11214 mm <sup>2</sup> (T32 - 14 Nos.)
Bottom face @ mid-span	1670 kN-m	4880 mm <sup>2</sup>	2403 mm <sup>2</sup> (T32 - 3 Nos.)

Insufficient Flexural Reinforcement. Hence, Unsafe.

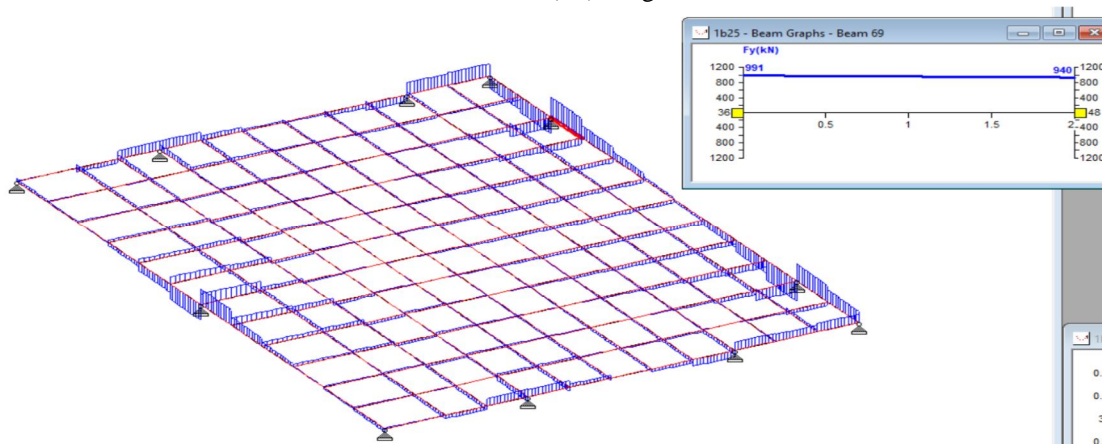
Shear Force (SF) Diagram:

Total Shear force = 991 kN

Shear taken by Concrete -  $0.4 \text{ N/mm}^2 = 228 \text{ kN}$

Shear to be taken by steel = 763 kN

Provided shear reinforcement = T10 @ 300 mm c/c (4 legged)

Actual shear carrying capacity = 432.7 kN

Unsafe to Carry Shear Force.

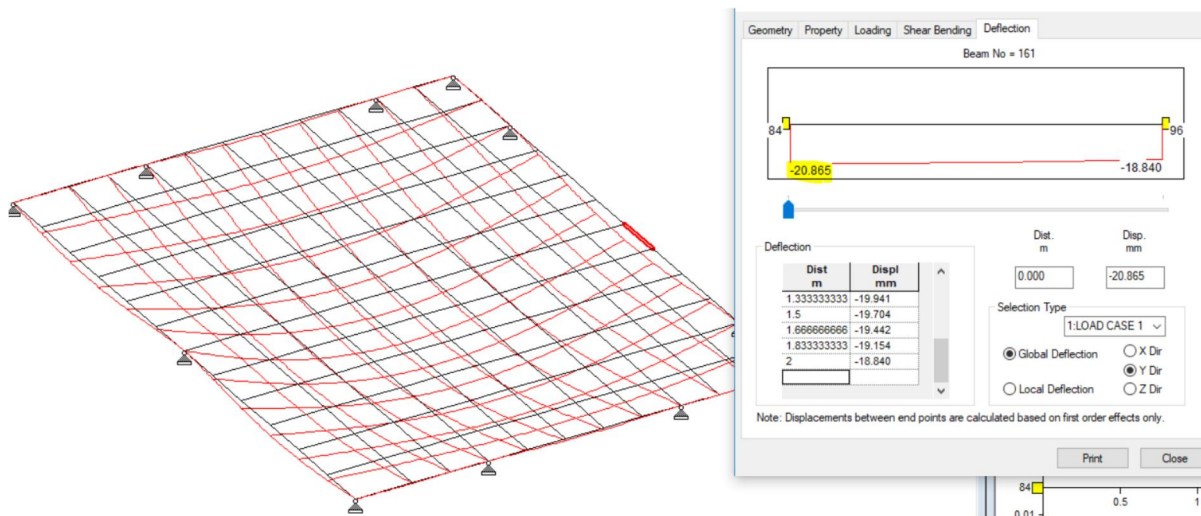
Maximum Deflection = 20.86 mm, as per analysis

Allowable Deflection = 64 mm for Span/250 as per Clause 23.2 Indian Standard (I.S.)

Notes: The analysis results should be correlated with the observed behaviour of the structural members. Appropriate strengthening measures should be undertaken, if required.
