Repair, Retrofitting and Rehabilitation Techniques for Strengthening of Reinforced Cement Concrete Structures Along with Experimental Work

Pushpendra Kumar Bachchan

Student, Civil Engineering, Lingaya's Vidyapeeth, Faridabad

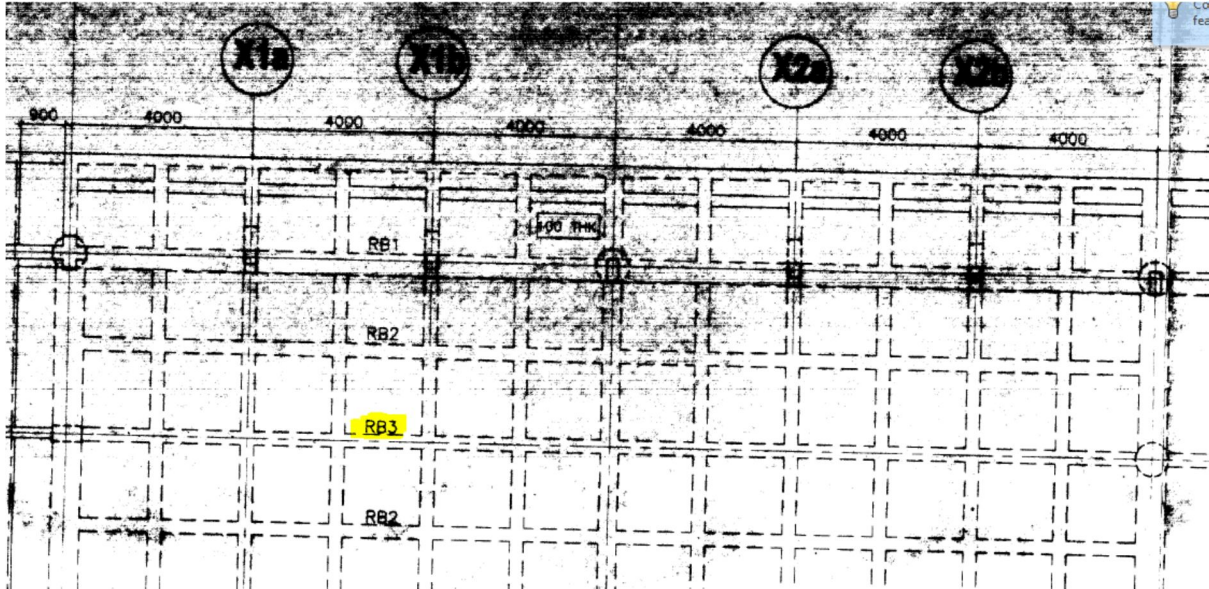
Fig. 1: Structural G.A. at 10.8 m Level, Drawing No. CEDZ-1743(S), Sheet 25/32, Dated 10-09-04.

In Banquet Hall, main portal having span of 24 m is analyzed in Staad Pro. The structural general arrangement (G.A.) drawing and the first-floor plan are as shown in Fig. 1 and Fig. 2.

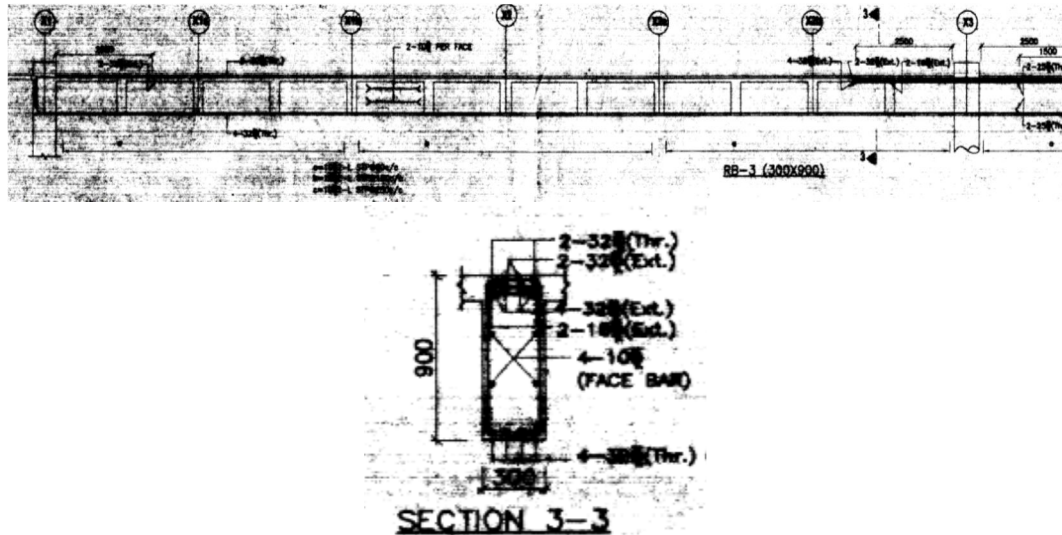
Fig. 2: Beam Details at 10.8 m Level, Drawing No. CEDZ-1743(S), Sheet 23/32, Dated 10-09-04.

Beam Size = 300 m × 900 m

Beam Span = 24 m

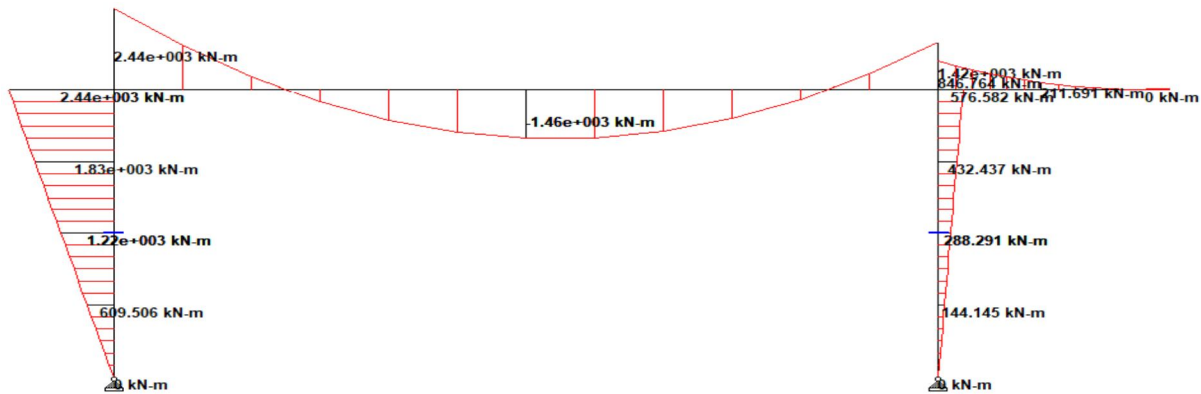
STAAD Analysis
Bending Moment (BM) Diagram (Ultimate Load Case)

TABLE I
Longitudinal Reinforcement Details:

Position	Bending moment	Ast-required	Ast-provided
Top face @ support	2440 kN-m	7730 mm ²	6834 mm ² (T32 - 8 Nos. + T16 - 2 Nos.)
Bottom face @ mid-span	1460 kN-m	4560 mm ²	3200 mm ² (T32 - 4 Nos.)

Insufficient Flexural Reinforcement. Hence, Unsafe.

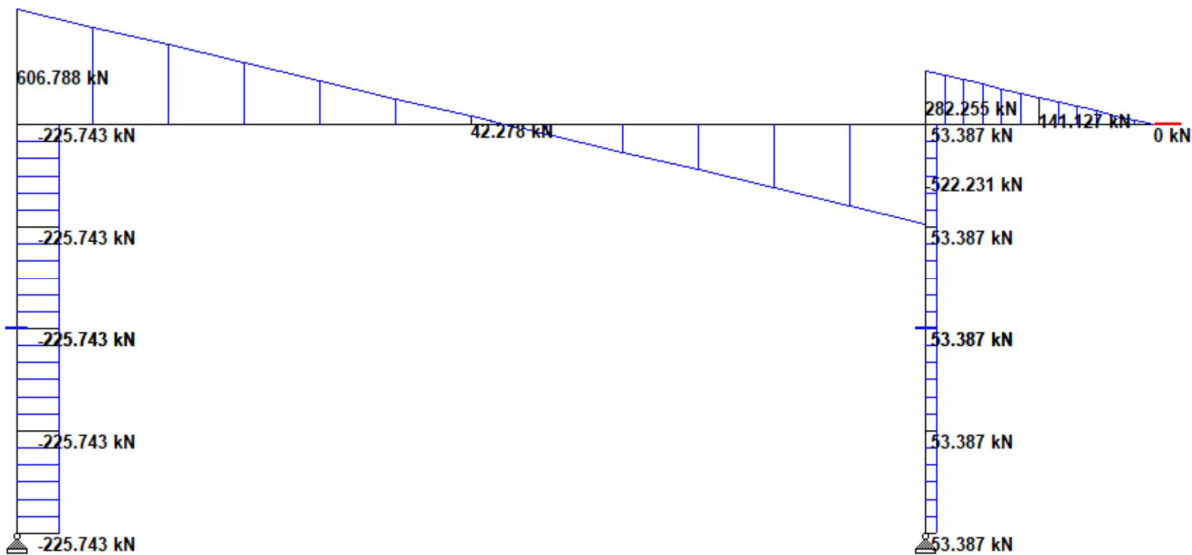
Shear Force (SF) Diagram:

Total Shear force = 607 kN

Shear taken by Concrete - $0.7 \text{ N/mm}^2 = 178.5 \text{ kN}$

Shear to be taken by steel = 428.5 kN

Provided shear reinforcement = T10 @ 100 mm c/c

Actual shear carrying capacity = 580 kN

Although the simplified analysis shows sufficiency of the shear reinforcement, the grid action and the torsional effects may make it vulnerable in shear.

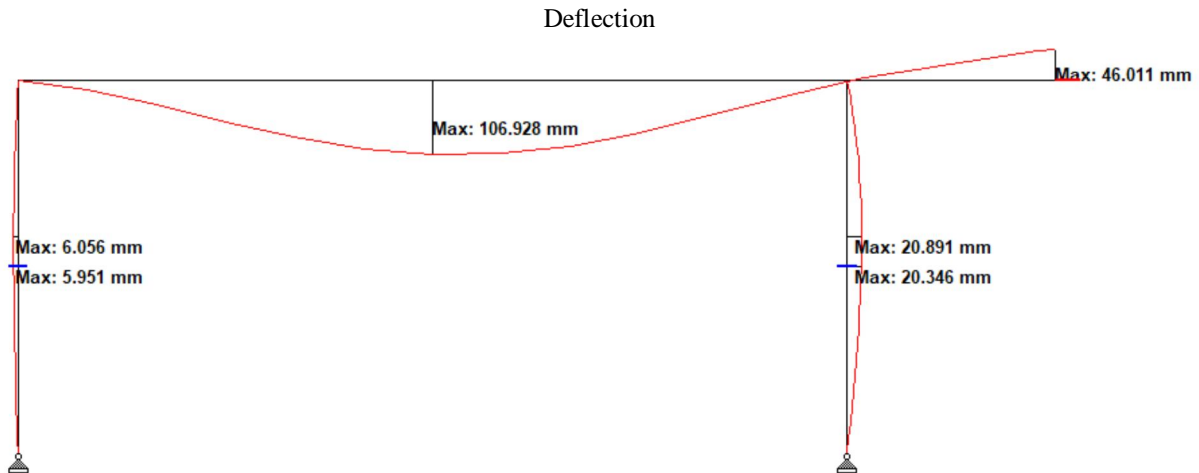
Maximum Deflection = 106.93 mm, as per analysis

Allowable Deflection = 96 mm for Span/250 as per Clause 23.2 Indian Standard (I.S.) 456: 2000

Unsafe in Serviceability Criteria of Deflection.

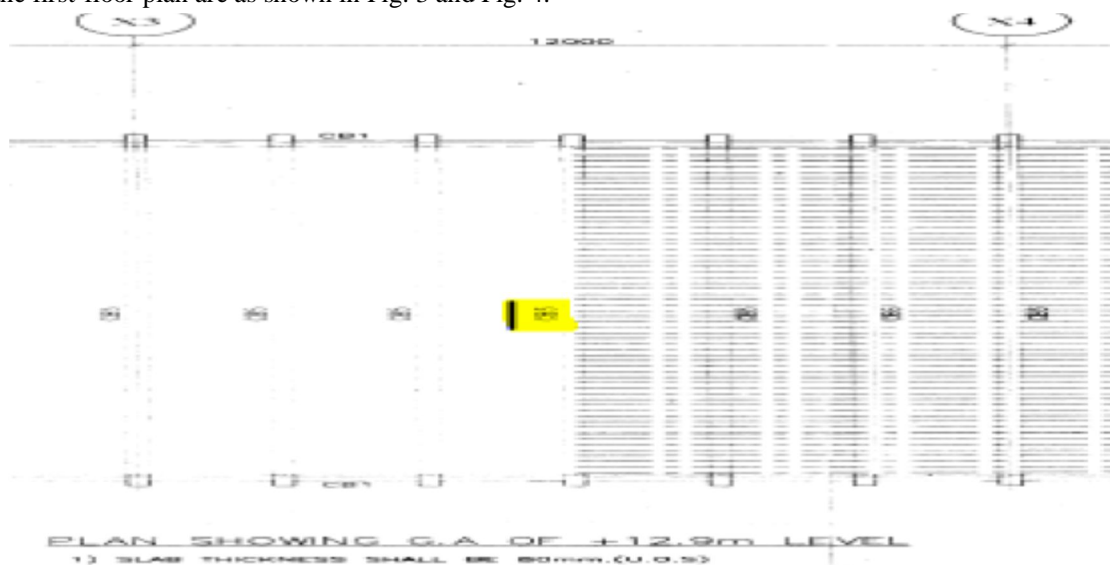
Fig. 3: Structural G.A. at 12.9 m Level, Drawing No. CEDZ-1743(S), Sheet 28/32, Dated 10-09-04.

In Entrance Lobby area, main portal having span of 18 m is analyzed in Staad.Pro. The structural general arrangement (G.A.) drawing and the first-floor plan are as shown in Fig. 3 and Fig. 4.

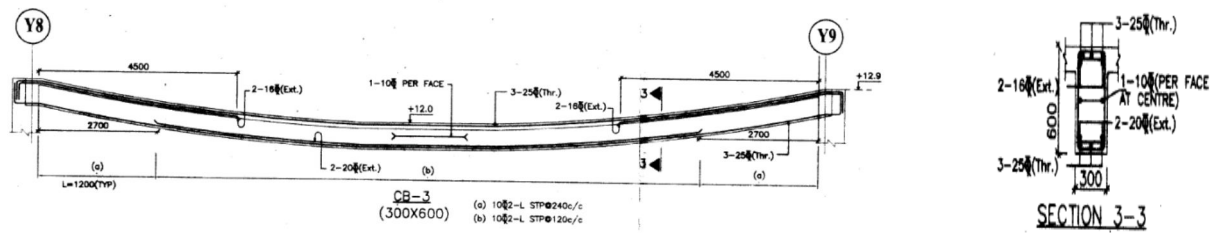
Fig. 4: Structural G.A. at 12.9 m Level, Drawing No. CEDZ-1743(S), Sheet 30/32, Dated 10-09-04.

Beam Size = 300 m × 600 m

Beam Span = 18 m

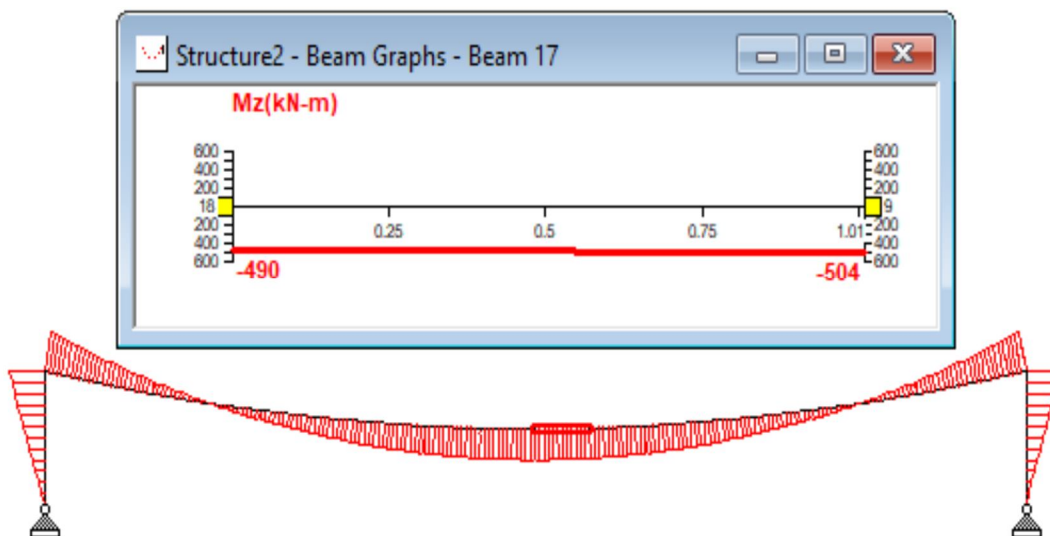
Bending Moment (BM) Diagram (Ultimate Load Case):

Longitudinal Reinforcement Details:

Position	Bending moment	Ast-required	Ast-provided
Top face @ support	637 kN-m	3080 mm ²	1875 mm ² (T25 - 3 Nos. + T16 - 2 Nos.)
Bottom face @ mid-span	504 kN-m	2440 mm ²	2100 mm ² (T25 - 3 Nos. + T20 - 2 Nos.)

Insufficient Flexural Reinforcement. Hence, Unsafe.

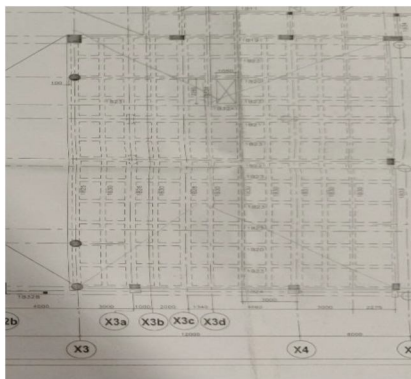
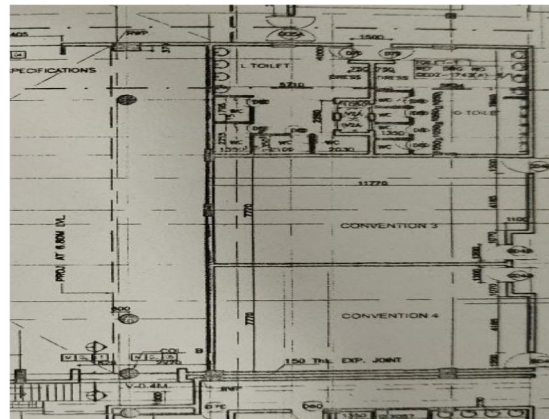
Fig. 5: Structural G.A. at 6.8 m Level, Drawing No. CEDZ-1743(S), Sheet 17/32, Dated 10-09-04.

Terrace Grid in Banquet Hall is analyzed in Staad Pro. The structural general arrangement (G.A.) drawing and the first-floor plan are as shown in Fig. 5 and Fig. 6.

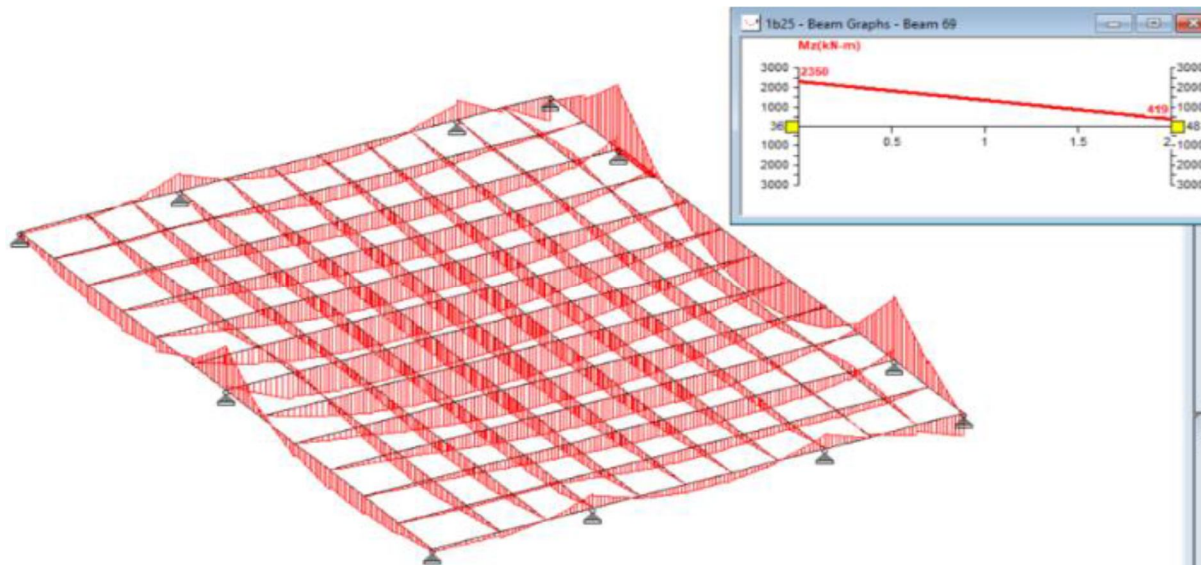
BM at support for 1B25

Bending Moment (BM) Diagram (Ultimate Load Case)

Position	Bending moment	Ast-required	Ast-provided
Top face @ support	2350 kN-m	7850 mm ²	11214 mm ² (T32 - 14 Nos.)
Bottom face @ mid-span	1670 kN-m	4880 mm ²	2403 mm ² (T32 - 3 Nos.)

Insufficient Flexural Reinforcement. Hence, Unsafe.

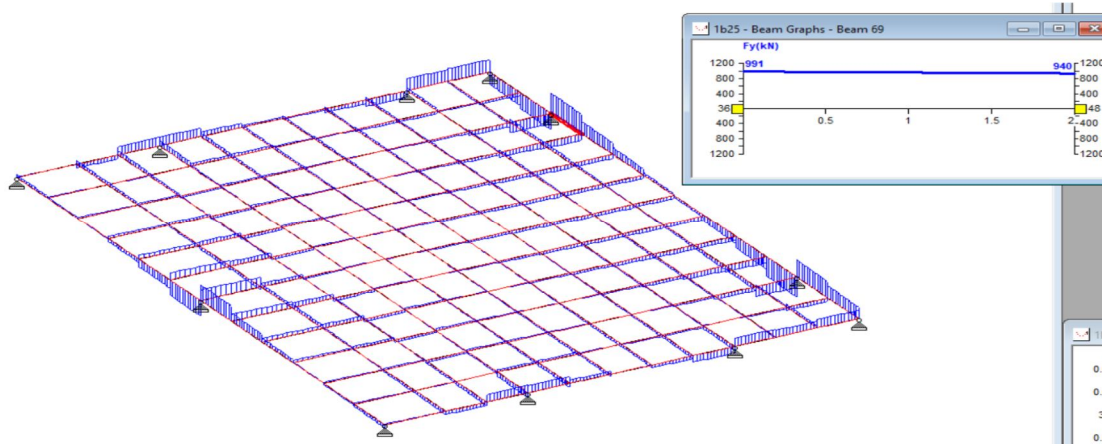
Shear Force (SF) Diagram:

Total Shear force = 991 kN

Shear taken by Concrete - $0.4 \text{ N/mm}^2 = 228 \text{ kN}$

Shear to be taken by steel = 763 kN

Provided shear reinforcement = T10 @ 300 mm c/c (4 legged)

Actual shear carrying capacity = 432.7 kN

Unsafe to Carry Shear Force.

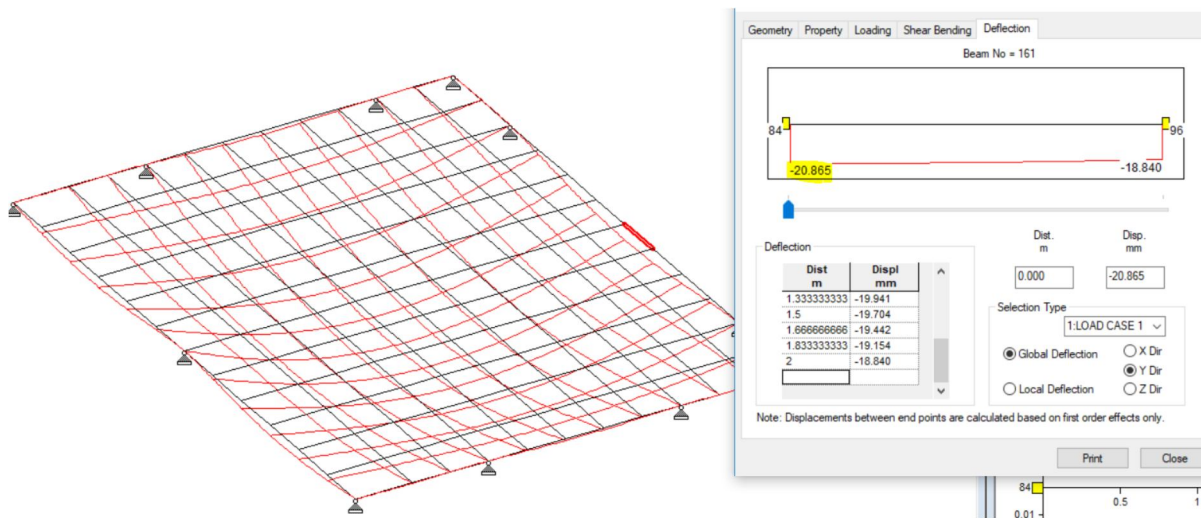
Maximum Deflection = 20.86 mm, as per analysis

Allowable Deflection = 64 mm for Span/250 as per Clause 23.2 Indian Standard (I.S.)
