Repair, Retrofitting and Rehabilitation Techniques for Strengthening of Reinforced Cement Concrete Structures Along with Experimental Work

The main scope work included assessing structural condition of existing reinforced cement concrete (RCC) structure at the Project Construction Site, New Delhi through visual survey and non-destructive testing (NDT). During the meetings held with the contact officers, two phases of the project were made: (a) first phase: visual survey and NDT, and (b) second phase: only if requirement is felt from the first phase of the project, (i) structural analysis of the existing structure based on available drawings and data. For gravity as well as seismic loads by using structural analysis software such as SAP/ STAAD/ ETABS/ NISA, etc. (ii) suggestions and designing retrofitting scheme for the structure if it demands as per relevant Indian standard (IS) codes. Preparation and submission of detailed estimates, bill of quantities (BOQ), and specifications for retrofitting scheme.

Second phase of the works was undertaken. Under the given circumstances, in such an exercise, the input details are taken from the investigations carried out in the first phase of

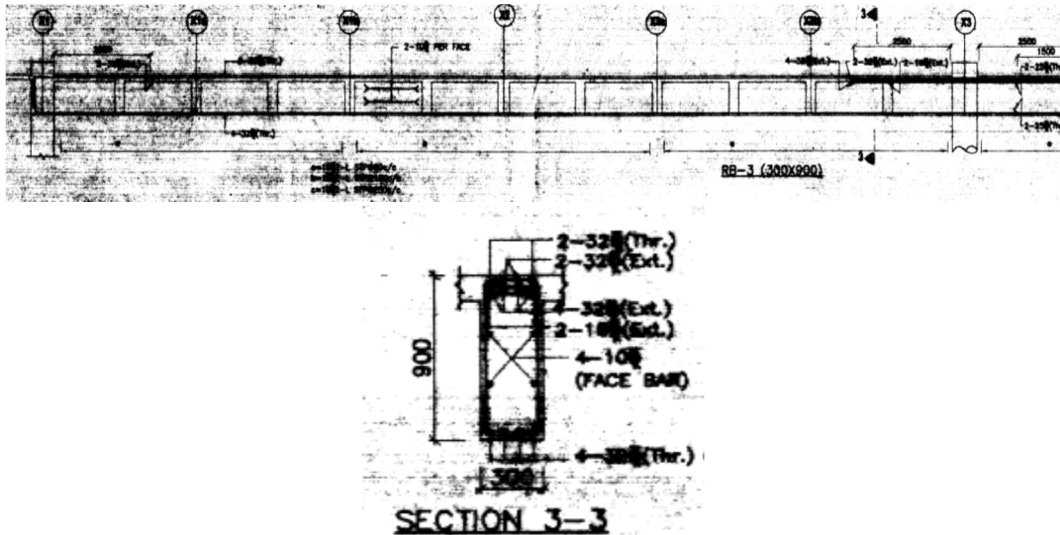
Fig. 2: Beam Details at 10.8 m Level, Drawing No. CEDZ-1743(S), Sheet 23/32, Dated 10-09-04.

Beam Size = 300 m × 900 m

Beam Span = 24 m

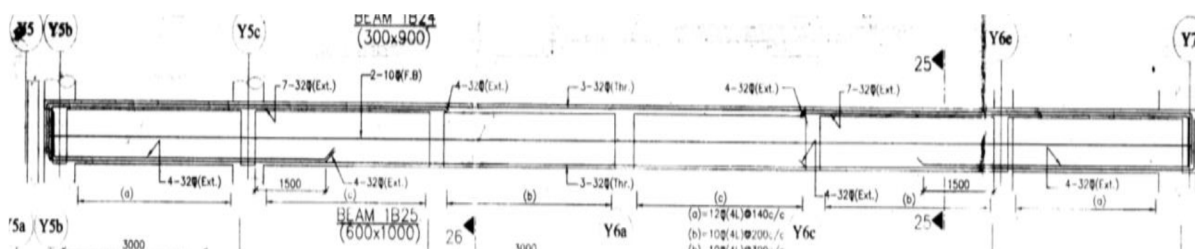
Fig. 6: Beam Details at 6.8 m Level, Drawing No. CEDZ-1743(S), Sheet 21/32, Dated 10-09-04.

Beam Size = 600 m × 1000 m

Beam Span = 16 m

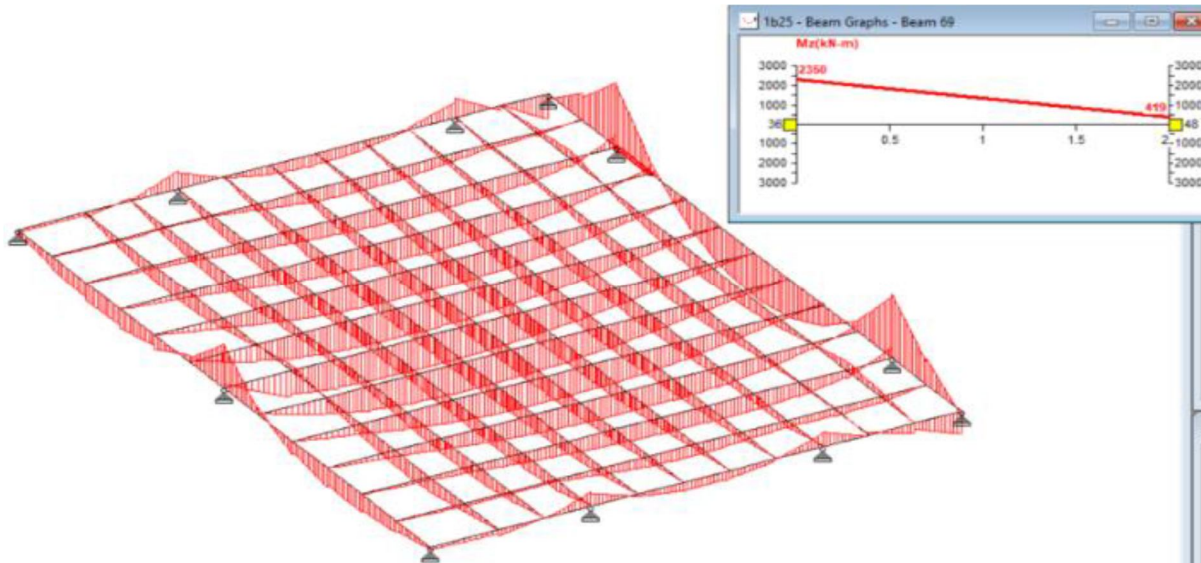
BM at support for 1B25

Bending Moment (BM) Diagram (Ultimate Load Case)

TABLE III
Longitudinal Reinforcement Details:

| Position | Bending moment | Ast-required | Ast-provided |
| Top face @ support | 2350 kN-m | 7850 mm ² | 11214 mm ² (T32 - 14 Nos.) |
| Bottom face @ mid-span | 1670 kN-m | 4880 mm ² | 2403 mm ² (T32 - 3 Nos.) |

Insufficient Flexural Reinforcement. Hence, Unsafe.

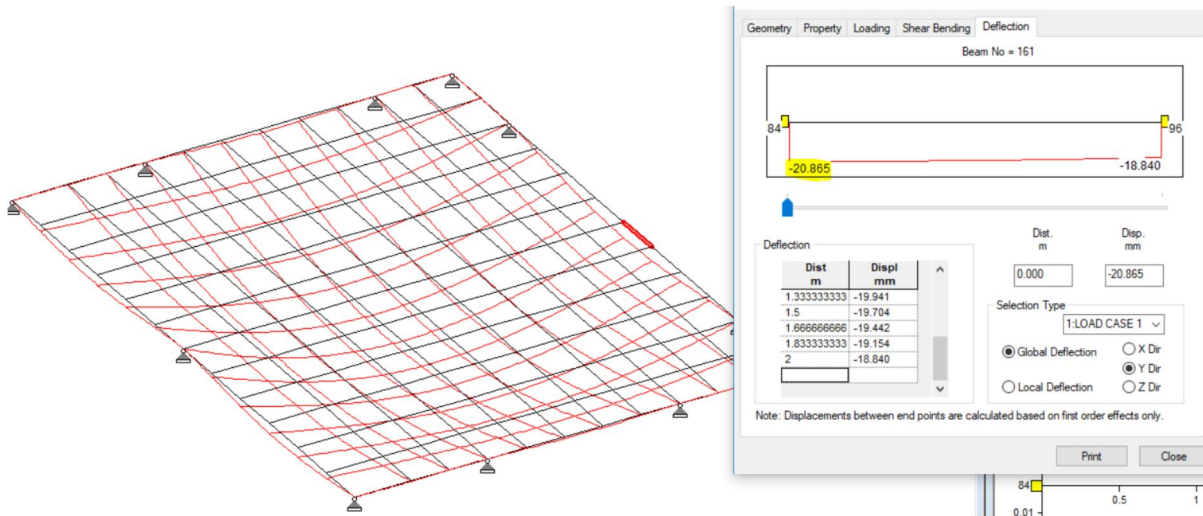
Maximum Deflection = 20.86 mm, as per analysis

Allowable Deflection = 64 mm for Span/250 as per Clause 23.2 Indian Standard (I.S.)
