Repair, Retrofitting and Rehabilitation Techniques for Strengthening of Reinforced Cement Concrete Structures Along with Experimental Work

Pushpendra Kumar Bachchan

Student, Civil Engineering, Lingaya's Vidyapeeth, Faridabad

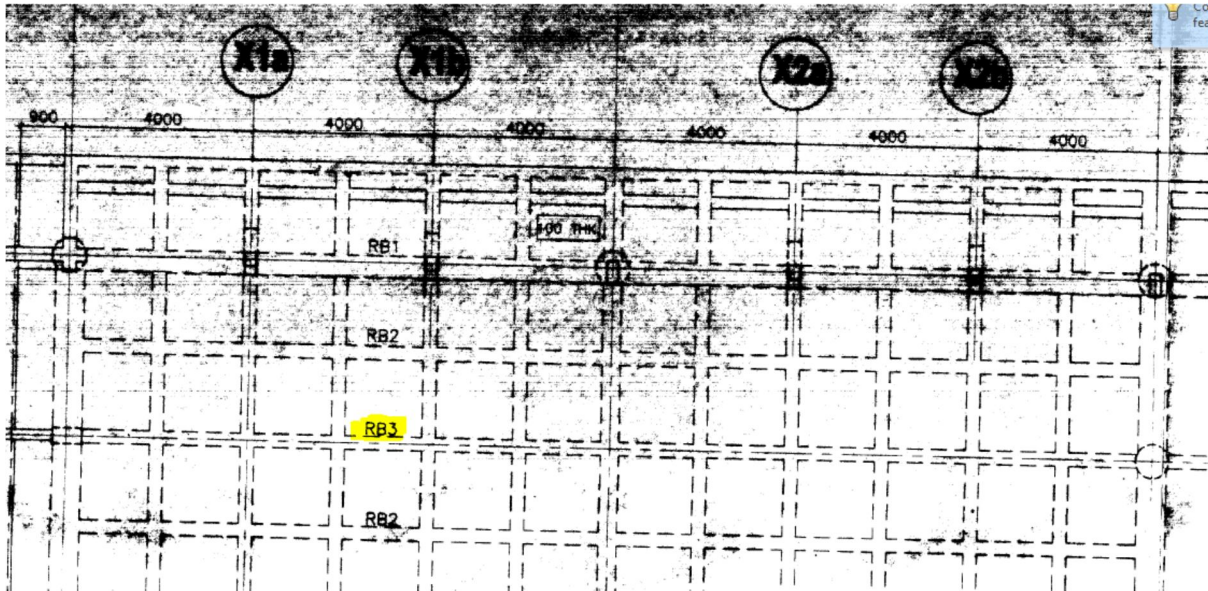
Fig. 1: Structural G.A. at 10.8 m Level, Drawing No. CEDZ-1743(S), Sheet 25/32, Dated 10-09-04.

In Banquet Hall, main portal having span of 24 m is analyzed in Staad Pro. The structural general arrangement (G.A.) drawing and the first-floor plan are as shown in Fig. 1 and Fig. 2.

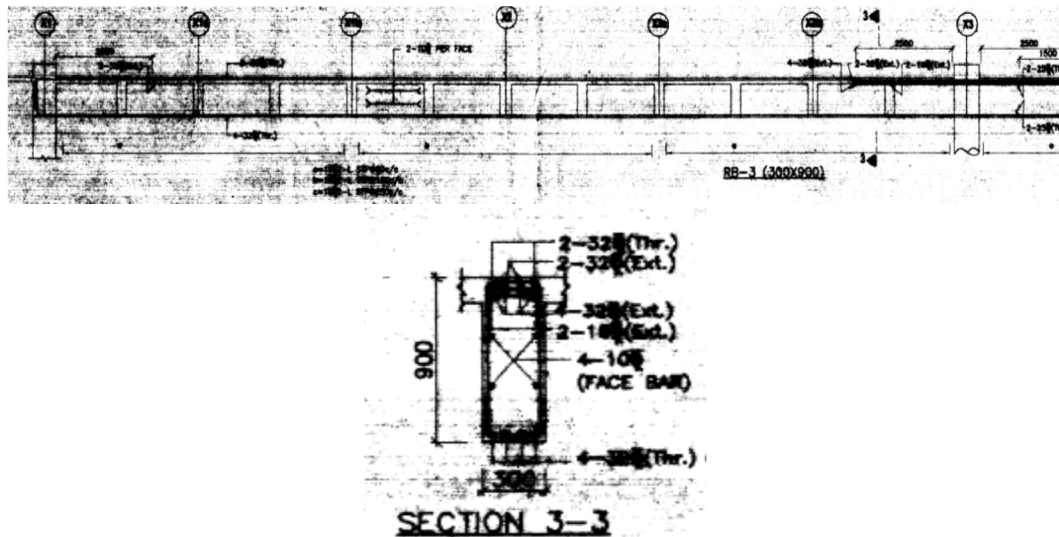
Fig. 2: Beam Details at 10.8 m Level, Drawing No. CEDZ-1743(S), Sheet 23/32, Dated 10-09-04.

Beam Size = 300 m × 900 m

Beam Span = 24 m

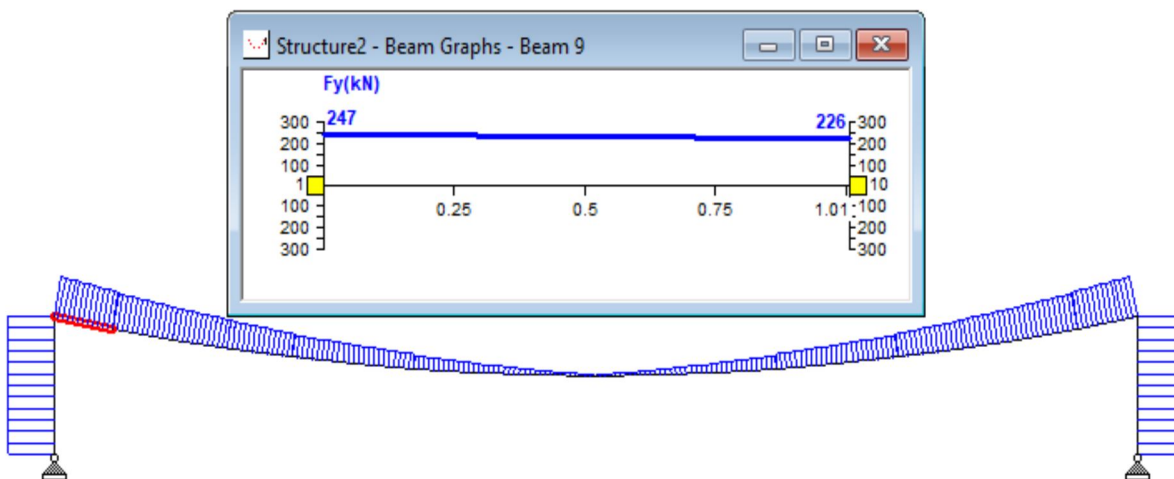
Shear Force (SF) Diagram

Total Shear force = 247 kN

Shear taken by Concrete - 0.7 N/mm² = 115.5 kN

Shear to be taken by steel = 131.5 kN

Provided shear reinforcement = T10 @ 120 mm c/c

Actual shear carrying capacity = 313 Kn

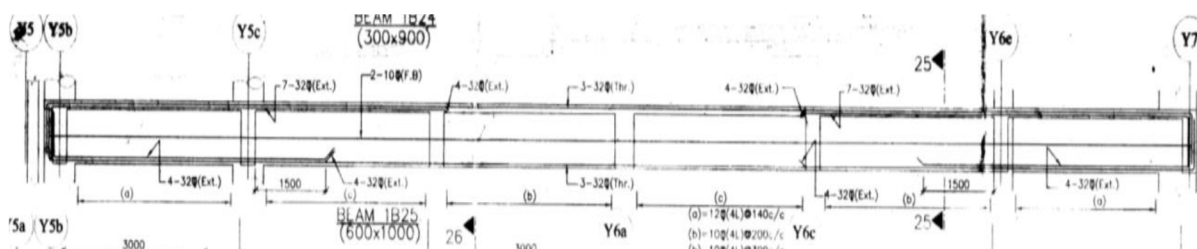
Fig. 6: Beam Details at 6.8 m Level, Drawing No. CEDZ-1743(S), Sheet 21/32, Dated 10-09-04.

Terrace Grid in Banquet Hall is analyzed in Staad Pro. The structural general arrangement (G.A.) drawing and the first-floor plan are as shown in Fig. 5 and Fig. 6.

Beam Size = 600 m × 1000 m

Beam Span = 16 m
