Repair, Retrofitting and Rehabilitation Techniques for Strengthening of Reinforced Cement Concrete Structures Along with Experimental Work

The main scope work included assessing structural condition of existing reinforced cement concrete (RCC) structure at the Project Construction Site, New Delhi through visual survey and non-destructive testing (NDT). During the meetings held with the contact officers, two phases of the project were made: (a) first phase: visual survey and NDT, and (b) second phase: only if requirement is felt from the first phase of the project, (i) structural analysis of the existing structure based on available drawings and data. For gravity as well as seismic loads by using structural analysis software such as SAP/ STAAD/ ETABS/ NISA, etc. (ii) suggestions and designing retrofitting scheme for the structure if it demands as per relevant Indian standard (IS) codes. Preparation and submission of detailed estimates, bill of quantities (BOQ), and specifications for retrofitting scheme.

B. Second Phase: Structural Analysis And Design Assessment

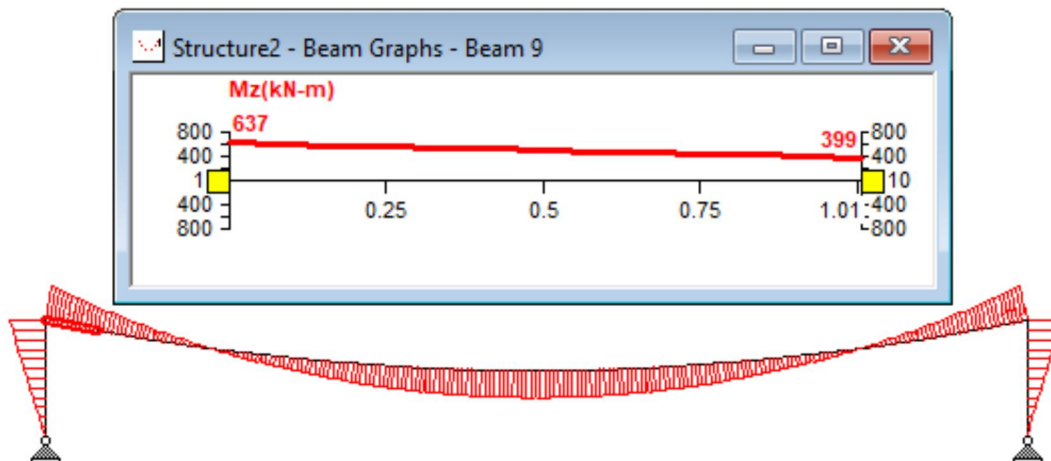
Bending Moment (BM) Diagram (Ultimate Load Case):

Position	Bending moment	Ast-required	Ast-provided
Top face @ support	637 kN-m	3080 mm ²	1875 mm ² (T25 - 3 Nos. + T16 - 2 Nos.)
Bottom face @ mid-span	504 kN-m	2440 mm ²	2100 mm ² (T25 - 3 Nos. + T20 - 2 Nos.)

Insufficient Flexural Reinforcement. Hence, Unsafe.

Some of the RCC members are found to be deficient their structural design. The distress observed and reported in Part-1 of the report, in the First Phase, can be related to these structural deficiencies mentioned above. Hence, in the current situation, immediate structural strengthening and tenantable repairs are essentially required. The analysis carried out for the typical selected members are indicative in nature. The agencies to be appointed for the strengthening should carry out a detailed evaluation of each member and implement appropriate strengthening technique based on the observed damage and analysis results. It is recommended that the enhancement in the structural properties due to the adoption of any strengthening strategy should be demonstrated by design calculations and/or on-site tests after execution, as applicable. Repairs and strengthening are suggested. While repairing all the distressed structural members and other related members need to prop for safety. The RCC elements in which extensive cracking, sapling of concrete and reinforcement is found exposed shall be repaired as per methodology and guidelines suggested by Indian standard (I.S.) codes, and separate detailed design of the structural strengthening be carried out.
