# Retrofitting of Confined Brick Masonry with FRP

Salman Hameed<sup>1</sup>, Samiullah Qazi<sup>2</sup> Muhammad Asif<sup>3</sup>, Sardar Ali<sup>4</sup>

**Keywords:** Confined brick masonry, RC tie beam column, FRP, Retrofitting, Seismic analysis, Quasi Static

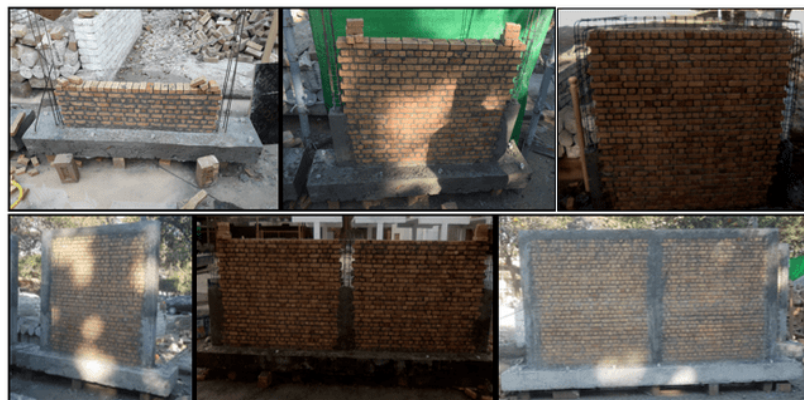
Figure 2. Models construction phases

A typical confined brick masonry walls of single bay and two bays was fabricated which replicated the walls of room of a typical building in Pakistan. The walls' dimensions were 1/3<sup>rd</sup> scale down due to limitations of the working space available in the research laboratory i.e. (UET) Peshawar. Dimensions of the Single Bay and two bay confined masonry walls was 46"x47" and 89"x47" respectively. These walls were constructed over 6" reinforced concrete pad with pre holes provided for securing it to the floor of testing frame. The walls were built using brick masonry in an English bond pattern with a thickness of 3" (76.2mm) and a 1:6 cement-sand mortar, as is typical in the area. In order to eliminate any vertical joint in the masonry each layer of the bricks is laid in a staggered pattern 0.75" toothing was provided in every course of masonry. Walls was confined by tie column having a size of 3"x3". 4 #1 longitudinal bars and #1 stirrups @ 6" c/c were used to for column reinforcing. Stirrups were made by combining three wires of 1mm diameter of binding wire. Tie beams were casted over the walls having a size of 3"x3" and reinforced with 4 #1 bars tied by #1 stirrups @ 6" c/c.

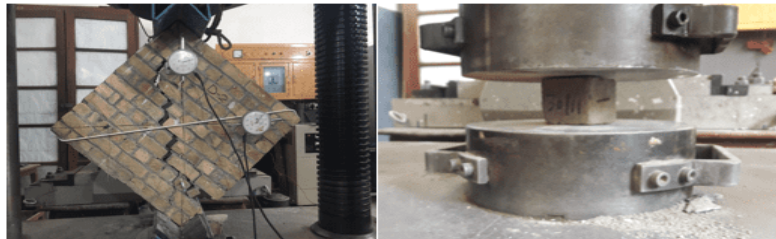
Figure 3. Diagonal Compression and Mortar Compressive Test

1/3<sup>rd</sup> scale brick of first class was selected after performing different types of tests from a local vendor. The Scale down brick replicated actual bricks qualitatively and quantitatively. After collecting all the essentials materials for the construction of walls, the second stage of experimental study was the testing of constituent materials to determine the different material properties. Compressive strength of masonry unit was calculated according to ASTM C-67 specification. Compressive strength of masonry unit was calculated according to ASTM C-67 specification. In order to measure the initial rate of absorption of brick units, Section 10 of the ASTM C-67 test specification was used. In compliance with the ASTM C-109 specification, the compressive strength of mortar used in brick masonry walls was determined using 2-inch mould. For the preparation of concrete, a standard ratio of 1:2:4 (1-part cement, 2 parts sand and 4 parts coarse aggregate) with a water-cement ratio of 0.6 was used. ASTM C39 parameters were used to measure the compressive strength of the concrete cylinder sample. The masonry tensile strength  $f_t$  was obtained by testing three masonry square prism of dimension 16”x16” under diagonal compression load as specified by ASTM 519 (ASTM C1391). All the results are shown in table 1.

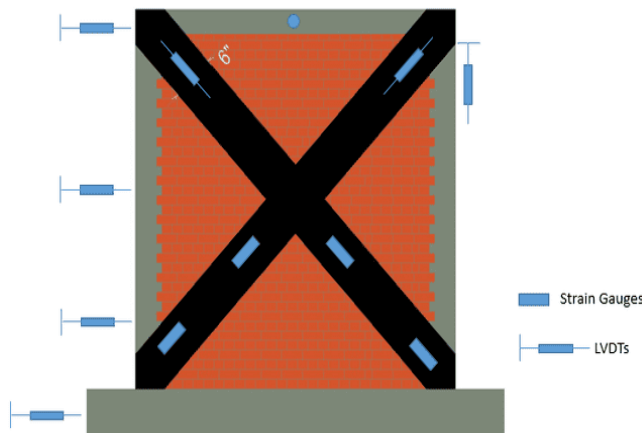
Figure 5. Instrumentation details

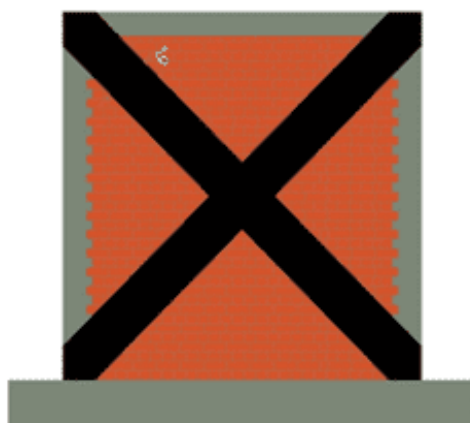
Figure 6. FRP Retrofitting configuration

FRP strips were bonded to both surfaces of damaged walls as part of the retrofitting process. Before joining the FRP strips, the cracks were cleaned with a brush and a blower but not sealed. A typical hand-held grinding machine was used to polish the surfaces of the walls. In order to achieve uniform and proper bonding between FRP and wall, surface along the diagonal strips were levelled with chemical mortar (Ultra Fairing Coat) as shown in figure. Diagonal configuration of FRP retrofitting was considered. Diagonal strips of width 6” were bonded in each direction on both sides of the wall as shown in figure. First, one coat of epoxy was applied to wall surface, then strip of FRP was bonded to pre-coated surface. Another coat of epoxy was applied over FRP strips with help of blade. In order to avoid detachment of FRP strips and to enhance the bond performance between the FRP and masonry substrate anchors were provided. Holes were driven at specific locations and then cleaned with pressurized air. Epoxy was injected in the hole through 100 ml syringe. Anchors made from FRP fiber were inserted in the holes and then fan out on FRP strips as shown in Figure 6.

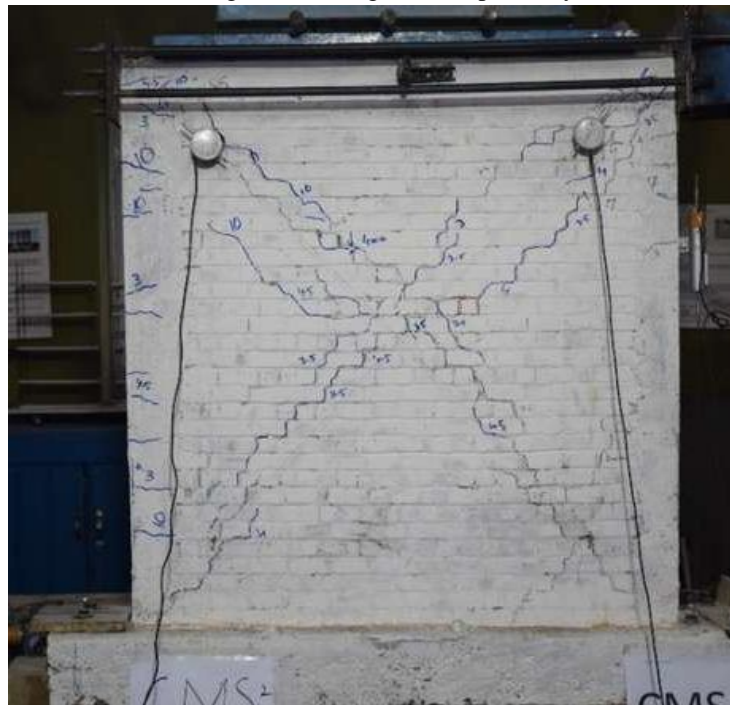
Figure 7: Damage pattern before retrofitting

A quasi-static load was performed in the specimen. The damage pattern of the specimen is shown in Figure 7. The dominant failure pattern was step crack passing through mortar joints. First crack was noticed at 2mm displacement cycle at bottom left corner. Major crack along the diagonal was started at 2.5mm displacement cycle. The cracks were mostly concentrated along the both diagonals. Cracks in the tie column was observed after 3mm displacement cycle. Some minor cracks originating from top corners were also noticed. The test was stopped at the maximum displacement of 10mm at which damages were of moderate. Hysteresis Curves and Bilinear Curve is shown in Figure 8 and Figure 9 respectively.

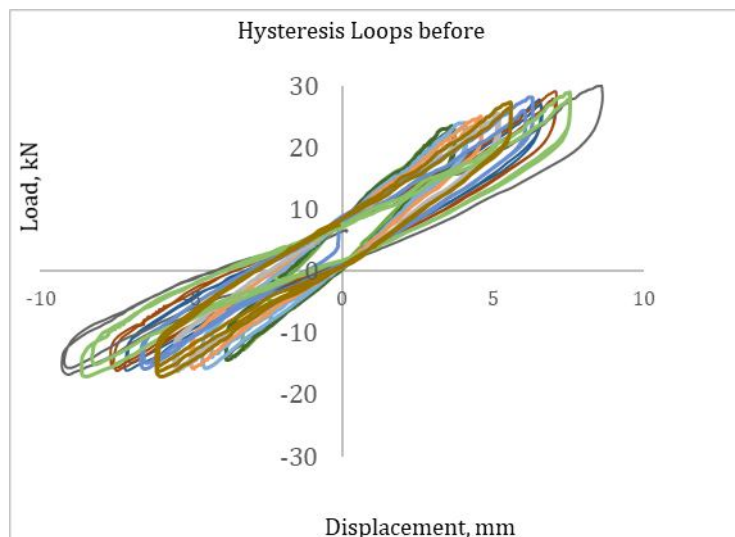
Figure 8: Hysteresis Curves before Retrofitting

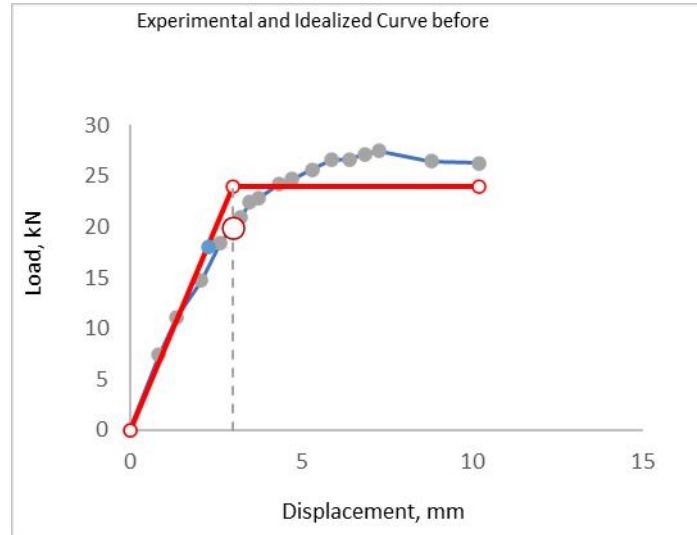
Figure 9: Bilinear Curve Before Retrofitting

#	Parameter	Before	After
1	Peak load V max (kN)	27.46	43.2
2	Peak displacement (mm)	7.29	4.65
3	Lateral Yield Strength, (kN)	25	35
4	Yield displacement (mm)	3	2.44
5	Ultimate Displacement (mm)	10.21	7
6	Lateral Stiffness, (kN/mm)	8.33	14.46
7	Yield Drift (%)	0.25	0.2
8	Ultimate Drift (%)	0.86	0.59

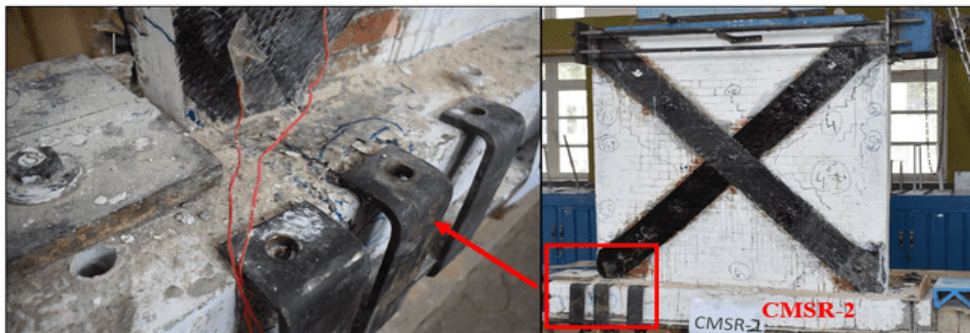
Figure 10. Crack pattern and failure mode after Retrofitting

The damage specimen and cracks pattern are shown in Figure 10. Formation of first crack occurred when the specimen was subjected to 2.5mm displacement. At 5mm displacement a horizontal crack at the interface of masonry and footing was observed which extend toward the tie columns in both directions. A diagonal shear crack appeared in the tie column which was wide enough to be visually seen during testing. Foundation pad become cracked at the top near the bottom of left tie column. This crack becomes wide and extended toward the bottom due to increase in lateral displacement. The test was then stopped. Hysteresis Curves and Bilinear Curve is shown in Figure 11 and Figure 12 respectively.

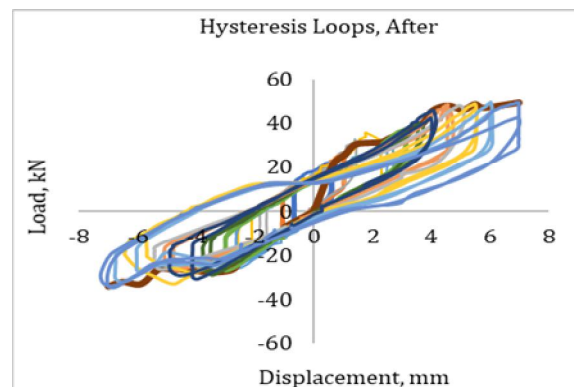
Figure 11. Hysteresis Curves after Retrofitting

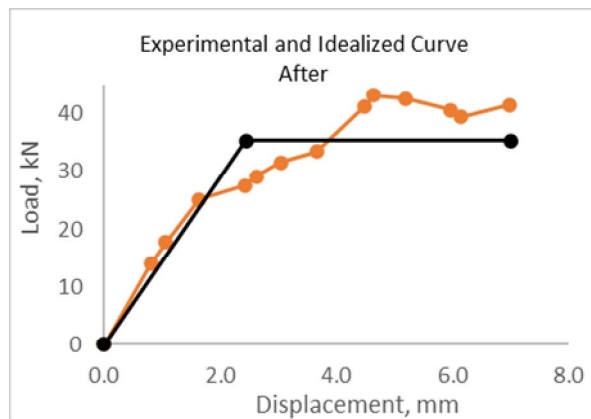
Figure 12: Bilinear Curve After Retrofitting
