# Retrofitting of Confined Brick Masonry with FRP

Salman Hameed<sup>1</sup>, Samiullah Qazi<sup>2</sup> Muhammad Asif<sup>3</sup>, Sardar Ali<sup>4</sup>

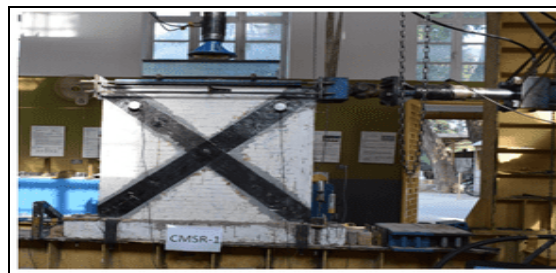
Figure 4. Load setup and instrumentation details

All the models were investigated in Structural Engineering laboratory. The bottom of specimen was fixed with stiff steel girder through bolts. Top of the specimens were kept free to allow free translation and rotation. This setup is used to simulate cantilever type setup. One actuator of 50-ton capacity was used to subject constant vertical compression load. Another actuator of same capacity was used to subject horizontal load. Vertical load was subjected on steel girder placed on 1.5” steel roller. The steel roller was roll ed on 1.5” inch thick steel plate placed on the top beam, which in turn distributed vertical load uniformly s shown in figure. Three LVDTs were connected to record horizontal displacement. LVDTs along the diagonals were also connected. Location of various LVDTs are shown in Figure 3.25. As illustrated in the figure, strain gauges were also utilized to record strain in the FRP strip at various points. As indicated in the diagram, all of these instruments were linked to a data logger machine (UCAM 70). All the LVDTs were calibrated in the UTM machine before test. Also, the load cells and data cable were checked and calibrated.

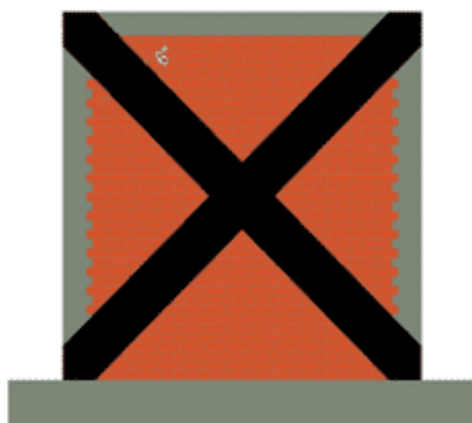
Figure 6. FRP Retrofitting configuration

FRP strips were bonded to both surfaces of damaged walls as part of the retrofitting process. Before joining the FRP strips, the cracks were cleaned with a brush and a blower but not sealed. A typical hand-held grinding machine was used to polish the surfaces of the walls. In order to achieve uniform and proper bonding between FRP and wall, surface along the diagonal strips were levelled with chemical mortar (Ultra Fairing Coat) as shown in figure. Diagonal configuration of FRP retrofitting was considered. Diagonal strips of width 6" were bonded in each direction on both sides of the wall as shown in figure. First, one coat of epoxy was applied to wall surface, then strip of FRP was bonded to pre-coated surface. Another coat of epoxy was applied over FRP strips with help of blade. In order to avoid detachment of FRP strips and to enhance the bond performance between the FRP and masonry substrate anchors were provided. Holes were driven at specific locations and then cleaned with pressurized air. Epoxy was injected in the hole through 100 ml syringe. Anchors made from FRP fiber were inserted in the holes and then fan out on FRP strips as shown in Figure 6.

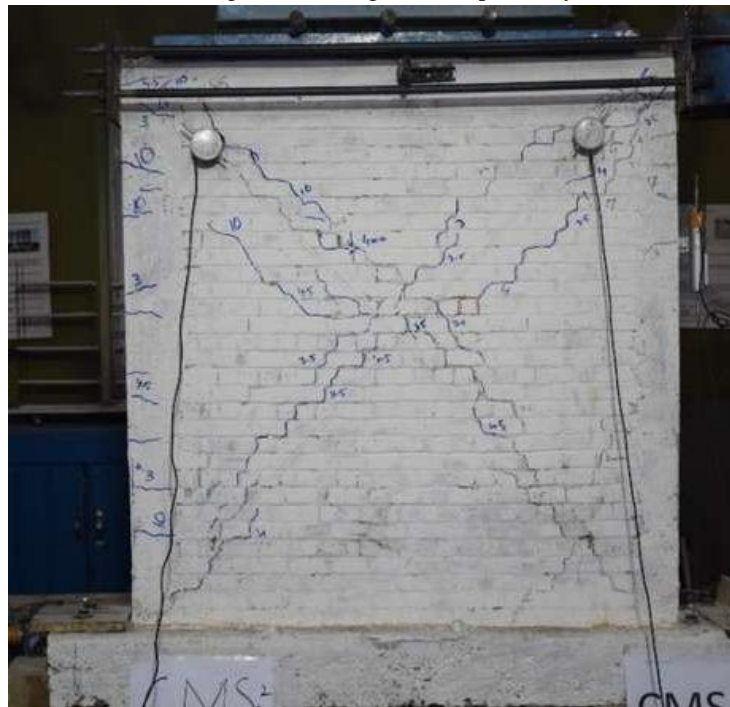
Figure 7: Damage pattern before retrofitting

A quasi-static load was performed in the specimen. The damage pattern of the specimen is shown in Figure 7. The dominant failure pattern was step crack passing through mortar joints. First crack was noticed at 2mm displacement cycle at bottom left corner. Major crack along the diagonal was started at 2.5mm displacement cycle. The cracks were mostly concentrated along the both diagonals. Cracks in the tie column was observed after 3mm displacement cycle. Some minor cracks originating from top corners were also noticed. The test was stopped at the maximum displacement of 10mm at which damages were of moderate. Hysteresis Curves and Bilinear Curve is shown in Figure 8 and Figure 9 respectively.

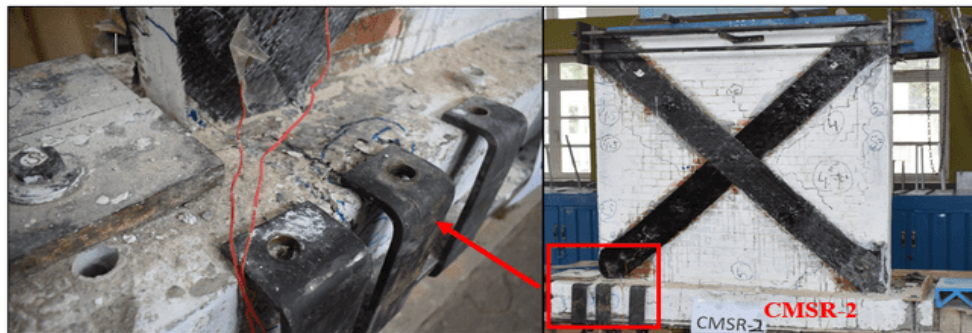
Figure 10. Crack pattern and failure mode after Retrofitting

The damage specimen and cracks pattern are shown in Figure 10. Formation of first crack occurred when the specimen was subjected to 2.5mm displacement. At 5mm displacement a horizontal crack at the interface of masonry and footing was observed which extend toward the tie columns in both directions. A diagonal shear crack appeared in the tie column which was wide enough to be visually seen during testing. Foundation pad become cracked at the top near the bottom of left tie column. This crack becomes wide and extended toward the bottom due to increase in lateral displacement. The test was then stopped. Hysteresis Curves and Bilinear Curve is shown in Figure 11 and Figure 12 respectively.
