# Seismic Assessment of Unreinforced Concrete Block Masonry Buildings Before and After Retrofitting: A Case Study

Jaineshwar Verma<sup>1</sup>, Satish Parihar<sup>2</sup>

<sup>1</sup>PG Student, <sup>2</sup>Associate Professor, Civil Engineering Department, Faculty of Engineering and Technology, Rama University, Kanpur

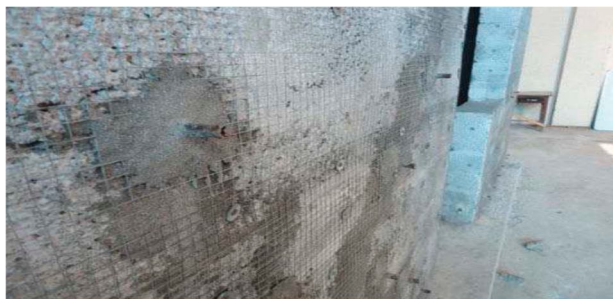
The URCBM structure previously tested under quasi-static reverse cyclic loading was first repaired with surface grouting having 1:4 cement-sand mortars. The walls were repaired with a rich cement mortar and cured afterwards for seven days. Galvanized steel welded wire mesh capable of resisting corrosion was attached to the outside and inside walls of the structure by means of 38 mm (1.5 in) long screws, plastic plugs, and steel washers. Special care was taken to ensure that the holes drilled for the screws in blocks (and not in mortar), since the latter could further damage the already cracked masonry to be repaired. Two screws per square foot were placed over the retrofitted region.

The walls were then cured for a period of three days so that the repair mortar develops the necessary bond. Locally designed and fabricated assembly was used for injecting the grout at a known pressure. Before grout injection, cracks in the masonry walls were sprinkled with tap water to ensure proper adhesion of the masonry and mortar. As the water was passed through the walls, the cracks became visible from the exterior. After a few minutes of this operation, grout was then injected through the nozzles at a pressure of three bars for 2–3 min so that the injected grout gets absorbed. The wall was cured afterwards for three days in order for the injected grout gain sufficient strength and develop bond. The walls were plastered with 1:4 cement-sand mortar and then allowed to undergo regular wet curing for a period of 14 days. Finally, the walls were white washed with lime to better visualize the cracks during testing.

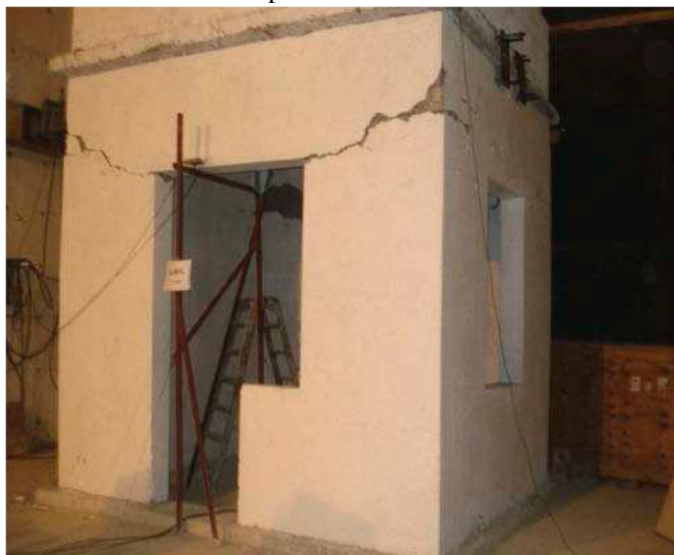
Fig. Final damage pattern for the retrofitted building

The cracking pattern of the structure after retrofitting is shown observed damage at the in-plane north wall and out-of-plane east wall are provided. A spiral cracking pattern rather than stair stepped pattern was observed for the retrofitted building. The increase in the thickness of the walls due to the application of the ferro-cement overlay caused a reduction in the aspect ratio, which resulted in a stable rocking mode of failure rather than a mixed compression-shear failure.

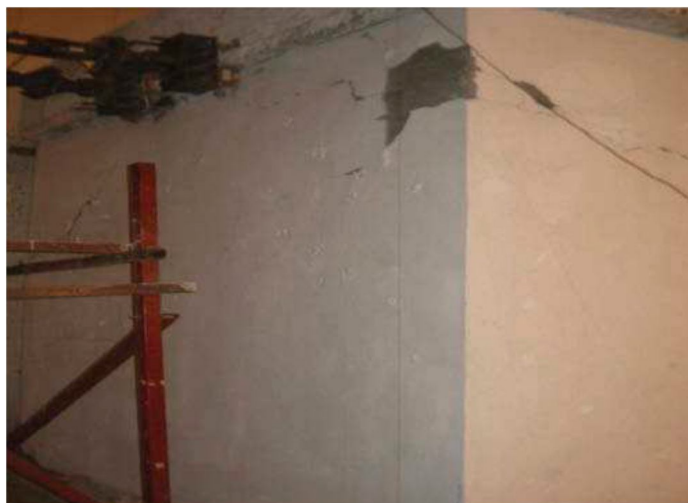
Fig. Falling of plaster observed on retrofitted building.
