Seismic Assessment of Unreinforced Concrete Block Masonry Buildings Before and After Retrofitting: A Case Study

Jaineshwar Verma¹, Satish Parihar²

¹PG Student, ²Associate Professor, Civil Engineering Department, Faculty of Engineering and Technology, Rama University, Kanpur

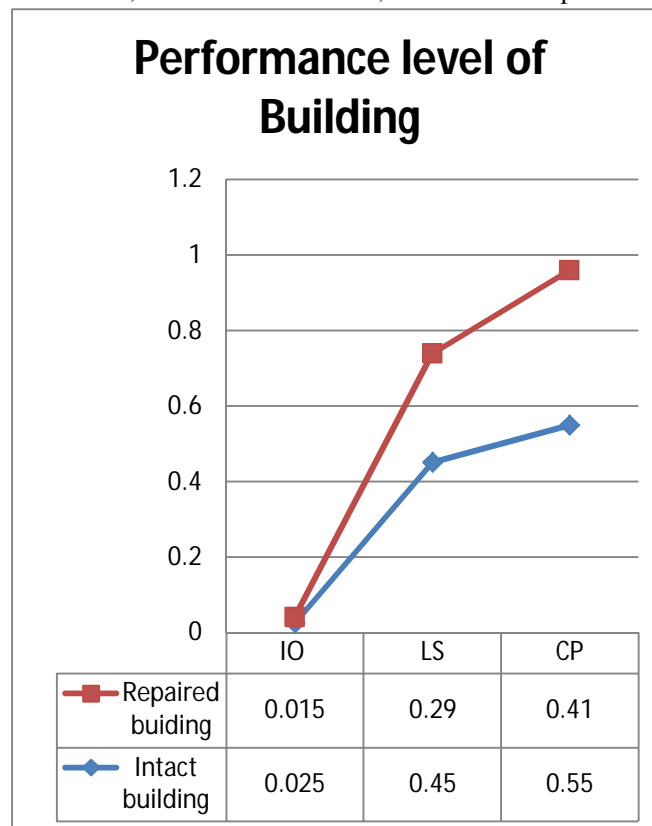
- 7) The deformation capacity of the retrofitted structure reduced by 66.7%, 29.8%, and 26% for the IO, LS, and CP limit states, respectively.
