Seismic Assessment of Unreinforced Concrete Block Masonry Buildings Before and After Retrofitting: A Case Study

Abstract: *This article presents the results of a case study on the performance of unreinforced concrete block masonry building system. The configuration and materials used for the single-story building are typical of those found in the northern areas of 2005 Kashmir earthquake. The retrofitting of the building was done using Ferro-cement overlay and cement based grout injection. Combined shear and flexure failure was observed during the test before retrofitting. The lateral load capacity of the retrofitted building was significantly improved and the damage mechanism was transformed from mixed compression-flexure-shear to a more stable flexural rocking mode. Damage patterns and deformation behavior of the retrofitted structure are compared to the intact structure to quantify the benefits of retrofitting scheme, which is proposed as an efficient approach for the rehabilitation of the existing buildings. Study data were analyzed and presented in the form of force-deformation loops and envelope curves. Based on the measured data, different performance levels before and afte

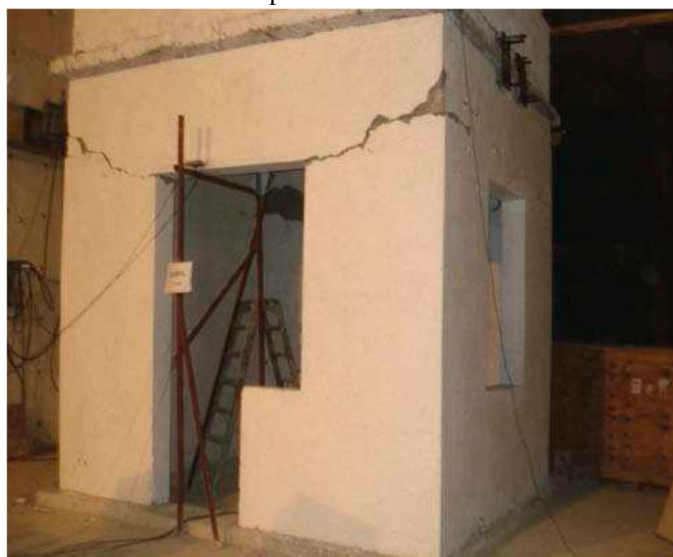
The cracking pattern of the structure after retrofitting is shown observed damage at the in-plane north wall and out-of-plane east wall are provided. A spiral cracking pattern rather than stair stepped pattern was observed for the retrofitted building. The increase in the thickness of the walls due to the application of the ferro-cement overlay caused a reduction in the aspect ratio, which resulted in a stable rocking mode of failure rather than a mixed compression-shear failure.

Fig. Final damage pattern for the retrofitted building
