Geohazard and Vulnerability Risk Analysis as Inputs in Mainstreaming Climate Change in Developing Country

Oliva Canencia¹, Vida Fe K. Lagumbay², Vicenta Ansigbat³, Arnulfo Osio⁴, Richmund Palma⁵, Rogel Tulang⁶, Gina Lacang⁷, Remy Tamang⁸, Ronela Enguito⁹

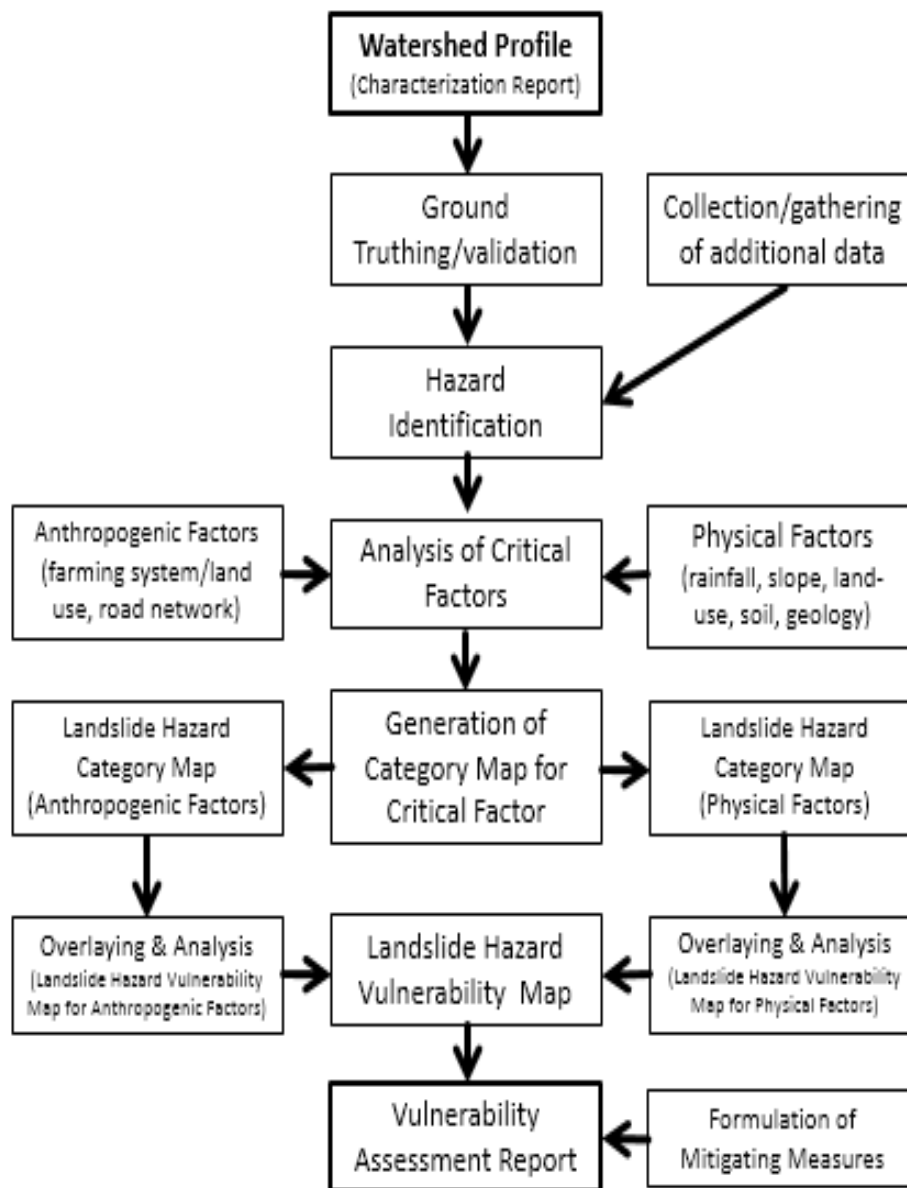
Figure 2. Framework of the Identification of Critical Factors Affecting Landslide Hazard

There were two (2) major components adopted in assessing vulnerability risk uncertainties namely, Landslide Hazard and Soil Erosion Hazard respectively presented their framework in Figures 2 and 3.

- 1) *Landslide Hazard (Physical and Anthropogenic Factors)*: This consist of major steps to consider in the analysis of landslide hazard such as: (a) identification of critical factors that affect the vulnerability of an area to landslide hazard that include slope, rainfall, land use or vegetative cover, soil type, and geologic formation; (b) mapping of critical factors for each of the identified factors affecting the occurrence of landslide; (c) preparation of landslide hazard category maps of the critical physical factors for the the slope of the area, five (5) slope ranges are categorized with its corresponding vulnerability rating from 1 to 5 wherein 1 has slopes ranging from 0-8% and 5 has the worst slope category of more than 50%. Table 1 shows the Rating of Critical Factors affecting Landslides;

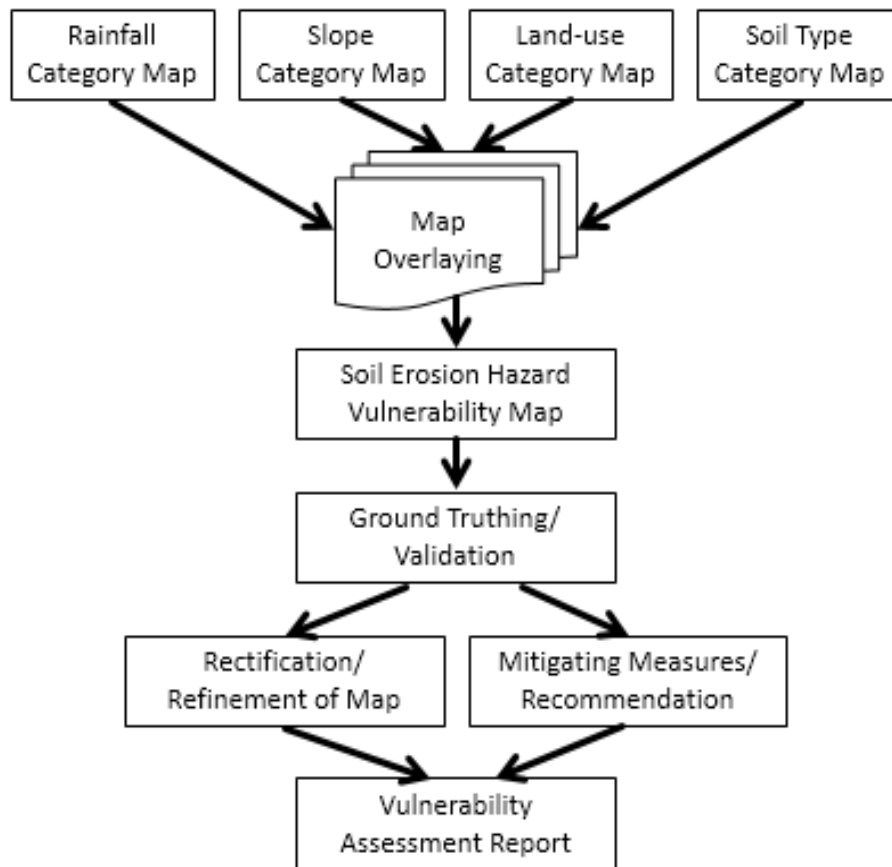
2) *Soil Erosion Hazard Vulnerability Assessment*: The framework presented in Fig. 3 follows the vulnerability assessment and analysis of soil erosion hazard addressing the four steps namely: (a) Methods of assessing the vulnerability of the area to soil erosion hazard; (b) Identification of critical factors that influence the occurrence of soil erosion; (c) Generation of critical factors category maps and assignment of weights; and (d) Overlaying of physical factors category maps and determination of soil erosion hazard vulnerability map.

Figure 3. Framework of Soil Erosion Hazard Vulnerability Assessment

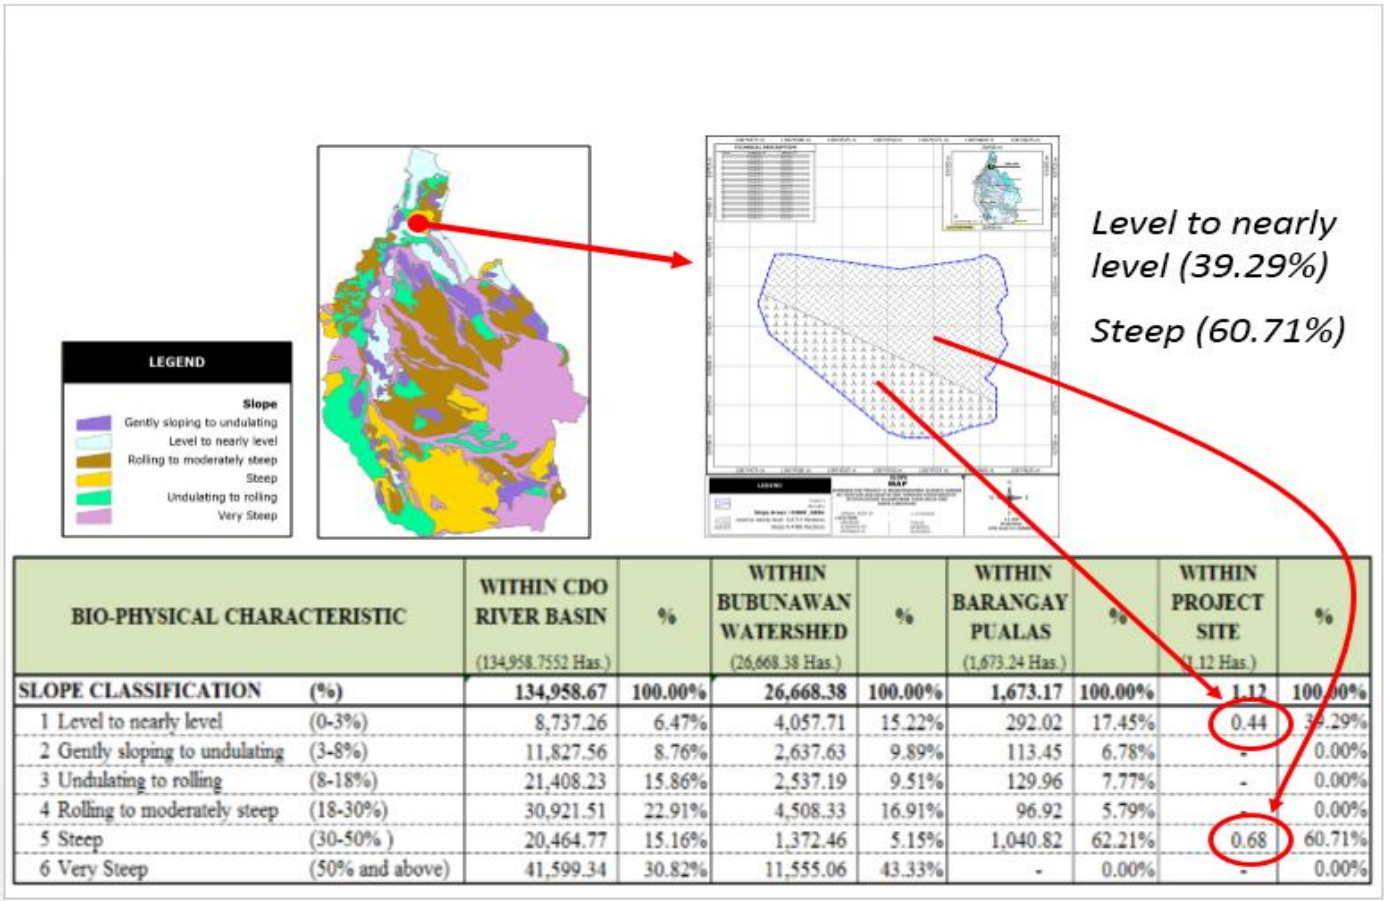
Figure 4 presents the slope classification of the project site with reference to the Cagayan de Oro River basin, the Bubunawan sub-watershed and the entire landscape. The project site was classified under two slope categories: level to nearly level (0-3%) of about 39% of the total area and steep (30-50%) category consisting of about 61%. The table further presents that for the entire CDO River basin, 31% of its total land area belong to the Very steep category (50% and above); for the entire Bubunawan subwatershed, 42% of it also falls under the same category. In the case of Pualas, about 66% of the barangay is classified as steep (30-50%) slope. Moreover, in all four locations presented in figure 4, there is a small percentage to the level to nearly level category.

Figure4. Slope Map of the Pilot Area

The elevation gradually increases as the direction shifts to the north where an intermittent creek radiates to the west going downstream in the southeast direction, further joining other small tributaries that drain towards the Bubunawan River. In terms of the overall aspect, the Agroforestry (AF) pilot site can be described as generally exposed to sunlight during daytime. This location greatly favors the growth of agroforestry species planted in the site since enough sunlight is also necessary for plant growth.

Furthermore, the agro-forestry pilot site consisted of about sixty-seven per cent (67%) level to nearly level and about thirty-seven percent (37%) of steep slope. Per ocular inspection conducted, the steeper portions are generally covered with grass vegetation and the evidence of soil erosion was also noted.

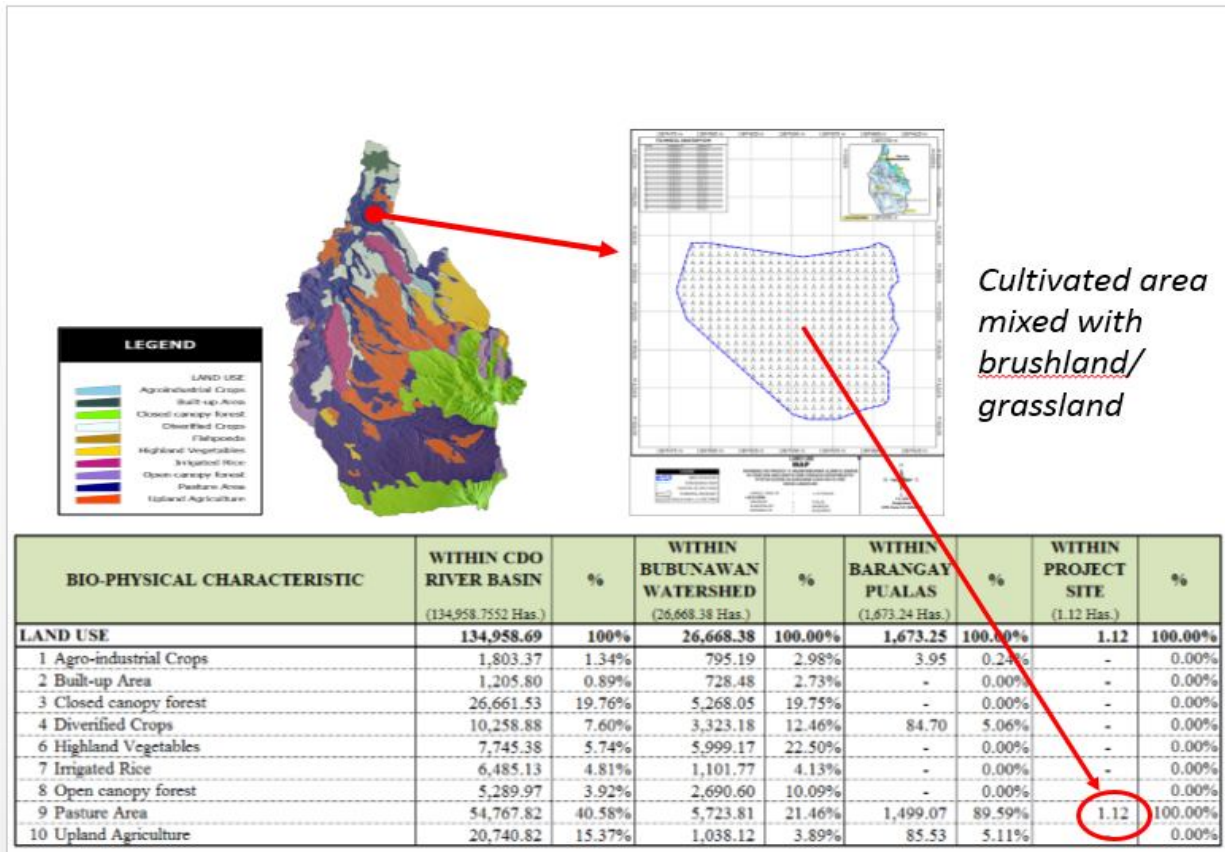
Figure 5 shows the Land Use of the entire Bubunawan Sub-watershed of which the Pilot Site is situated within one component area, barangay Pualas.

Figure5. Land Use of the Pilot Site

As can be gleaned from table, about twenty-two percent (22%) of the entire Bubunawan watershed is classified as pasture in as much as grasses predominate. In the same manner, the identified CBFM-owned Agroforestry Pilot site is also occasionally used as pasture by the residents. The local community is engaged in diversified crop farming. This further shows that agro industrial crop production is higher within the Bubunawan watershed (2.62%) compared to the Cagayan de Oro River basin (1.32%) and much smaller in Barangay Pualas (0.20%). These data are attributed to the presence of pineapple, banana, and rubber crops established. On the other hand, there is more percentage of open canopy forest in Bubunawan Watershed than within Cagayan de Oro River Basin which may suggest that there is a higher rate of forest degradation in Cagayan de Oro environs. The land cover map for the Agroforestry pilot site presented in figure 6, is categorized as pasture area then grasses predominate among other vegetative type.
