International Journal For Research in
Applied Science and Engineering Technology

Volume: 5 Issue: XI Month of publication: November 2017

Advanced and Improved Non-Destructive Method for Rail Axle Inspection

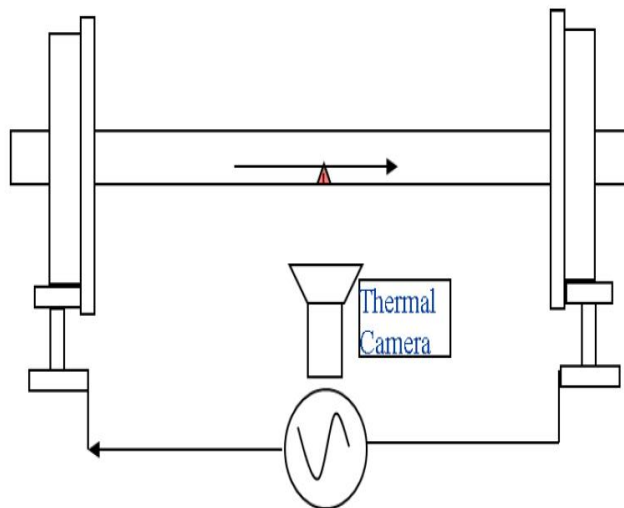
Fig 1 Principle of AC thermography technique

A high frequency electric current is passed through the axle when it passes over the inspection station, causing it to heat slightly. The current flow is distorted near a crack and this result in a different heating pattern. This method which is very sensitive and capable of detecting cracks of 0.8mm deep, only if the right conditions can be reached.

The main concept of this method is shown in Figure 1.

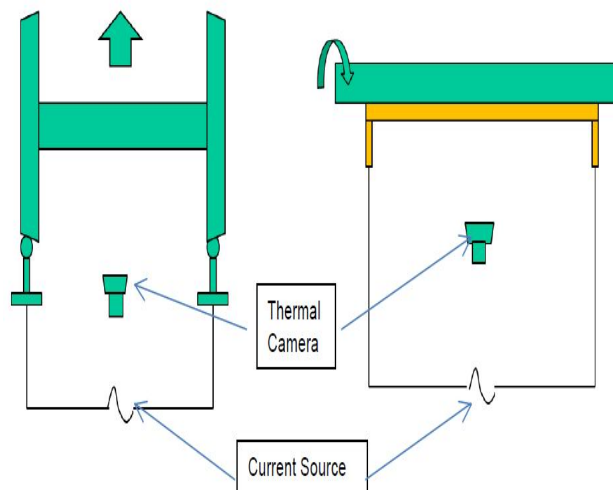
Figure 1 Configurations of the induction system

Left: track mounted system using direct AC. Right: axle mounted on rollers and workshop using induced AC. The project was attempted using modelling and with practical trials, which are described below.

However, to inspect a moving axle, the electric current has to be passed directly through the axle and this can be shown in below figure.

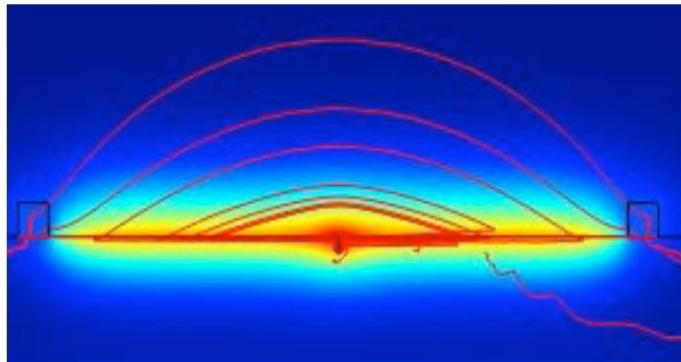
The crack gap was set at $100\mu\text{m}$ and the heating time was up to 3s. The potential at the electrodes was set at 1V (meaning that the current was less for higher frequency). 2D models were used first. Figure shows a typical result.

Fig 2 Showing heating and electric field for 20 KHz, 2 mm deep crack

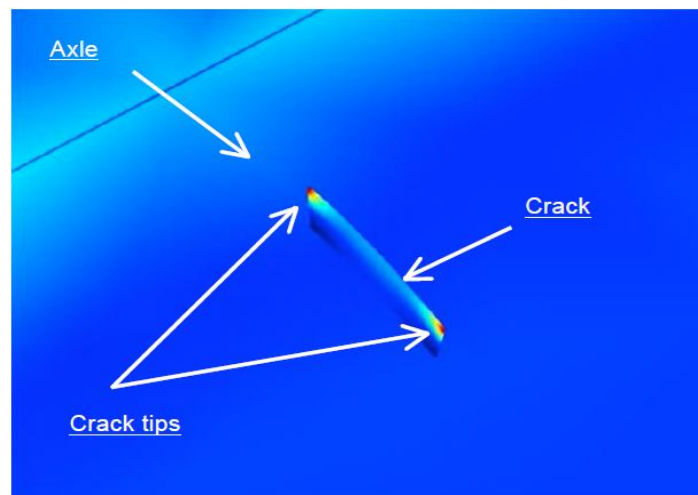
An Indication of crack through 2D models was successful to some extent but could not give a full explanation of crack depth so for this purpose 3D full size model was attempted. The potential shown by the 2D model resulted in 3D model for full axle which proved successful and this result output is shown in the following figure.

Fig 2.1 Figure showing the result output from 3D model

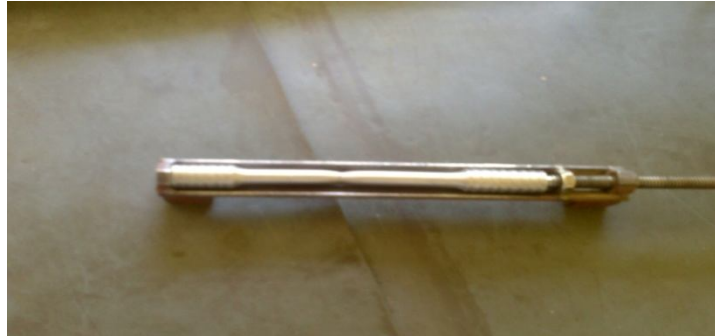
Specimen used i.e. Steel bar of 20mm diameter is as shown in below figure

Figure showing the steel bar of 20mm diameter

To carry out the small scale, set of three samples of 20mm steel bar were manufactured with fatigue crack of different size of 0.9mm, 1.7mm and 4.3mm deep. This fatigue crack depth was accurately measured by ACPD i.e. An ACPD method has been developed as an NDT technique that can accurately characterize surface breaking fatigue cracks in metal specimens. The required high current was able to pass through them by means of direct heating.

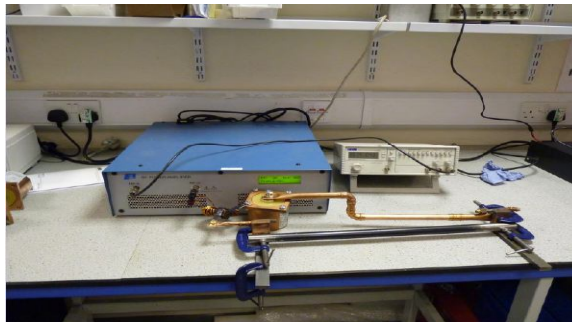
Direct Heating setup for a small scale sample

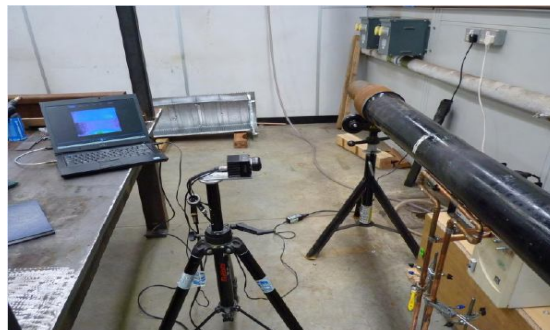
The mode of heating to this setup is through induction system. The full scale arrangements for an axle by induction heating system is shown in below figure

Figure showing the complete Induction method of full axle setup.

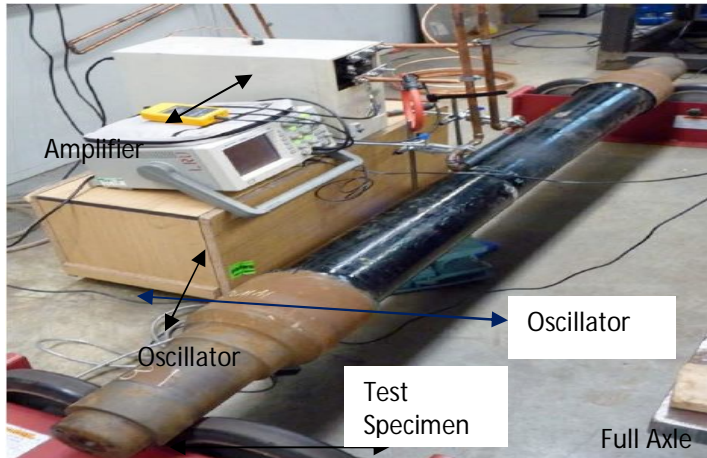
Figure showing the Induction type of heating system.

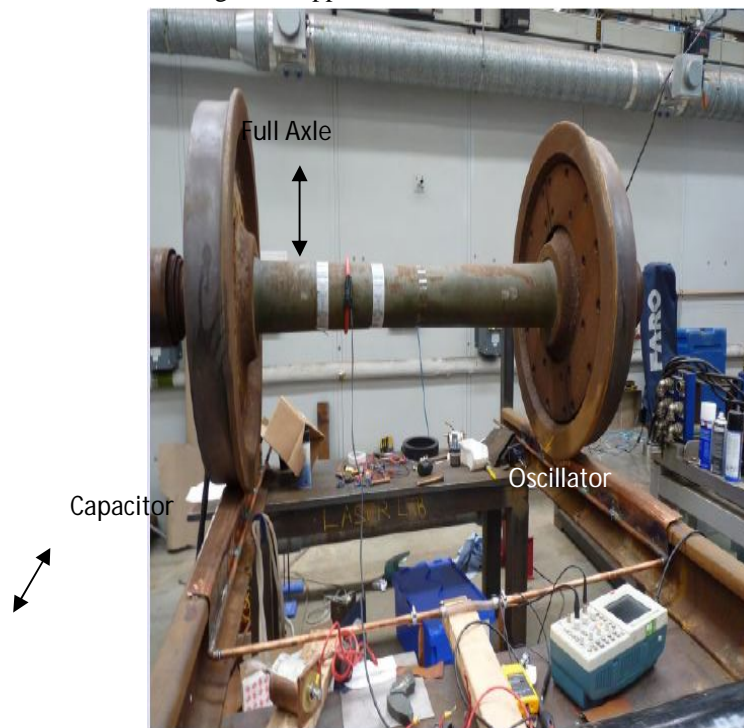
Investigations were carried out for the total view of field of the thermal camera. This was done by making a practical trial of experiment by conducting on full scale working axle. Application of direct current on full axle is as shown in figure.

Direct Heating of Complete Wheel set (Front View)

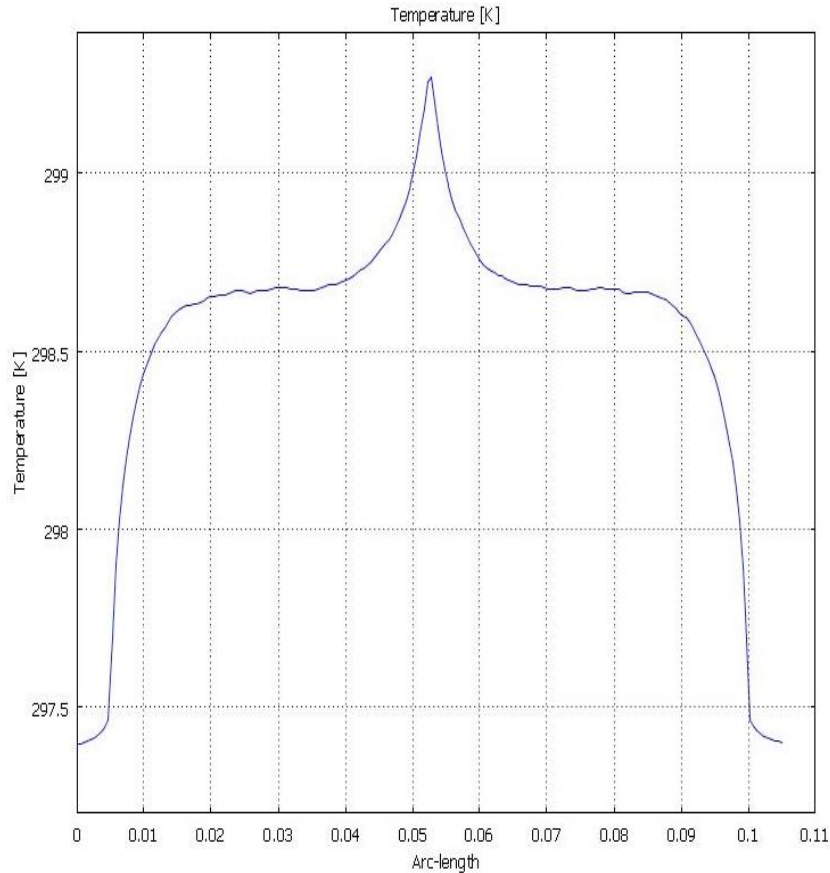
Graph2.1 Showing Surface temperature with 2mm deep crack at 100 KHz.

From the above graph 5.1 we can clearly detect the crack. It shows in X-axis the applied Temperature in Kelvin, it shows that the surface temperature is 298.65°K and crack temperature to be 299.25°K. In Y-axis is the arc length ie the length of the crack depth from the surface. This is shown in below table 2.1.

By looking at the figure 1.6 we can't understand the concept of the method and Probability of crack detection, so to detect the crack in more easy way a cross section of the crack was taken to get a better idea and this is shown in the below figure .

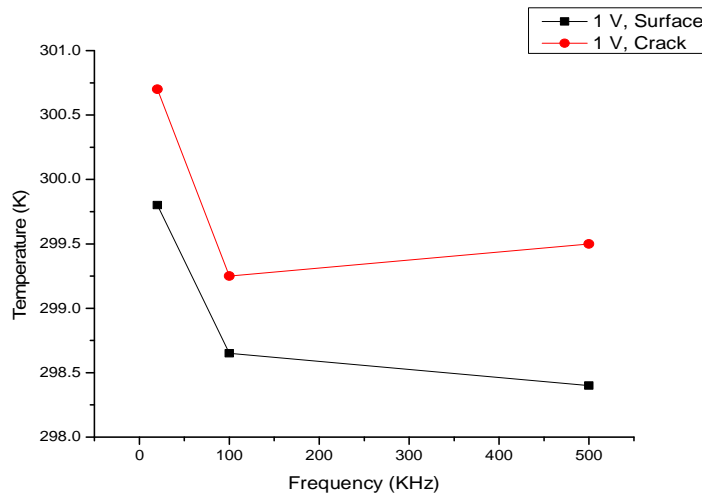
Keeping this in mind, various sets of 2D trials were conducted and comparison was made particularly for crack. Comparison of crack was made starting with 20 KHz and there by varying the frequency to 100 KHz and 500 KHz by keeping the potential to 1 V. This is Shown in following Table 2.2.

Graph 2.2 Crack and Surface temperature Comparison of 2D models.

From the point of view of discrimination the 2D models Showing the Graph 5.2 and Graph 5.3 it appears to be advantage to use as a high a frequency of 500 KHz and potential of 2 V. This gives the better crack detecting probability i.e. Crack temperature being 307°K as the surface temperature being 302.5°K .

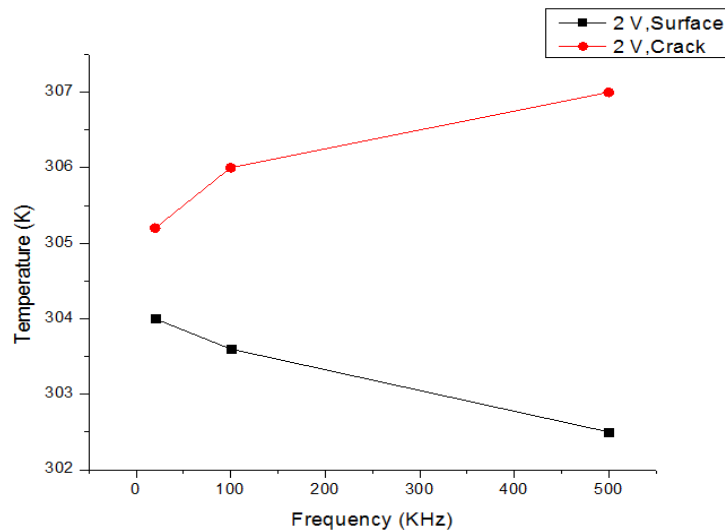
Next Comparison was made by changing the potential to 2V and varying the frequency 20 KHz, 100 KHz and 500 KHz. This is shown in below table 5.3.

Graph 2.3 Crack and Surface temperature Comparison of 2D models.

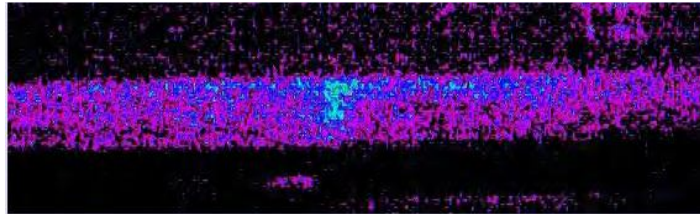
The experiment was carried with direct heating starting with steel bar painted black for quick heating purposes so that it can be more visible in thermal camera, For this purpose Thermoteknix 310L camera was used to take thermal image. So steel bar of 0.9mm fatigue crack was used to check the possibility of visual which proved to be fatal i.e. no proper thermal image could be seen. As this can be seen in the below figure 3.1.

Fig 3.1 Showing the fatigue crack of 0.7mm small scale sample of 20mm steel bar.

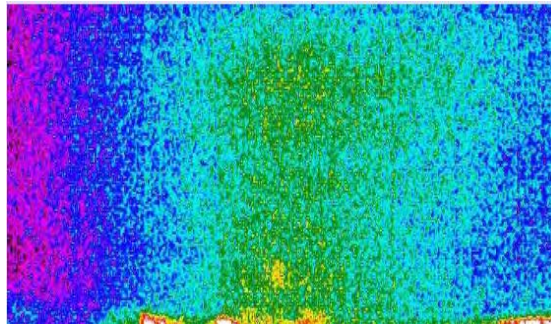
The above figure 5.1 was not pictorially clear to recognize the crack points, so the next sample of 1.7 mm fatigue crack was used again by direct heating. Again for this to no proper visibility was seen. This is shown in below figure 3.2.

Fig 3.2 Showing the fatigue crack of 1.7mm of 20mm diameter steel bar.

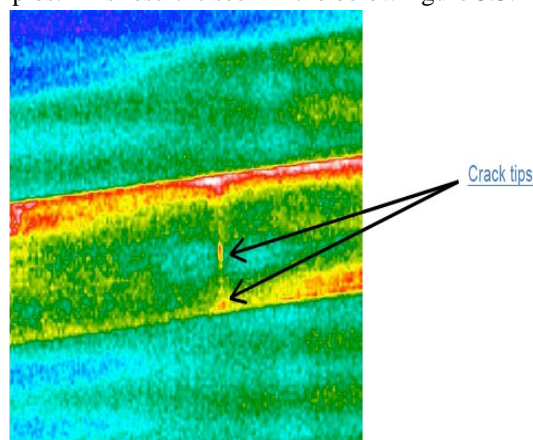
So the final sample of 4.3mm fatigue crack of steel bar was taken and experiment was carried out with direct heating. Using Thermoteknix 310L camera the thermal image was taken and could get satisfaction result of detecting the crack tips, which were more noticeable than the rest of the steel samples. This result is seen in the below figure 3.3.

Fig 3.3 Crack tips are easily noticeable in 4.3mm fatigue crack of steel bar.

From the above figure 5.3 we could easily distinguish between the three samples of steel bar of 20mm diameter. Crack can be easily noticeable in 4.3mm fatigue crack of steel bar because reason is simple, when current is passed across the steel bar by direct heating the crack gets heats up due to this reason the crack tips can be seen. This is shown in the above figure 3.3.

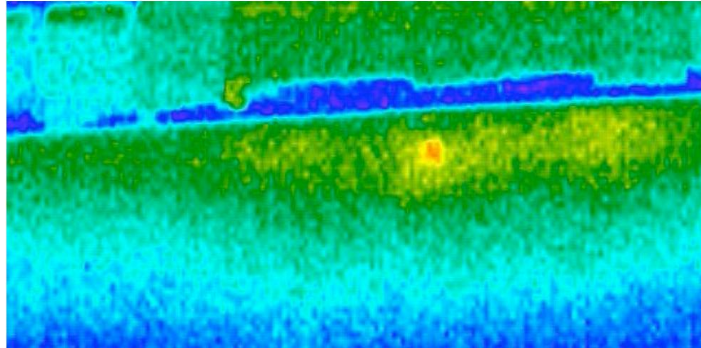
An Axle is made to rotate on its axis as shown in figure 4.11 by a set of rollers connected at the end. This is done to completely cover the axle surface without missing any portion of the surface. A thermal image was taken to see any crack defect in the full axle, by scanning the whole axle. The visibility of hot spot from crack end was seen. This is shown in the below figure 3.4.

Fig 3.4 Clear view of Hot spot from crack end.

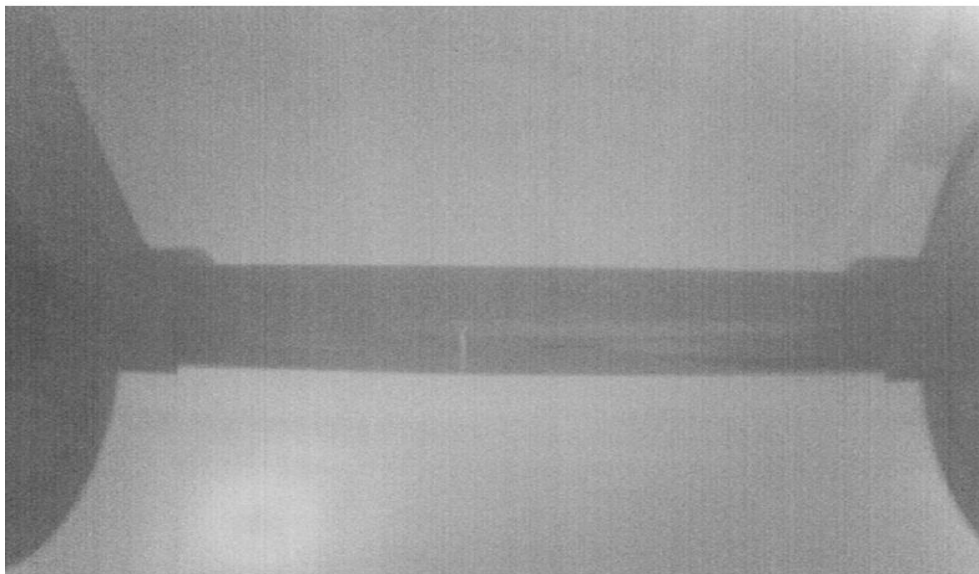
The above image was not still clear so it was magnified and again seen in the camera and could see a small thread like warm wire on an axle as shown in figure 3.5.

Fig 3.5 Showing warm wire on an axle surface.

Axle length between the wheels could be easily viewed by the thermal camera and to detect heat sources so as to check with its sensitivity provided they were above 1mm in size.

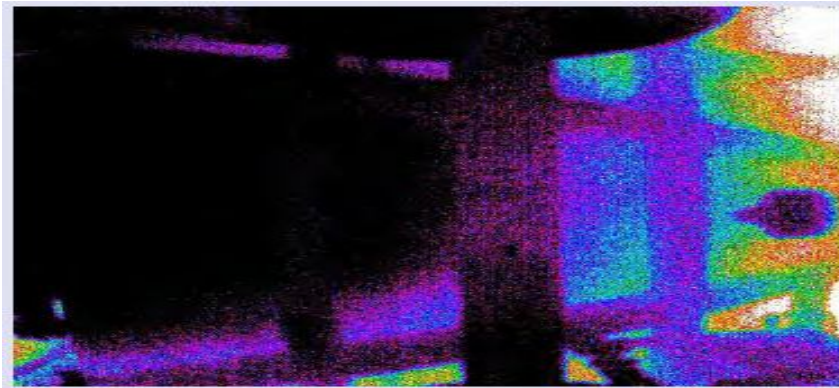
The view from Thermal Camera of the above tests were taken and image was properly examined crack defect was not seen This is shown in below figure 3.7.

Fig 3.7 No crack defect.

With no crack seen other boogie of wheel set was tested and again the result was same that there was no crack on the working axle.
