Rapid Visual Screening for Seismic Evaluation of an Existing Building

Fig 4.1 MSCB Godown

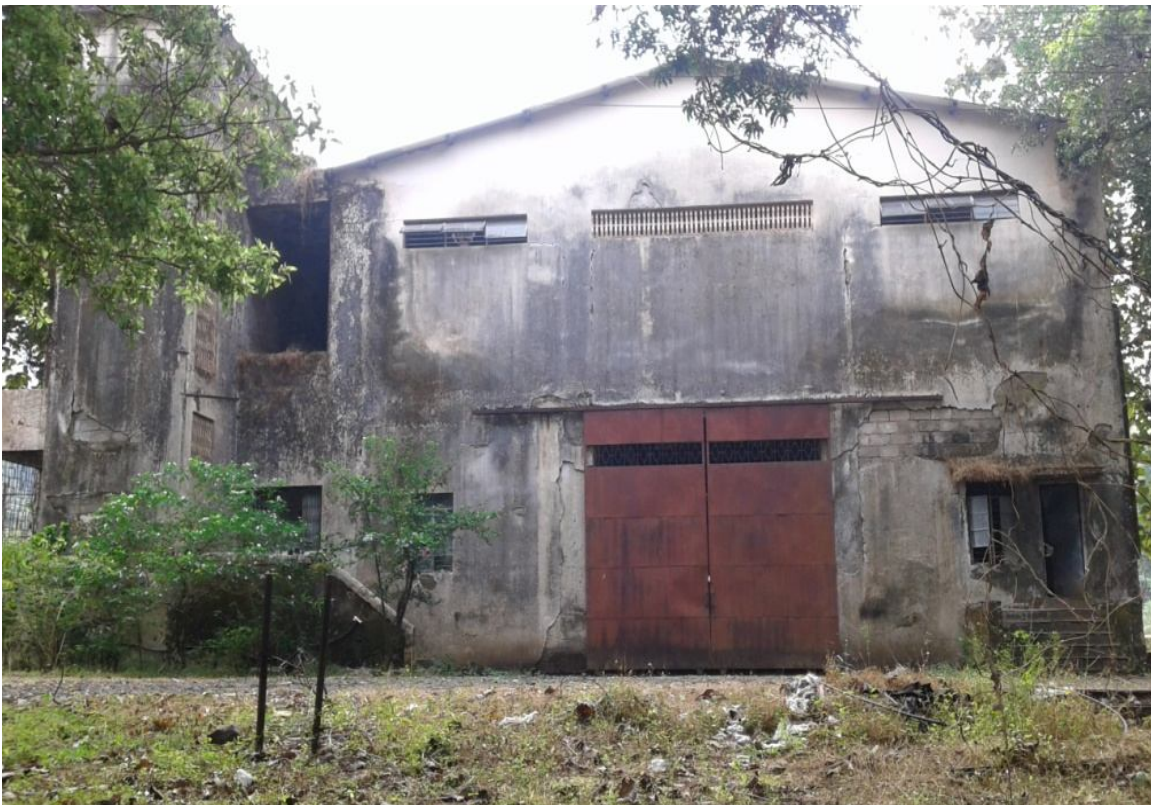
The said structure is RCC structure. There are two buildings attached together one is RCC structure and another is Steel structure which is connected to the each other. The structure is constructed in year 1980. The condition of the structure is very bad in appearance (fig-1). In a building observe plan and vertical irregularities (fig-2) which make structure instable for earthquake. The condition of the roofing is quite bad. Many of the sheets are breaks. In the building observe that dislocking of beams and column (fig-3), crakes in wall as well as in plaster. Condition of Door and window are not good. The bulking of columns is also observed during the survey. The said structure does not seem to be suitable for any use. The performance score is less than basic score, so building required detailed investigations.

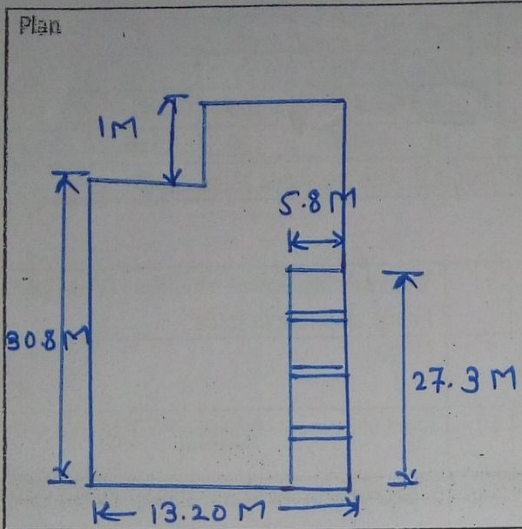
<p>Plan</p>

<p>Building Name: <u>Godown (mscb)</u></p> <p>Use: <u>Storage</u></p> <p>Address: <u>POFali naka</u></p> <hr/> <p>No. of stories: <u>2</u> Year Of Const. <u>1980</u></p> <p>Storey Ht: 1st <u>3.5</u> 2nd <u>3.8</u> 4th etc</p> <p>Total Covered Area: <u>406.56</u></p> <p>Soil Type: <u>Stiff</u></p> <p>Foundation Type: _____</p> <p>Depth of Ground Water Table: <u>-</u></p> <p>Thickness of mull wall: - Ext <u>300</u> Int <u>930</u></p> <p>Structural Drawing: - Yes / <u>No</u></p> <p>Stair Case: - Separated / Connected / Enclosed</p> <p>Type of Building: <u>RCC</u></p> <p>Roof Type: <u>Pitch</u></p> <p>Wall Type: <u>concrete brick</u></p> <p>Seismic band: <u>Lintel,</u></p> <p>Structural components: <u>Lintel, beam, column</u></p>									
<p>Photograph</p>										
Soil Type						Occupancy				
A	B	C	D	E	F	Assembly	Govt	Office	Number of persons	
Hard rock	Avg. rock	Dense soil	Stiff soil	Soft soil	Poor soil	Commercial	Historic	Residential	0-10	11-100

<p>COMMENT</p> <p>130 > 95</p> <ul style="list-style-type: none"> • Detailed evaluation is required • Separation of beam column connection • Major deterioration. 	<p>Performance score</p> $\sum BS + \sum \{(VS) \times (VSM)\}$ <p>95</p>
---	---
