# Geophysical Changes Analysis of Patalan River using High Resolution Satellite Imageries of Google Earth

**Abstract:** *The study aimed to determine the geophysical changes of the river outlet, riverbank and coastlines in Patalan, Pangasinan. Clear satellite imageries were analyzed in Google Earth from 2004 to 2014. The actual measurements were gathered using South Total Station (NTS-362R6L) in September 2015. The insight of the residents regarding the feature changes of the river and coast was obtained through one on one interview. Root Mean Square Errors (RMSE) were computed to determine horizontal positioning and measurement accuracy of Google Earth Satellite Imageries. To perceive changes of the sea level, historical data (2004-2015) from online tides and currents predictions were also analyzed. Results revealed that Patalan river outlet decreased in width size due to natural factors and human activities. There was increased in width of Patalan riverbanks which could be due to natural calamities and weak bank resistance brought by frequent flooding caused by heavy rains. The coastlines of the Patalan River moved landward due to natural occurrences and increased in population.

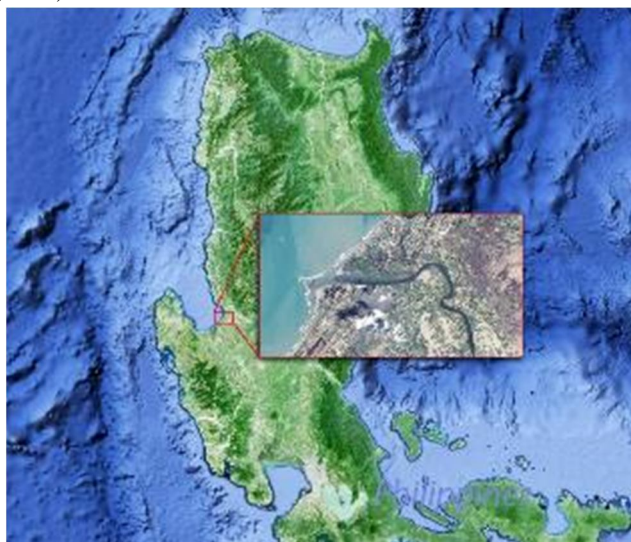
Figure 1. Patalan Watershed

La union side (Pugo, Rosario and Sto. Tomas) and Pangasinan side (Sison, Pozzorubio, San Jacinto and San Fabian) the river covers about 16,920.66 hectares<sup>[4]</sup>(Lopez et al., 2011). The river originates in the southeastern portion of Baguio City and traverses the municipality of Tuba, Sison, Pozorrubio, San Jacinto, Mangaldan which empties into the Lingayen Gulf at the border between San Fabian and the city of Dagupan (Figure 1).

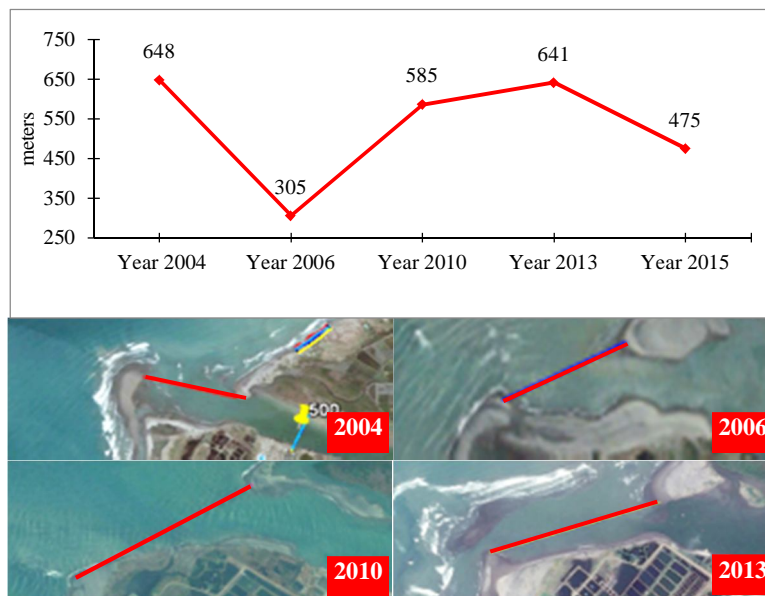
Figure 2. Satellite images of the Patalan river outlet showing its width size in different years (2004 -2013)

Result of the study showed that there was a decreased and increased of width size of the Patalan river outlet. Figure 2 shows that in 2004, the width of the river outlet is 648m but the width decreased in size in 2006 (305m). However, the width increased again in size in the years 2010 (585m) and 2013 (641m), respectively. These changes in size overtime are due to numerous factors such as natural and human interventions. The changes of its size are perhaps due to sedimentation/accretion and erosion. Moreover, during the actual ground validation in November, 2015 the width size decreased again to 475m that maybe due to sedimentation which occurred in the area

These occurrences maybe due to erosion of the left side of the river outlet that happened because of high velocity of the river flow during typhoons and heavy rains and sedimentation/accretion from transport of soil materials.

These erosion and sedimentation/accretion processes played active roles in the changes of the Patalan river outlet from 2004 to 2015. Mines and Geoscience Bureau <sup>[5]</sup>(MGB, 2004) reported that the upper portion of the river is silted and is occasionally dredged. It is also been the drainage of mine tailings from copper and gold mines in Tuba, Benguet <sup>[2]</sup>(McManus, 1990). The landslides along Kennon Road <sup>[5]</sup>(MGB, 2004) including quarrying and aggregates crushing plants in riversides released silt and sand into the river <sup>[6]</sup>(Cadalg, 2015). During rainy season, mine tailing discharge affected the farmlands along the floodplains of Patalan river <sup>[2]</sup>(McManus, 1990).

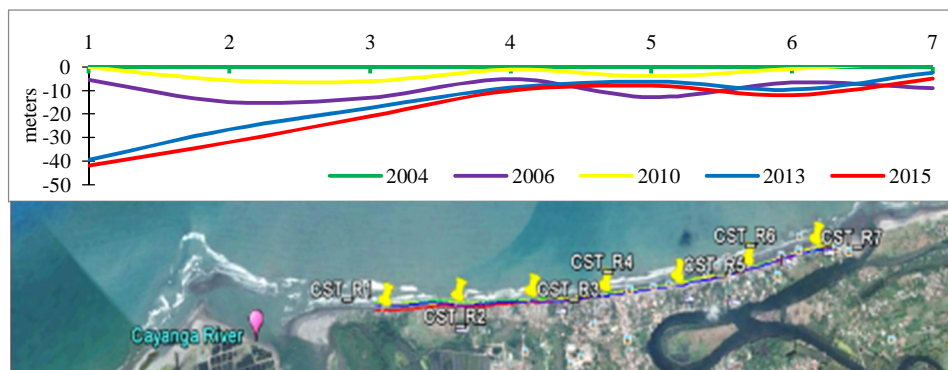
Figure 4. North coastline of the Patalan River

The north coastline of the Patalan River shows big changes through time, specifically near the river outlet which are data points 1 and 2 where there is a decrease in width size (Figure 4). The extent of changes in the coastline indicates that the coastline changed physically. It moves landward from 2004 to 2015. The type of sand in the coastal area was coarse. The coast was described by the residents as flat and wide. Most of the time, the presence of strong winds was observed by the residents in the coastal area. A destructive wind was also observed during typhoons which contribute to the erosion in the coastal area.

Coastline changes mostly occur as a result of large-scale landscape transformations in the upper basin that determine the quality and amount of the material transported into the sea<sup>[8]</sup>(Alphan, 2005). It was stated in the<sup>[9]</sup>Philippine Development Plan (2011-2016) that sedimentation in coastal areas due to unsustainable land use in upland areas continues to threaten coastal ecosystems. Changes in the coastal landscape are, thus, the function of not only in situ alterations but also external factors such as land use/cover changes at watershed scale that result from human activities<sup>[8][10]</sup>(Alphan, 2005 and Kaki et al., 2011). Based on the 2010 Census of Population and Housing (CPH), the province of Pangasinan posted a total population of 2,779,862 persons as of May 1, 2010, larger by 345,776 persons counted in the 2000 CPH. The increased in the population count from 2000 to 2010 translated to an average annual population growth rate of 1.34 percent<sup>[11]</sup>(PSA-NSO, 2010). As population increased, the needs and living space also increases which affects the environment.

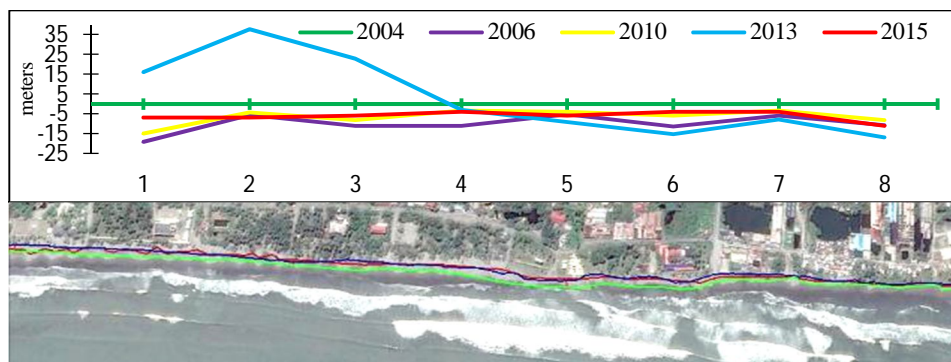
Figure 5. South coastline of the Patalan River

The south coastline of Patalan river decreased in size through the years. From 2004, the coastline eroded up to 19 meters in width size. Heavy rains brought by the southwest monsoon, or “habagat” on August 2013, caused severe flooding in the city that caused some soil particles and debris to accumulate near the coastlines which can be observed in Figure 5 wherein point 1 to 3 of the coastline accreted.

The area according to the residents was hit by several typhoons every year which brought high waves with a height of up to 3 meters constantly weathering the coastlines. Frequent rains were also observed in the area which also cause the frequent release of water from San Roque Dam that caused flooding especially to low-lying areas. Moreover, some parts of the city had been declared under state of calamity due to severe flooding caused by continuous rains.
