Surface Water Quality Analysis in the Command Area of Perumal Tank Cuddalore District, South India

Abstract: *The Perumal tank is the major source of irrigation water for crop production in the tail end of Cuddalore district, Tamilnadu. The tank irrigate 6503 ha of land through its 11 supply canals, which is receiving NLC mine drain water through the stream Paravanar. This water is found to carry with it a lot of suspended particles like as coal dust and small amount of fly ash etc.,. The water quality degradation sequential use and re-use of a single water supply for irrigation are well documented. Thus, in order to ensure the water quality for crop production is vital. Hence, the water quality analysis was carried out by testing the chemical parameters of sample in the Perumal tank command area. The results were analysed and compared with the BIS standards for various purposes.*

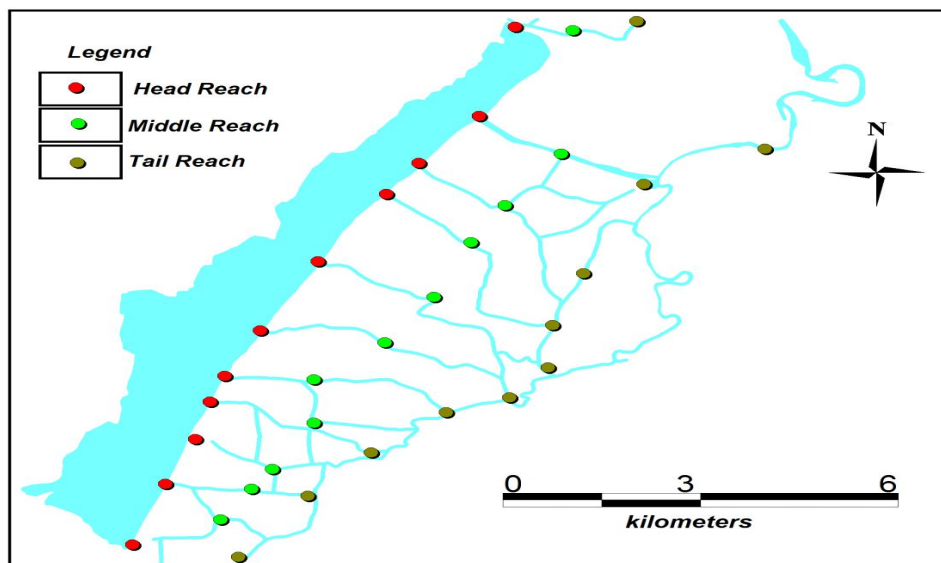
Fig. 2: Map showing the location of sampling points.

Water from the 11 supply canals at three stages i.e Head, Middle and Tail was sampled monthly from august 2017 to December 2017 at 33 monitoring sites distributed over the entire command area (ple see fig 2). The water samples were taken manually from the centre of the supply canals at a depth of 5 cm at the respective monitoring site. The collected sample are stored at 4° c temperature and transported to the laboratory.

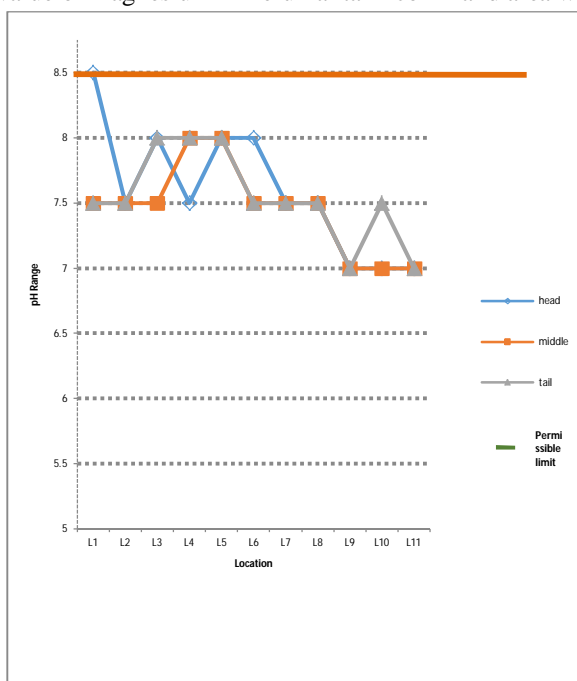
Fig.3.1 pH Range

- 1) **pH:** pH is an important factor that determines the suitability of water for various purposes, including toxicity to animals and plants. The pH is a measure of the intensity of acidity or alkalinity and measures the concentration of hydrogen ions in water. It has no direct adverse effect on health, however a low value below 4.0 will produce sour taste and higher value above 8.5 shows alkaline taste. As per WHO and BIS standard pH for aquatic life is in the range of 6.5 to 9.0 and drinking purpose standard is 6.5 to 8.5 (please see table 3). The highest concentration of pH 8.5 was at Kundiyamallure head reach and lowest value was found at Aandalmullipallam, Aalapakkam and Umaiyam Mathagu. The average value of pH in Perumal tank command area was 7.5 (please see fig.3.1). The pH level is well within the permissible limits.

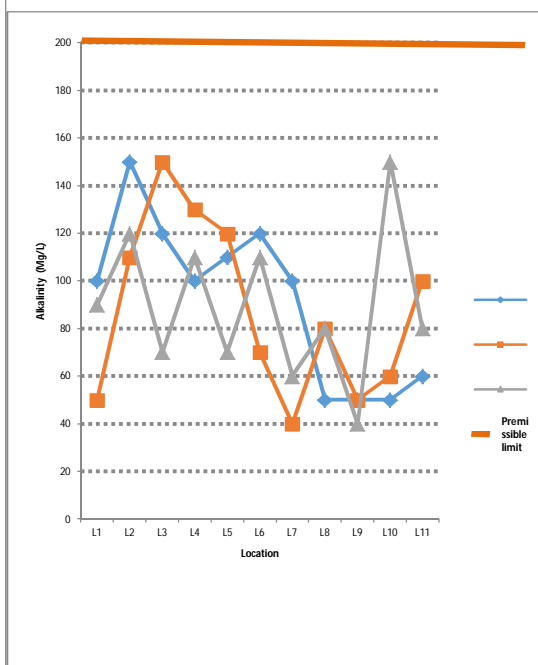
Fig. 3.2 Alkalinity Range

- 2) **Alkalinity:** Measuring alkalinity is important in determining a stream's ability to neutralize acid pollution from rainfall or waste water. It is one of the best measures of sensitivity of the stream to acid inputs; there can be long-term changes in alkalinity of streams and rivers in response to human disturbances. The highest concentration of alkalinity 150 mg/l was found at Thittuveli head reach, T.Kalayankupam middle reach and Aalapakkam tail reach. The lowest value was found at Aandalmullipallam tail reach and NewThanure middle reach. The alkalinity levels are well within the permissible limits. The average value of alkalinity in Perumal tank command area was 90 mg/l (please see fig 3.2).

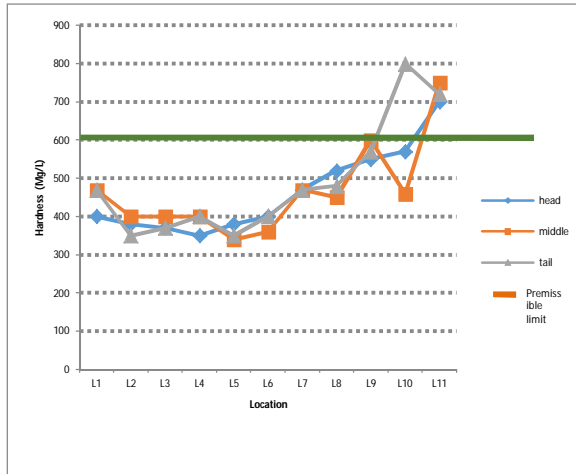
Fig. 3.3 Hardness Range

- 3) **Hardness:** Hardness is defined as the concentrations of calcium and magnesium ions, expressed in terms of calcium carbonate. This mineral in water can cause everyday problems. There are major non-metallic constituents in water. The hardness values were determined; the obtained results show the highest value of hardness 800 mg/l was found at Aalapakkam tail reach and lowest value 340 mg/l was at middle reach of Thirthanagiri and Aandalmullipallam. The average value of hardness in Perumal tank command area is 570 mg/l (please see fig.3.3). Hardness of the water is within the permissible limits for stations up to 9.

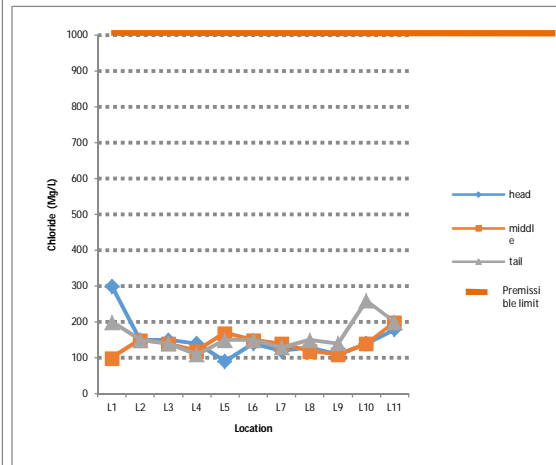
Fig. 3.4 Chloride Range

- 4) **Chloride:** Chloride occurs naturally in all types of water. This is the most common inorganic anion present in water. High concentration of chloride is considered to be an indicator of pollution due to organic wastes of animal or industrial origin. Chloride is troublesome in irrigation water and also harmful to aquatic life. Main sources of chloride in waters are sediment, sewage and trade and industrial effluents. Sewage with man and animals excrete which are rich in chloride content. The BIS suggested standard of chloride is 1000 mg/L. The highest concentration of chloride 300 mg/l was found at Kundiyamallure head reach and lowest value 90 mg/l was obtained at Thirthanagiri regions. The concentration of chloride level in the water is well within the permissible limits. The average value of chloride in Perumal tank is 180 mg/l (please see fig.3.4)

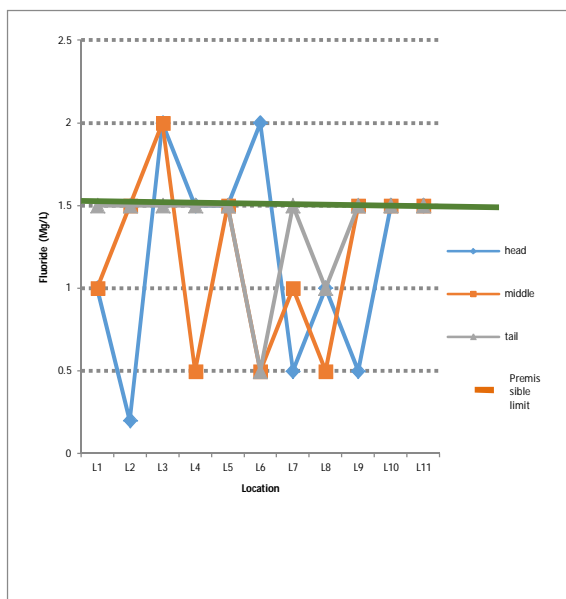
Fig. 3.5 Fluoride Range

- 6) **Fluoride:** Fluoride is an inorganic monovalent anion of fluorine with the chemical formula F⁻. Fluoride is the simplest anion of fluorine. The highest value of fluoride 2.0 mg/l was found at T.Kalayankupam head reach, middle reach, and lowest value 0.2 mg/l was obtained at Thittuveli head reach. The average value of fluoride in Perumal tank command area was 1.1 mg/l (please see fig.3.6). Head region has value beyond the permissible limits from Thittuveli to Old-Thanure locations, middle regions have value beyond safe limit at Thittuveli to Old thanure, tail regions have value on the safe line. Hence it is not safe, may cause adverse effect.

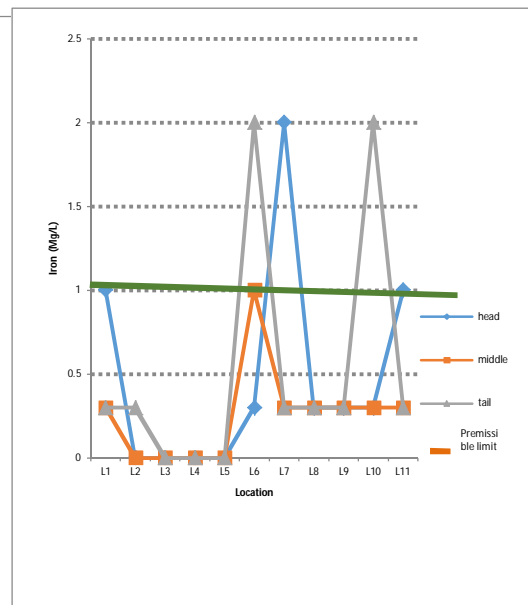
Fig. 3.6 Iron Range

- 7) **Iron:** Iron is a chemical, it is the first metal in transition series. The highest value of iron 2.0 mg/l was found at Old Thanure tail reach, New Thanure head reach and Aalapakkam tail reach. The average value of iron in Perumal tank command area was 1.0 mg/l. The level exceeds the safe limit in head region at locations New Thanure and in medium regions at locations Old Thanure and Aalapakkam. Iron levels are well within the safe regions in most of the locations (please see fig.3.7)

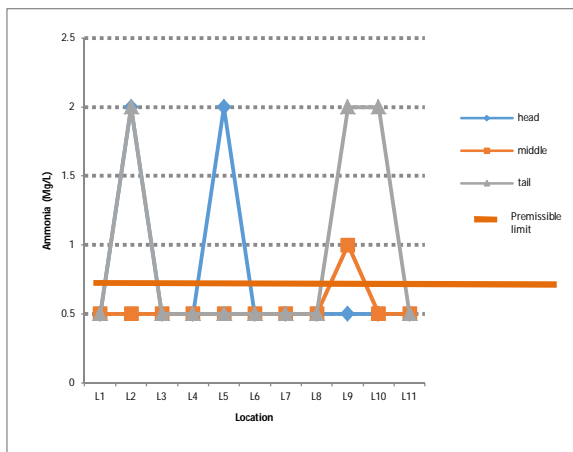
Fig. 3.7 Ammonia Range

- 8) **Ammonia:** Ammonia or Azane is a compound of nitrogen and hydrogen. Ammonia is colourless with a characteristic pungent smell. It is a common nitrogenous waste particularly among aquatic organisms and it contributes significantly to the nutritional needs of terrestrial organisms by serving as a precursor to food and fertilizers. Ammonia levels vary differently at various regions. The ammonia values were tested; the obtained results show the highest value of ammonia 2.0 mg/l was found at head and tail reach of Thittuveli, head reach of Thirthanagiri, and the tail reaches of Aandalmullipallam and Aalapakkam. The remaining all stations had the lower value of 0.5 mg/l. The average value of ammonia in Perumal tank command area was 1.0 mg/l (please see fig.3.8).

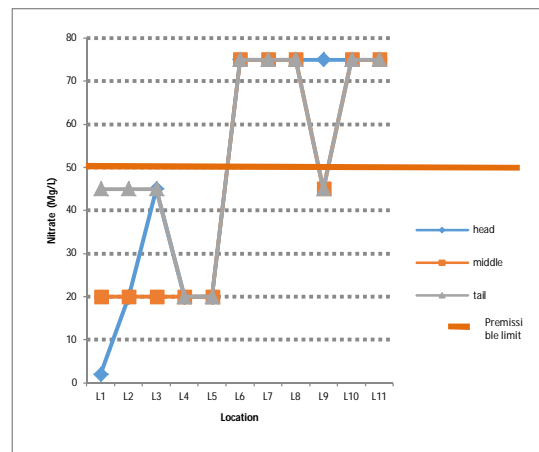
Fig. 3.8 Nitrate Range

- 9) **Nitrate:** Increasing concentration of nitrogen compounds in river and reservoir lead to eutrophication and could be due to sewage water with agriculture wastes. Nitrate concentration also depends on the activity of nitrifying bacteria which in turn get influenced by presence of dissolved oxygen. Water containing more than 45 mg/l of nitrate is not considered for drinking purpose Among the 33 samples in 11 canals, the highest value of nitrate 75 mg/l was found at Old Thanure, New Thanure, Samparettipalayam, Alapakkam and Umaiyam mathagu regions. The lowest value 20 mg/l was found at Sirupalaiyur, Thirthanagiri regions. The average value of nitrate in Perumal tank command area was 45 mg/l (ple see fig.3.9).

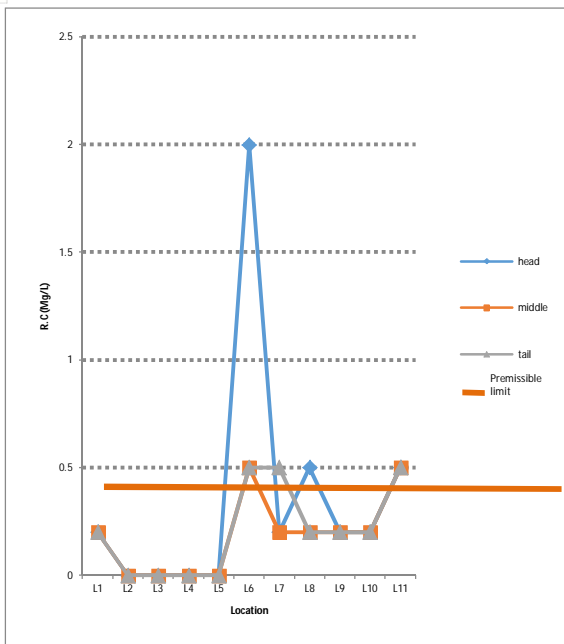
Fig.3. 9 R.C Range

- 10) **Residual chlorine:** Residual chlorine is the amount of chlorine that remains in the water after certain period or contact time. There are three forms of residual chlorine in water treatment they are: Free, Combined and Total. The Residual Chlorine value were tested, the obtained results show the highest value for RC 2.0 mg/l at Old Thanure head reach and lowest value 0.0 mg/l is obtained at Thittuveli, T.Kalayankuppam, Sirupalaiyur and Thirthanagiri regions. The average value of RC in Perumal tank command area was 0.2 mg/l (Pl. see fig.3.10). Residual chlorine levels at almost all points were above the permissible limit.

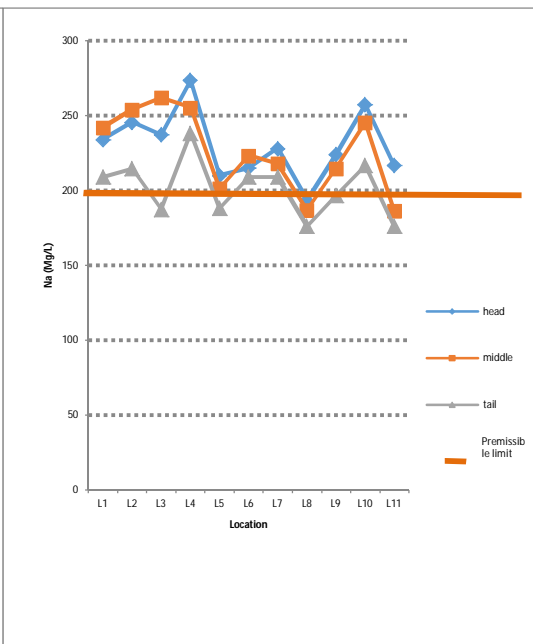
Fig. 3.10 Sodium Range

- 11) **Sodium:** The above figure show the sodium concentration obtained from the sampling results in the study area. The sodium is often taken important parameter in deciding the suitability of water for irrigation. Excess sodium in water produces the undesirable effect on water infiltration rate. As per the BIS standards, if the water containing more than 200 mg/l of sodium is not fit for drinking purpose. Among the 33 samples in 11 canals, the highest value of sodium 273.35 mg/l was found at the middle reach of Sirupalaure and lowest value 170.66 mg/l was obtained at Samparettipalayam tail reach. Except the tail reaches of T. Kallayankuppam, Thirthanagiri and umaiyam mathagu and the entire reach of Samparettipalayam all are above the permissible valve. The average value of Sodium in Perumal tank command area was 225 mg/l. (pl see fig.3.11)

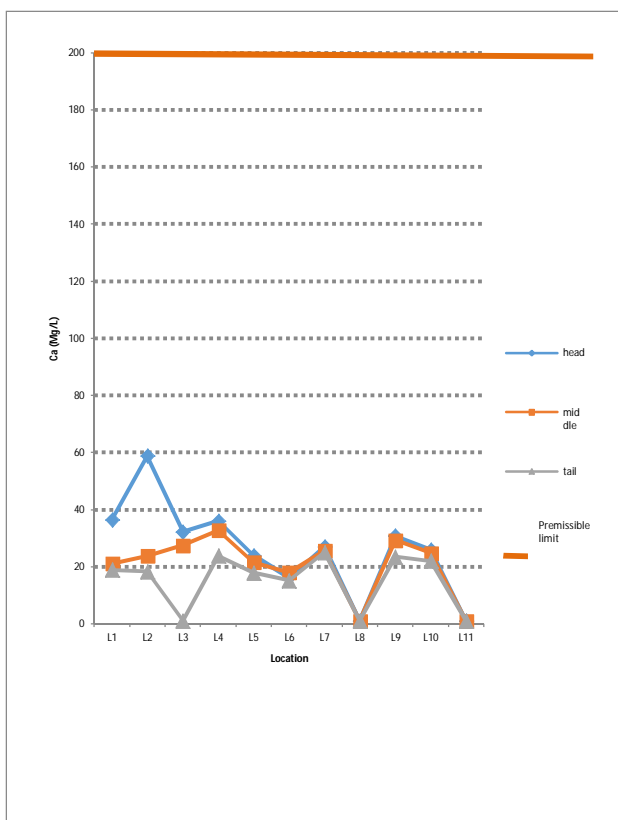
Fig. 3.11 Calcium Range

- 12) **Calcium:** The Calcium concentration was tested and the results show the highest value of calcium 58.74 mg/l was obtained at Thittuveli head reach and lowest value less than 1.00 mg/l was obtained at T.kalayankuppam tail reach regions. The average value of calcium in the Perumal tank command area was found 30 mg/l. The permissible value of calcium for drinking purpose is 75 to 200 mg/l (according to BIS), the obtained value of calcium at all locations were below the permissible limits (Pl. see fig.3.12).

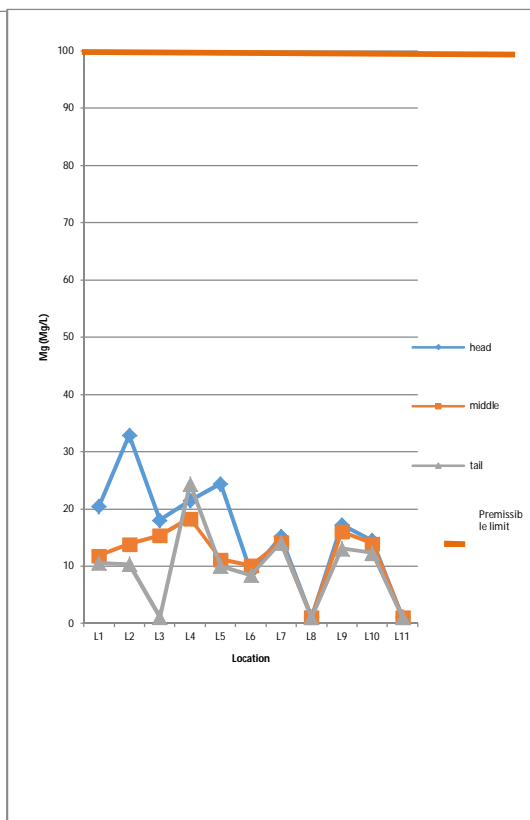
Fig. 3.12 Magnesium Range

- 13) **Magnesium :** Magnesium concentration also was tested, which is directly related to hardness. Magnesium is a co-factor for various enzymatic transformations within the cell especially in the trans-phosphorylation in algal, fungal and bacterial cell. According to the BIS standards the permissible range of magnesium is 30 to 100 mg/l for drinking purpose. The maximum value of magnesium (32.89 mg/l) was found at Thittuveli head reach, the remaining places all are below 30 mg/l were obtained. The minimum value of 1.10 mg/l was obtained at T. Kalayankuppam, Samparettipalayam and Umaiyam mathagu regions. The average value of magnesium in Perumal tank command area was 15.8 mg/l (Pl. see fig.3.13).
