Identification of Geometrical Defects on ADB Road-A Road Safety Audit

Himanku khataniar¹, P. Srinivasa Apparao², Mycherla Chaitanya³

^{1, 2, 3} Civil Engineering Department, Aditya College of Engineering and Technology

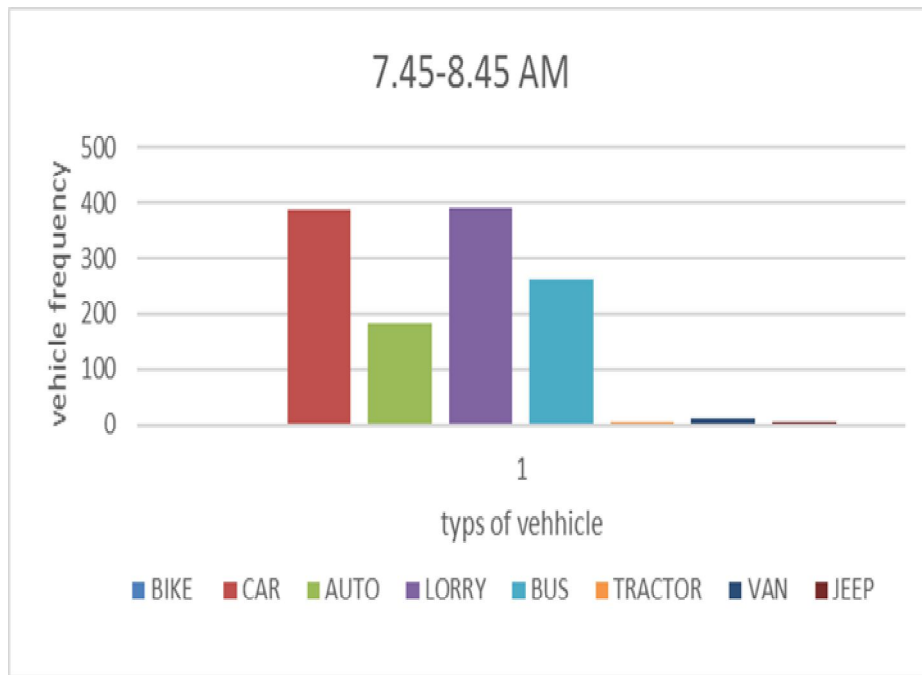
Figure 3: Peak hour vehicle frequency

In table 1 three days peak hour data is presented. Peak hour is the time when the number of vehicles in the road is maximum in a day. The obtain peak hour is 2336 PCU.

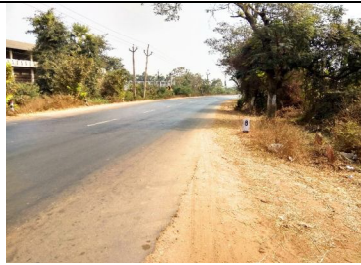
S no	CHAINAGE	PHOTO	DISCREPANCIES	INTERVENTIONS
1	ALTITUDE-144ft LATITUDE-17.008189 LONGITUDE-82.10554 MITIGATION POINT-CURVE LOCATION-SATYANAGAR (RCW & LCW)

<ul style="list-style-type: none"> • Earthen shoulder not provided. • Level difference between shoulder and paved shoulder. • Proper illumination not provided • Traffic signals are not provided • There is no cat eyes 	<ul style="list-style-type: none"> • Minimum width of 2 m earthen shoulder should be provided • There should not be any level difference between pavement and shoulder • Proper illumination required • Traffic signals should be provided • Cat eyes are required to show road alignment.

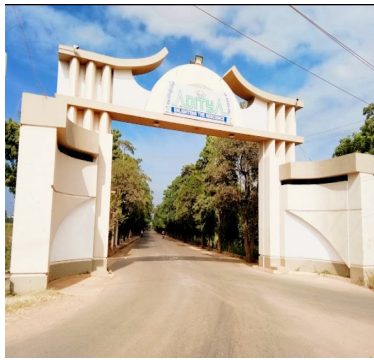
S no	CHAINAGE	PHOTO	DISCREPANCIES	INTERVENTIONS
1	ALTITUDE-233ft LATITUDE-17.08337 LONGITUDE-82.06685 MITIGATION POINT-INSTITUTION LOCATION - ADITYA GROUP OF INSTITUTE (RCW)

<ul style="list-style-type: none"> • Rumble strips are not provided at approach of industry • Level difference between paved shoulder and earthen shoulder • Sufficient illumination not provided • Road sides are not free from any objects. 	<ul style="list-style-type: none"> • Rumble strips must be provided at approach of institution. • Level difference between shoulders to be rectified. • Sufficient illumination is required • Road sides are should be clear for better visibility • Median gap of minimum 18 to 20 Meter maintained.

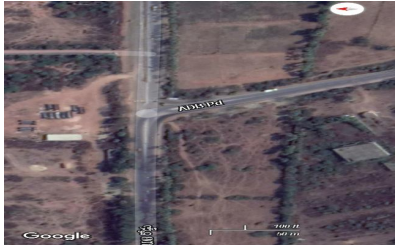
S no	CHAINAGE	PHOTO	DISCREPANCIES	INTERVENTIONS
1	<p>ALTITUDE- 174ft</p> <p>LATITUDE- 17.08172</p> <p>LONGITUDE- 82.11932</p> <p>MITIGATION POINT- ROAD INTERSECTION (Y)</p> <p>LOCATION- ENTRANCE OF PEDDAPURAM (LCW & RCW)</p>

<ul style="list-style-type: none"> • Proper signals are not provided as per the location. • Minimum shoulder width not provided • Paved shoulder are not free from level difference • Cat eyes are not provided • There is no gap in median. • Road sides are not free from bushes or trees. • Road safety cameras are not used • Proper illumination not provided • Hoardings distance are not maintained are its not free from RGB colors. • Pedestrian crossing not provided. 	<ul style="list-style-type: none"> • Proper signals should be provided as per the location. • Minimum shoulder width 2 meter should be provided • Level difference to be rectified • Cat eyes are should be provided • Gap in median provided at the intersection • Road sides are should be clear for better visibility. • Road safety cameras should be provided. • Proper illumination should be provided. • Hoardings distance 10 m should be maintained from carriageway. • Pedestrian crossings are required.
