# Road Safety Audit on Selected Stretch of NH-27 (Greenland Chowkdi to Hirasar Diversion)

Akshay Kumar V. Keraliya<sup>1</sup>, Ravindra V. Solanki<sup>2</sup>, Jay K. Kalaria<sup>3</sup>

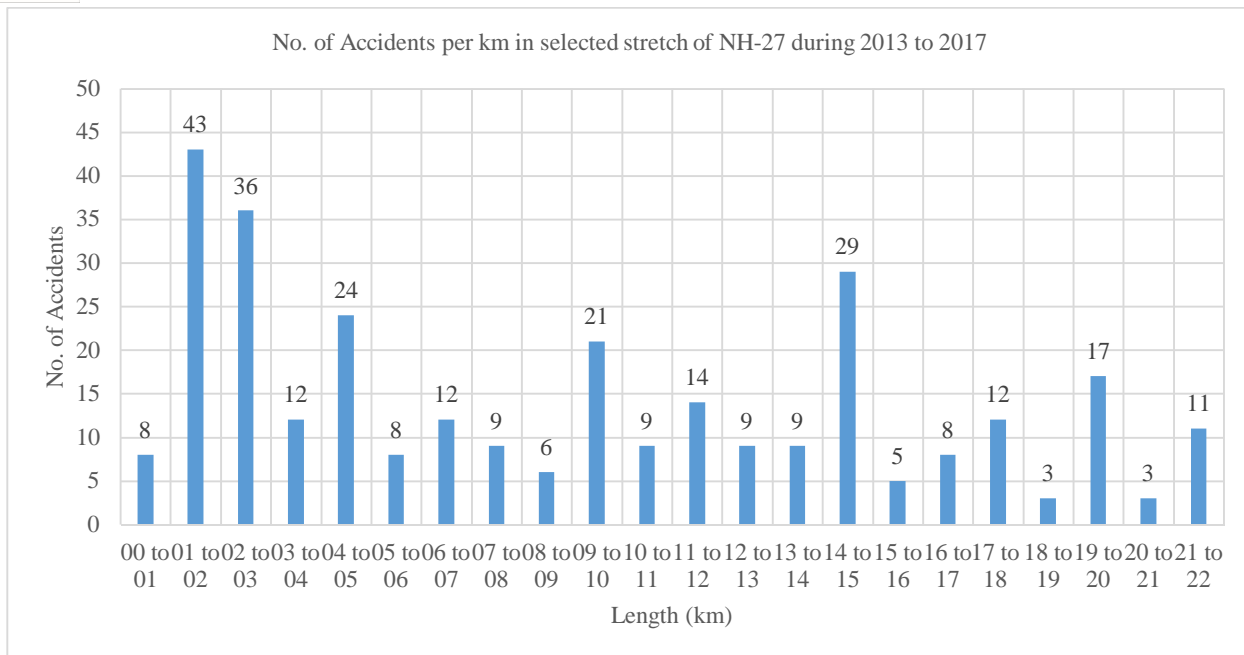
Figure 2. Number of accidents per km length in selected stretch of NH-27 during 2013 to 2017

From the figure number of accidents are more in 6 spots. The spot with high no. of accident is considered as the black spot. In this study stretch there are six black spots are seen, which are Navagam sub-urban area (01-02 km), Indian Oil Corporation Station (02-03 km), Near Maliyasan village (04-05 km), Rural area-Gunda diversion (09-10 km), Kuvadva GIDC (14-15 km), JK Hotel (19-20 km).

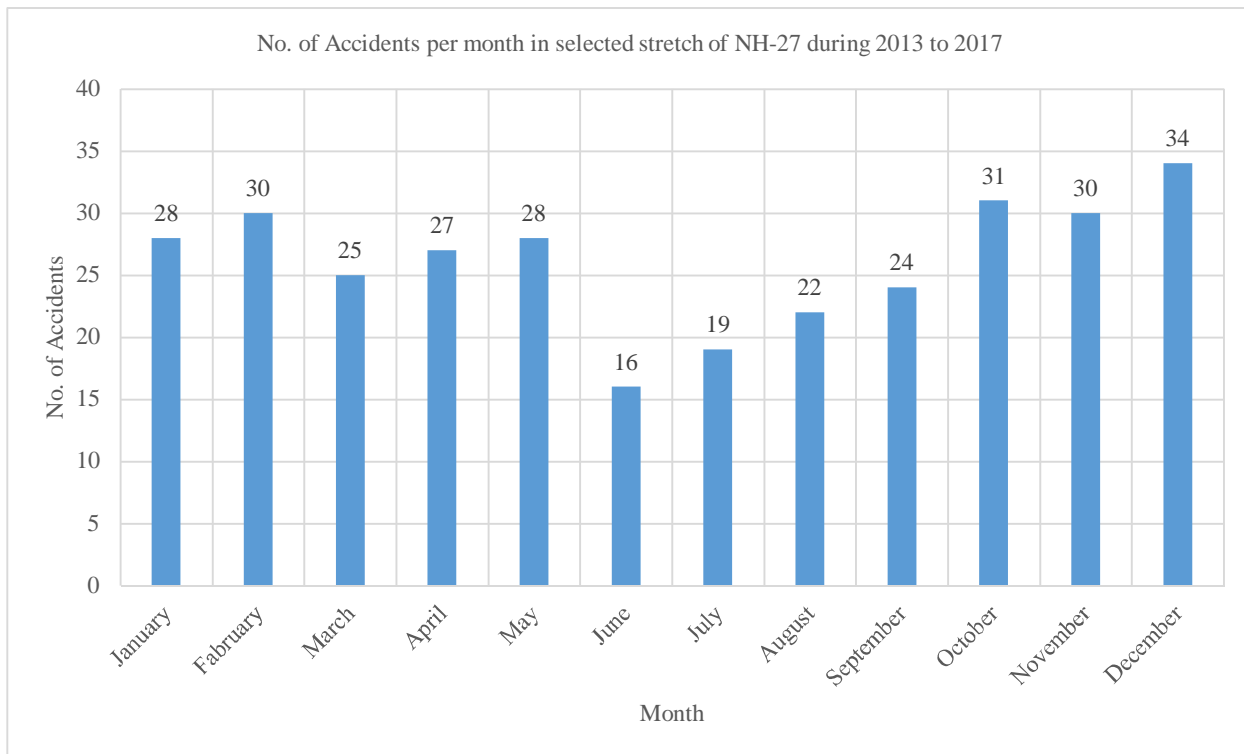
Figure 3. Number of accidents per month in selected stretch of NH-27 during 2013 to 2017

From the figure, the months in which number of accidents occurring more are: December, October, November and February. In other months also no more difference in number of accident except June, July and August.

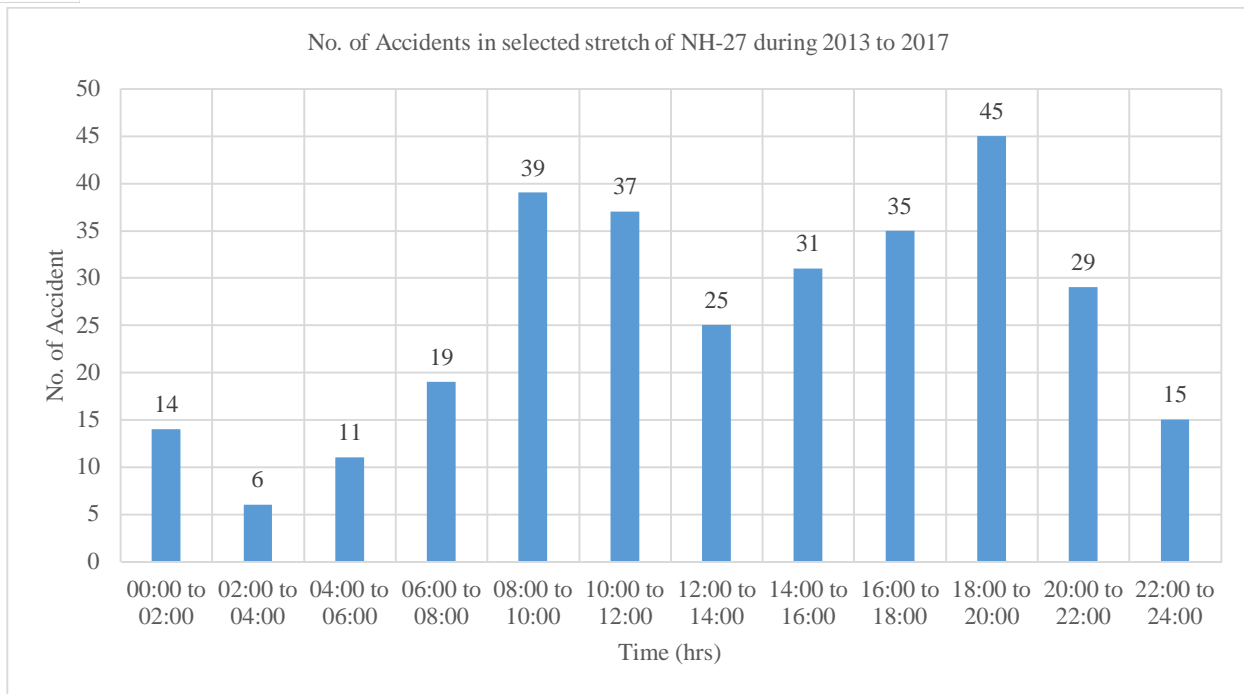
Figure 4. Number of accidents per 2-hour in a day in selected stretch of NH-27 during 2013 to 2017

From the figure, the accidents happened more during day time compare to night time. The reason for that is high traffic during day time. The accidents are more especially in morning peak hour and evening peak hour, when the worker and people living and working in Rajkot city and industrial area adjoining the study highway.

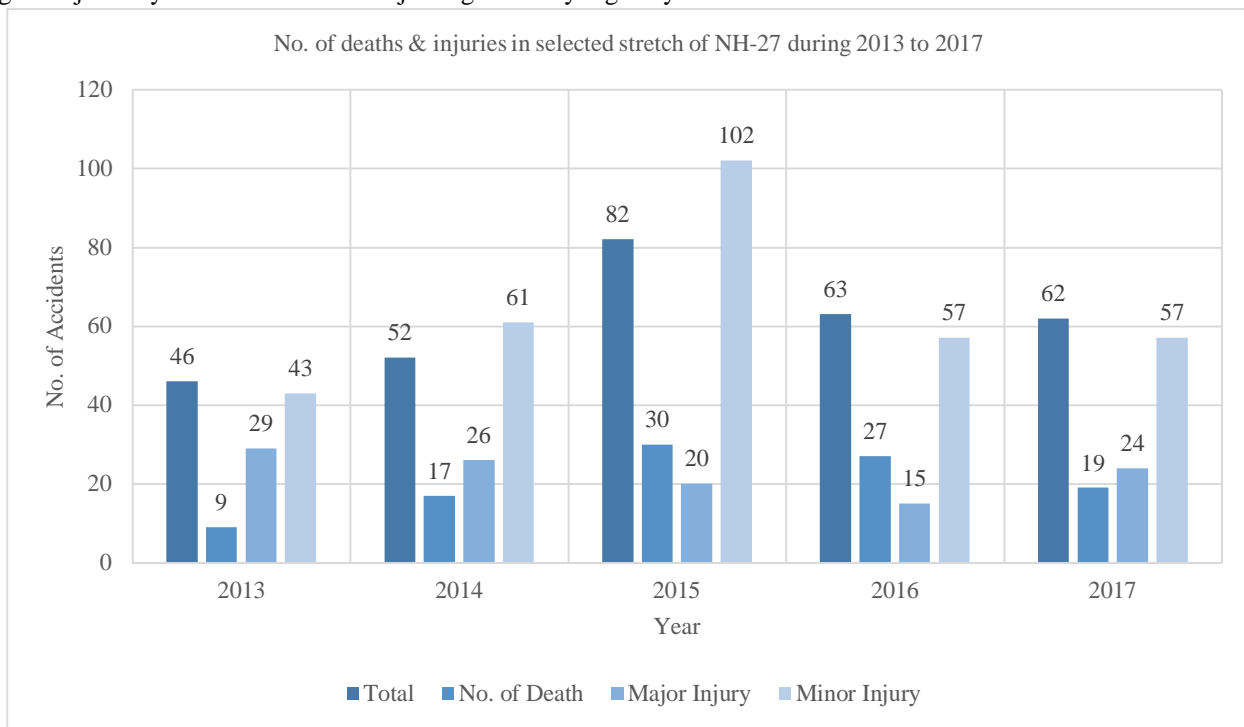
Figure 5. Number of accidents deaths & injuries in selected stretch of NH-27 during 2013 to 2017

From the figure, accidents were peak in year 2015, after that the number of accidents are decreasing. But deaths and major injuries are high. Which shows the requirements of the remedial measures to prevention of accidents.

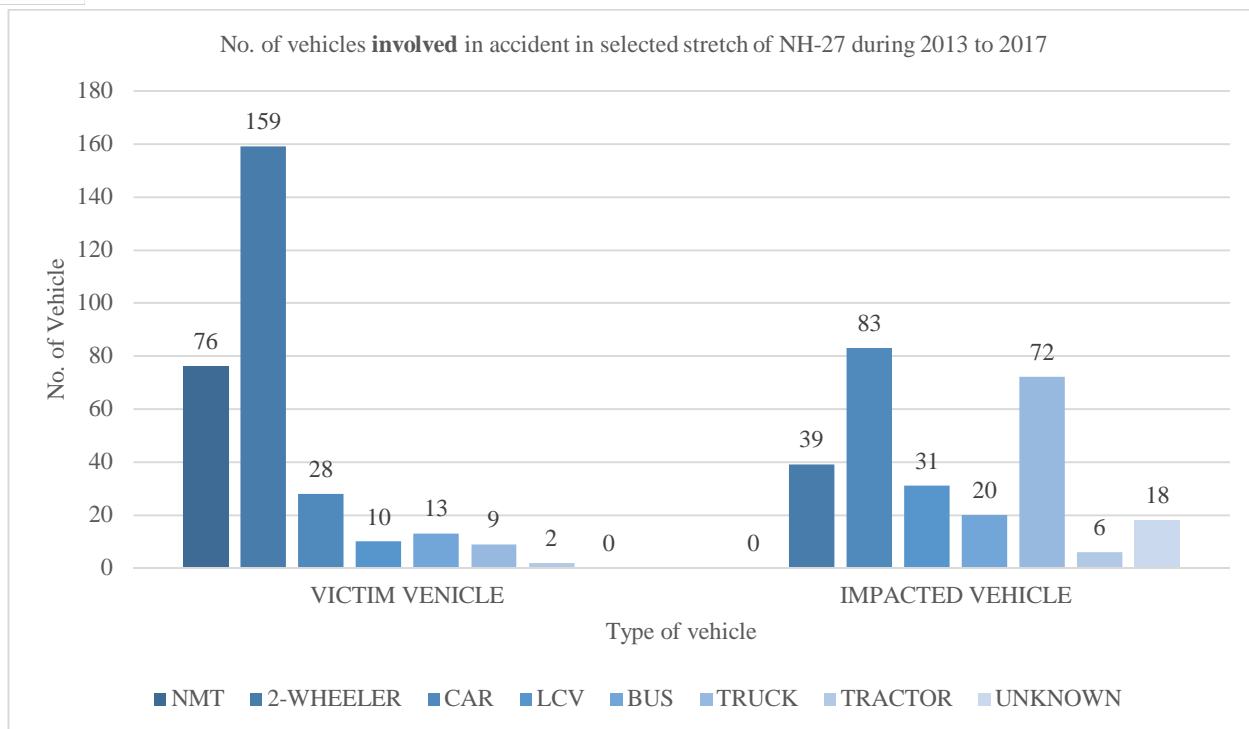
Figure 6. Number impacted vehicles & victim vehicle in selected stretch of NH-27 during 2013 to 2017

From the figure, it is seen that the victim vehicles are NMT (includes pedestrian) & Two Wheeler and impacted vehicles are Car, Truck & Two Wheeler. So the most vulnerable road user in study are NMT (includes pedestrian) & Two Wheeler.

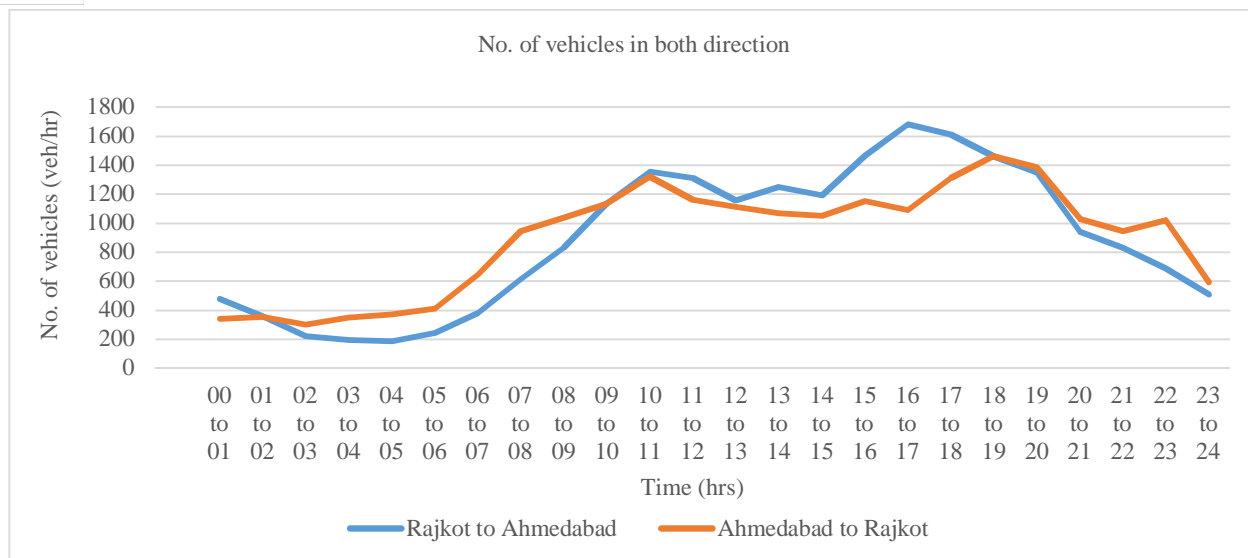
Figure 7. Number of vehicles per hour in both direction

For determining traffic on selected corridor of NH-27, classified volume count is carried out. Classified volume counts were carried out for 24 hours-2 days basis by video-graphic method at Kuvadva (CH 197+700) the study stretch. The categories observed during the traffic survey are Multi-Axle Vehicle, Truck, Bus, Light Commercial Vehicle, Car, Three Wheeler, Two Wheeler, Non-Motorizes Traffic and Pedestrian. At the study stretch the amount of trucks and cars are more because this road is connects central Gujarat to Saurashtra and more number of goods are transport between this two segments. Also the Two-Wheeler traffic is high due to surrounding villages and industrial areas. It is clear that the study highway operates huge number of the vehicles. Due to this high traffic volume than the design capacity of the study highway, the level of service is also decreased to LOC D and in sub-urban area LOC F is observed. The highest category observed during the survey is Car and Two Wheeler. While converting in PCUs the highest category observed is Multi-Axle Vehicle and Car.
