Land Use Change Detection in Akkulam-Veli Lake, Thiruvananthapuram, over the Last Three Decades- an Analysis using Remote Sensing and GIS Tools

Arya Unnikrishnan S. U.¹, Smitha Asok V², Rajesh Reghunath³, Neena P. T⁴

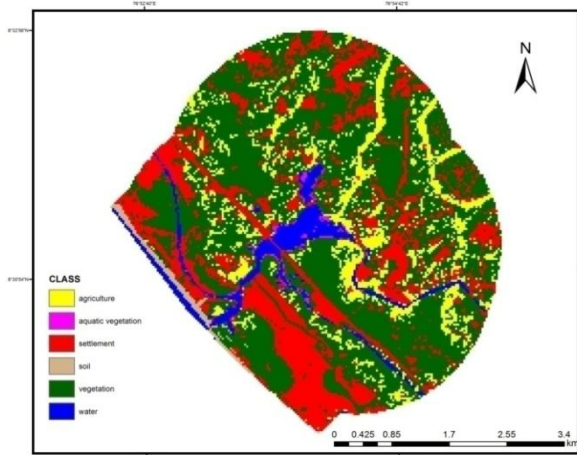
Fig 2: Landuse1989

From Figures (2,3,4) it is possible to compare and compute the availability of land designated for each class in three periods. Water body acquires an area of 1.54sq.km, 1.34sq.km and 0.98sq.km in 1989, 2006 and 2018 respectively. Decreased availability of water has been reflected in the productivity of that particular area implying the gradual decrease in agriculture ranging from 3.81sq.km, 2.71sq.km and 0.506sq.km for a period of 1989, 2006 and 2018 respectively. Akkulam – Veli buffer of 2km shows a wide progress in settlement area implying urbanization. Settlements area is found to increase from 4.23 sq.km to 5.87sq.km and 7.82sq.km. A stable use of land has been monitored in vegetation area in which only a minute decrease and subsequent increase pattern has occurred from 1989 to 2018. It remained in the range of 12.86 sq.km, 12.58sq.km and 12.34sq.km. The presence of aquatic vegetation mainly water hyacinth has been reported as a major problem in and around AV-Lake. The Fig 2,3 & 4 shows the gradual increase in aquatic vegetation from 1989, 2006 and 2018 as 0.18 sq.km, 0.29sq.km and 1.15sq.km respectively.

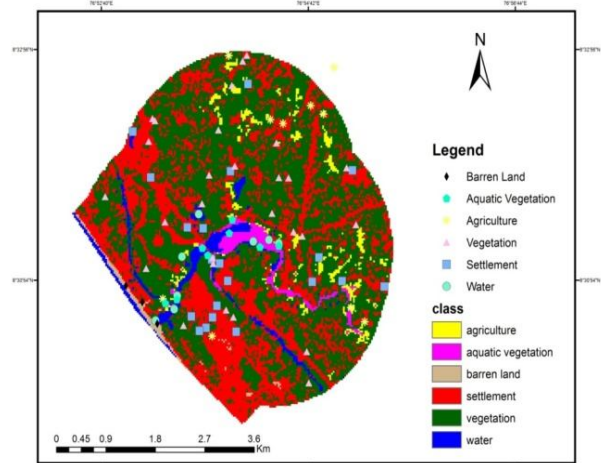
Fig 5: Overall accuracy assessment

The result from accuracy assessment provided an overall accuracy from random sampling process as 82.6%. User’s accuracy ranges between 0.66 to 1 while producer’s accuracy ranges between 0.75 to 1 (Figure 5). The measure of producer’s accuracy reflects the accuracy of prediction of particular category. The soil has 100% of users as well as producers accuracy (Table 3). The commission error reflects the points which were included in the classification category while they really do not belong to that category. Highest commission error is present in Aquatic vegetation. This study has provided an overall Kappa Coefficient of 0.784 which was rated as substantial (Bharatkar et al., 2013, Jiao et al.,2015).

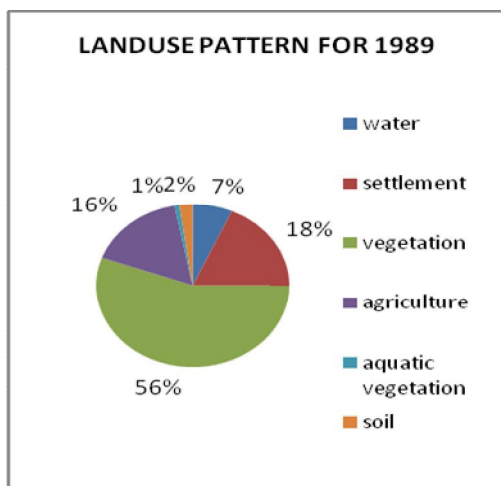
Fig 6 : LULC for 1989

The result obtained from 1989 land use image (Fig 6) shows the dominating land use of vegetation (56%) which is followed by settlement(18%), agriculture(16%), water body(7%),barren land(2%) and aquatic vegetation(1%). Most of the agriculture was formed to be around the Akkulam-Veli Lake, in which it may facilitate the irrigation facilities to the agricultural fields. Only 1% of aquatic vegetation was present during 1989.

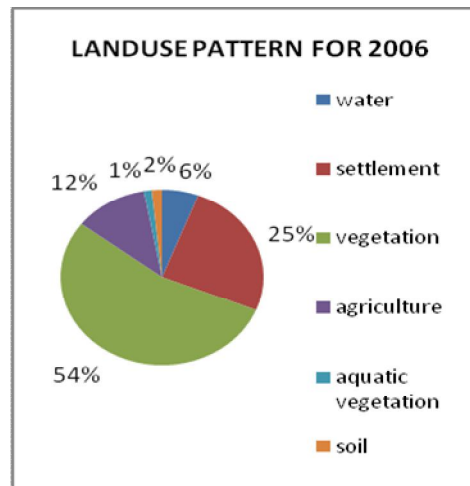
Fig 7 :LULC for 2006

From (Fig 7) it is observed to have the dominating vegetation (54%) and settlement (25%) which is followed by agriculture (12%), water body (6%), barren land (2%) and aquatic vegetation (1%). A gradual increase in settlement has been observed during this period pointing to progression of urbanization pattern.

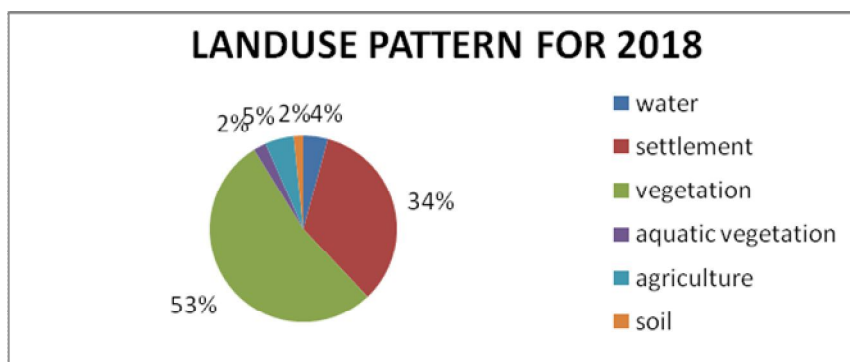
Fig 8: LULC for 2018

The result obtained from (Fig 8) shows that vegetation (53%) is dominating among the other land uses, but still the gradual elevation is present in settlement (34%). Agricultural is considered to be on the verge of its degradation because only 5% of agricultural areas remain in the Akkulam-Veli. The most common crops for agriculture include coconut, mango, jackfruit and cashew plants.

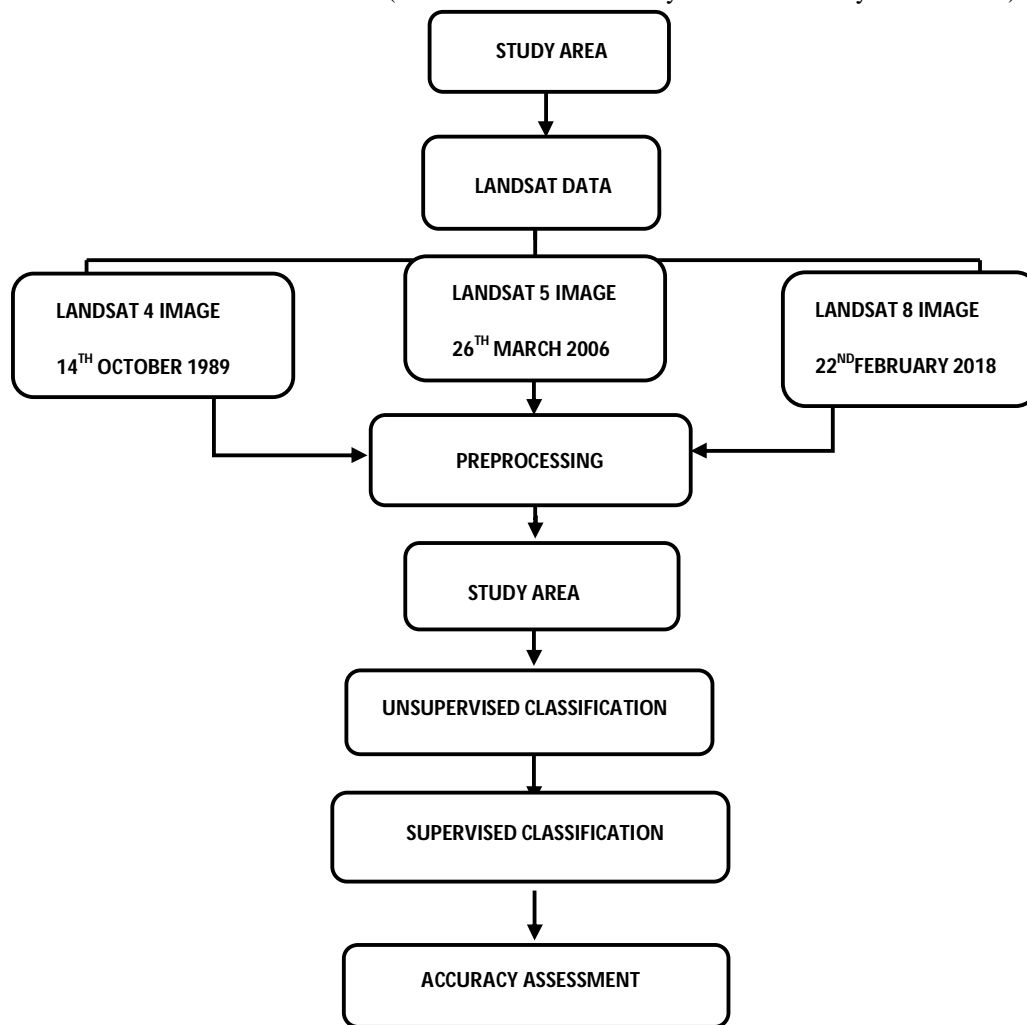
Fig 9 Work –flow on LULC analysis

Workflow (Landuse Landcover Analysis And Accuracy Assessment)

In this study, a total of, six LULC classes were established as water body, settlement, vegetation, agriculture, aquatic vegetation and barren land. Three dated landsat images were compared using unsupervised classification followed by supervised classification technique in Erdas Imagine (Cui et al., 2016). The supervised classification technique employs three Landsat images with different dates are independently classified. A supervised classification method was carried out using training areas and it was cross checked with Google Earth and toposheets (Fig 9).
