# Advanced Road Safety for Ghat Roads at Amboli

Prof. A. S. Manjarekar<sup>1</sup>, Rushikesh Majale<sup>2</sup>, Preetkumar Patel<sup>3</sup>, Indrajeet Patil<sup>4</sup>, Prajakta Dudhal<sup>5</sup>, Dhanashri Chavan<sup>6</sup>

**Abstract:** According to Government of India, Ministry of road transport and highway transport research wing, New Delhi, the regions of western ghat starting from Gujarat, Maharashtra, Goa, Karnataka, Kerala comes under accidents above 30,000 per year (2016). Among which, Amboli located in Sindhudurg district of Maharashtra has extreme curved ghat section, resulting in maximum number of accidents. This study is based on the actual minimization of accidents, from the study area Amboli ghat. We tried to study the theoretical road accidents, increase in rate of road accidents. We are giving the problems which were identified by us. Also we are suggesting the theoretical based solutions, which we are going to work practically to make Amboli ghat safer to drive.

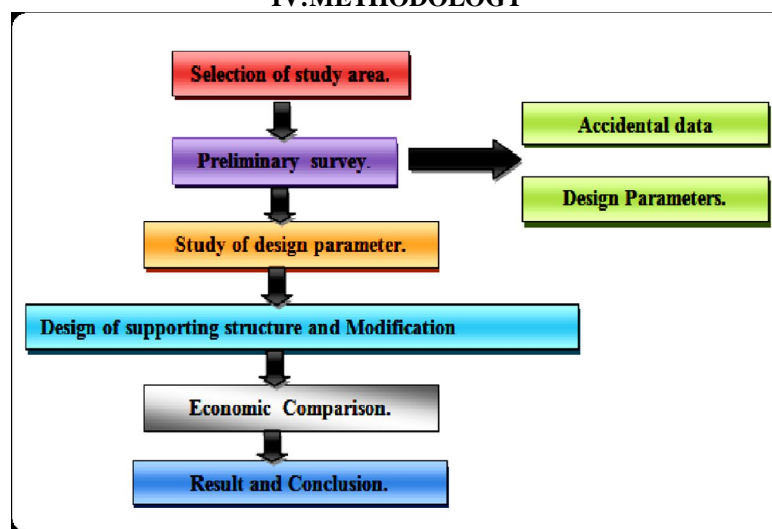
Fig no.1- Methodology

Activities which are taken grouped to prepare the detailed project report as shown in fig 1. The data collected from preliminary survey including secondary sources have been collected, compiled and analysed. The designs solutions on predefined proposed route are provided to make safe drive.

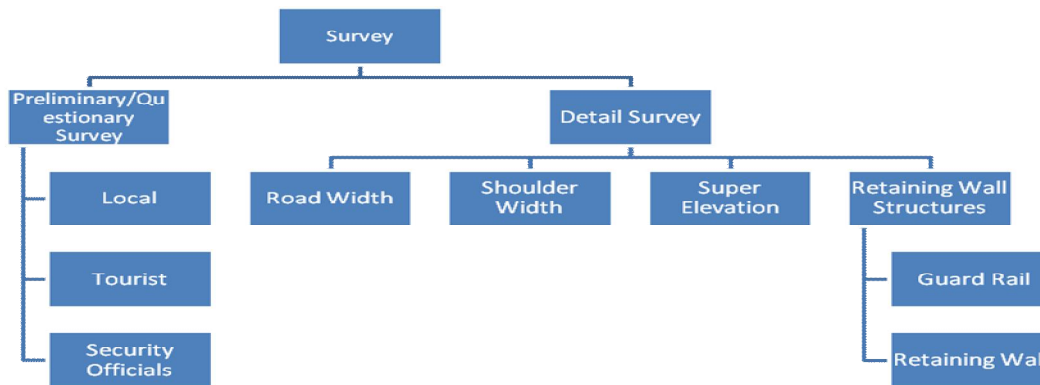
Fig no.2- Study parameters

After studying the analytical part of project, we decided to carry out the preliminary survey which would give us a brief idea about the problems faced by road users. We prepared a questionnaire sheet according to analysed problems. This survey gave an idea that modification of road would be required. So we carried out detail survey i.e. design parameters of road and retaining wall structures.

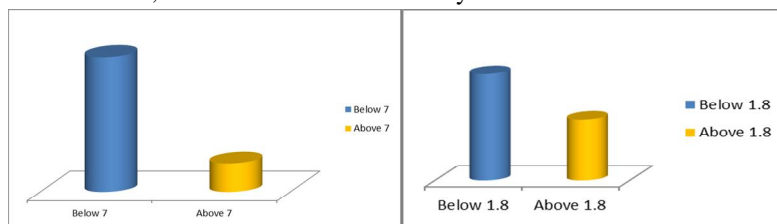
Fig no.3- Variation of carriage way width

- a) *Width of carriage way:*-Width of carriage way was measured at an every interval of 0.5 km. At also at curves. By using measuring tape, it was measured in to in distance between side margins of road in metric unit. As per IRC 52-2001 carriage width for NH double lane is min 7 m, but in Amboli there was very much variations.

Fig no.4- Variation of shoulder width

- c) *Width of Shoulder:* Width of shoulder was measured with the help of measuring tape. Width of the shoulder was measured from the outer side of the side margin. As per IRC 52-2001 it is min 1.8 m.

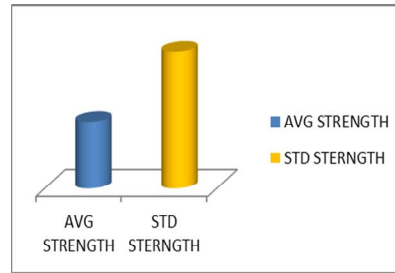
Fig no.5- Guard rail strength

- e) *Strength of retaining wall and guard rail:* - By the use Rebound hammer we conducted NDT test. Strength of the RCC retaining wall was known directly by the rebound hammer very accurately.

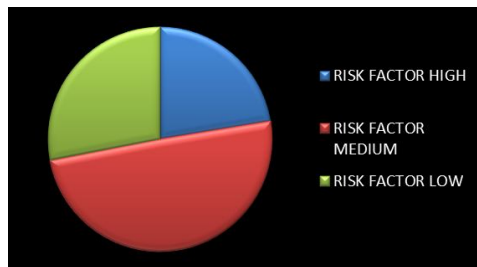
Fig no.6- Risk factor

For provision of solution we categorized this ghat into 3 stages, based on risk factor and vision factor. The risk zones are divided on the basis of various factors such as physical road conditions, intensity of curve i.e. sharp curve or smooth curve, critical points in ghat sections like waterfall, sunset point etc. There are total 107 curves are present in that some curves are critical as like hairpin bend and some are less critical.

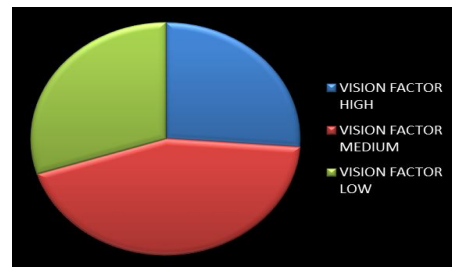
Fig no.7- Vision factor

Vision zones are also be divided. In some part of the ghat section there are obstacles are present. Trees branches are grows across the road also in rainy season due to smog and foggy environment vision problems are arrived.
