Advanced Road Safety for Ghat Roads at Amboli

Prof. A. S. Manjarekar¹, Rushikesh Majale², Preetkumar Patel³, Indrajeet Patil⁴, Prajakta Dudhal⁵, Dhanashri Chavan⁶

Abstract: According to Government of India, Ministry of road transport and highway transport research wing, New Delhi, the regions of western ghat starting from Gujarat, Maharashtra, Goa, Karnataka, Kerala comes under accidents above 30,000 per year (2016). Among which, Amboli located in Sindhudurg district of Maharashtra has extreme curved ghat section, resulting in maximum number of accidents. This study is based on the actual minimization of accidents, from the study area Amboli ghat. We tried to study the theoretical road accidents, increase in rate of road accidents. We are giving the problems which were identified by us. Also we are suggesting the theoretical based solutions, which we are going to work practically to make Amboli ghat safer to drive.

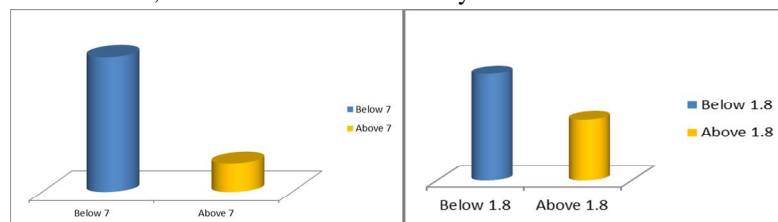
Fig no.3- Variation of carriage way width

- a) **Width of carriage way:**-Width of carriage way was measured at an every interval of 0.5 km. At also at curves. By using measuring tape, it was measured in to in distance between side margins of road in metric unit. As per IRC 52-2001 carriage width for NH double lane is min 7 m, but in Amboli there was very much variations.

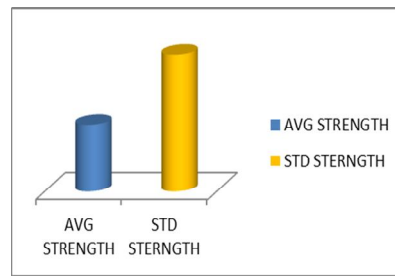
Fig no.5- Guard rail strength

- e) **Strength of retaining wall and guard rail:** - By the use Rebound hammer we conducted NDT test. Strength of the RCC retaining wall was known directly by the rebound hammer very accurately.

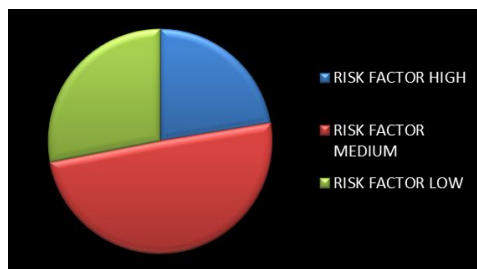
Fig no.6- Risk factor

For provision of solution we categorized this ghat into 3 stages, based on risk factor and vision factor. The risk zones are divided on the basis of various factors such as physical road conditions, intensity of curve i.e. sharp curve or smooth curve, critical points in ghat sections like waterfall, sunset point etc. There are total 107 curves are present in that some curves are critical as like hairpin bend and some are less critical.

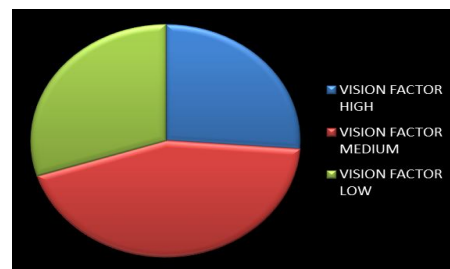
Fig no.7- Vision factor

Vision zones are also be divided. In some part of the ghat section there are obstacles are present. Trees branches are grows across the road also in rainy season due to smog and foggy environment vision problems are arrived.
