# Design Optimisation and Manufacturing Analysis of Transmission Fork of Heavy Motor Vehicles

Harikant Sahu<sup>1</sup>, Dheeraj Lal Soni<sup>2</sup>, Shailesh Singh Thakur<sup>3</sup>

**Abstract:** During the process of Milling for  $v$  cut Slot minor Cracks are generated in fork Surface, which during induction hardening process converts in to deep cracks and can only be detected during the non-destructive testing like MPI (Magnetic Particle Inspection). This leads to higher rejection ratio and incur financial and material losses. The existing design of fork is heavy and not compact which leads to problems during assembly and leads to bending in rails. This necessitates a new design of fork which is compact and light weight. The second design is manufactured without  $v$  slot using standard manufacturing techniques which includes process flow diagrams and PFMEA.

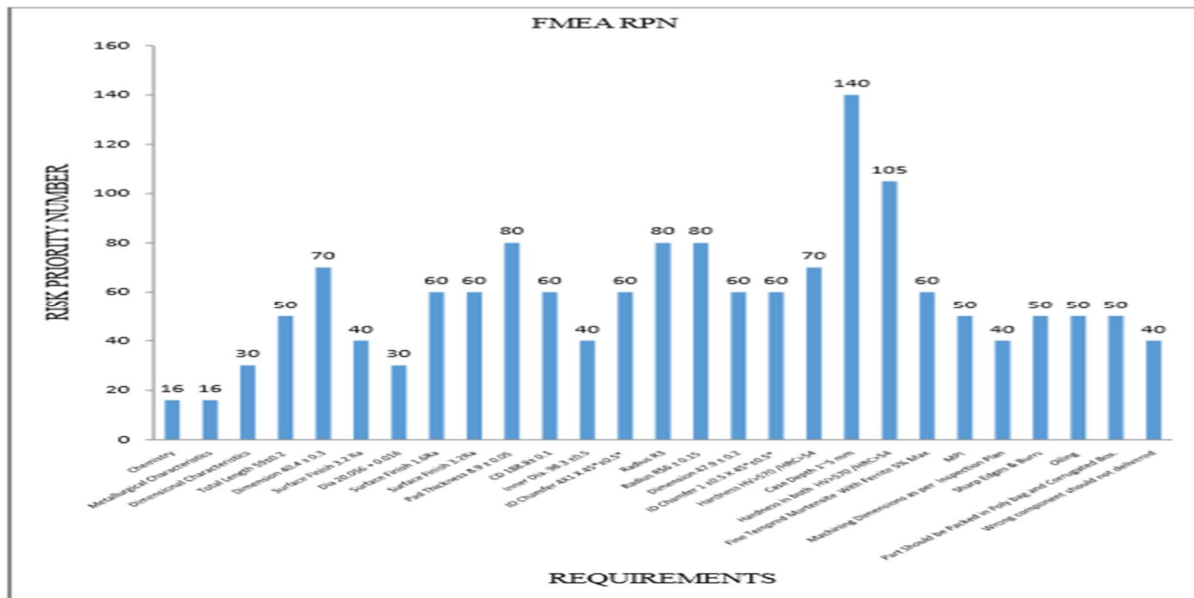
Fig. 3 Process Flow Diagram of 671 Fork

The analysis of the effective modes of process error is based on different parameters to determine the number of risk priorities obtained by the severity of the specifications, the appearance of errors and the detection of dimensions in different operations as shown in the Figure 3.

Risk priority number = severity x occurrence x detection

As should be obvious in the chart between the necessities and the quantity of hazard needs, the most extreme hazard in the fork is to keep up the profundity of the crate of 125 mm and accomplish the hardness in the acceptance procedure.
