Evaluation and Visualization of surface Defects on Automotive Body Panels by Root-Cause Methodology

N. Nandakumar¹, S. Siva²

^{1,2}Department of Mechanical Engineering, Government College of Technology, Coimbatore.

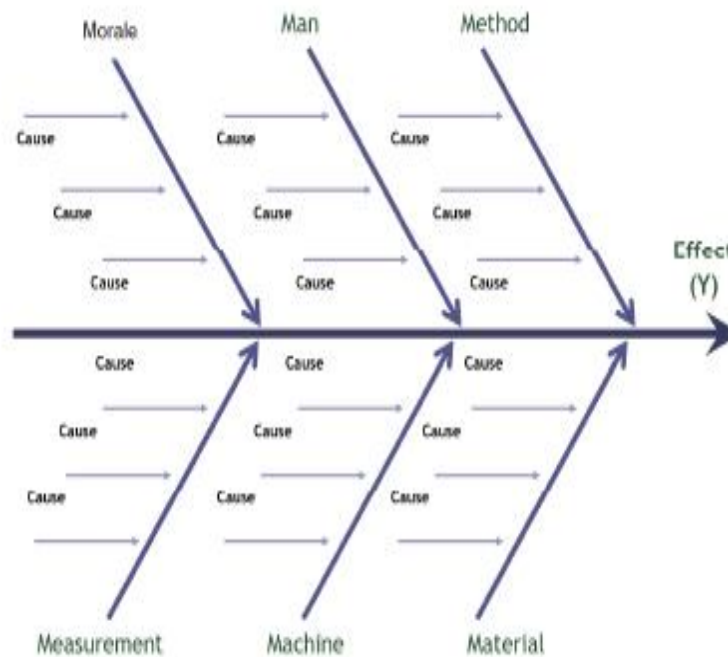
Figure 3 Fish Bone Diagram

This fishbone diagram is prepared using 6M principle of Toyota Production System (TPS). The potential causes for Inefficient Time Management are contributed by Man / People, Material, Method /Process and Measurement. Our solution tries to address these elementary level causes as much as possible. After the problem was identified the group was split into two. One group analyzed the causes for dents and the other identified the causes for scratches. The fish bone diagram is depicted below. Linear analysis was done in various stations across the plant.

6M analysis was carried out each and every station of the different lines through personal examination of the works. The operations of the workers, the tools used, the materials used were observed thoroughly.

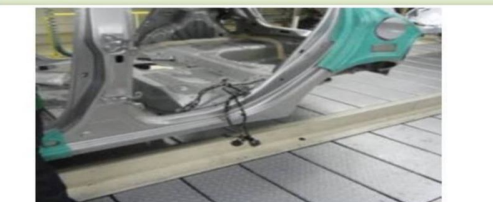
<p>Wiring loom and tail gate release cable hitting with body at aperture area</p> <p>Proposed</p>

<p>Aperture to be covered and parts handling to be improved by operators</p>
3	Door sub assembly 6M Methodology METHOD	Door	Doors are not tightly locked, easily shaking	<p>Dent at edges</p> <p>Current condition</p>

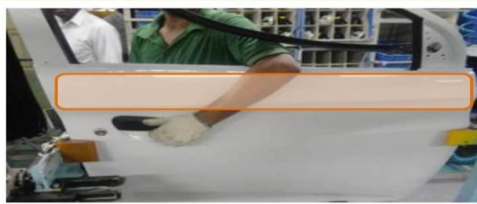
METHOD			<p>Current condition</p>   <p>Lock assembled handle touches / hits with door</p> <p>Proposed : Should not be kept over the door</p>
5	Door sub assembly 6M Methodology METHOD	Divisional channel	Part kept over the fixture in previous station to assembly station through the gap between 2 doors	<p>Scratch at door</p> <p>Current condition</p>   <p>Divisional channel loading through the gap between doors</p> <p>Proposed</p>   <p>Divisional channel loading to be avoided and to be fed at the point of use</p>
6	Door sub assembly 6M Methodology METHOD	Divisional channel	Divisional channel hitting with the door during sub assembly of channel with runner	<p>Scratch and dent</p> <p>Current condition</p>   <p>Sub assy of divisional channel and runner done at door condition and so the channel hits the door</p> <p>Proposed</p>   <p>Sub assy feasibility at separate place to be tried out</p>
7	Door sub assembly 6M Methodology METHOD	Divisional channel	Outside mirror plate and O/Side handle hitting with door	<p>Scratch</p> <p>Current condition</p>   <p>Fixing outside mirror plate and plastic door handle from the other side causes dent and scratches in door</p>

<p>Camouflage for the shaded area of doors supported at the side edges</p>
8	Final 3 6M Methodology METHOD	Sill panel	Removal of Sill Protectors at beginning of final 3	<p style="text-align: center;">Scratch and dent</p> <p style="text-align: center;">Current condition</p>

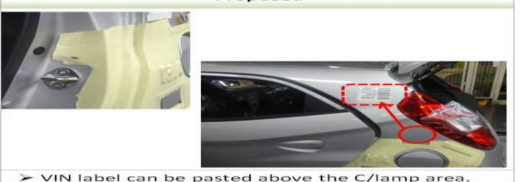
<p>Protectors got damaged due to improper seating of protector (Magnetic pad removed to accommodate VIN Label)</p> <p>Proposed</p>

<p>➤ VIN label can be pasted above the C/lamp area. ➤ Damaged protectors to be replaced and magnetic pad to be fixed again</p>
14	Final 3 6M Methodology MAN	Aperture, Door	Operators handling many screws at a time	<p>Scratch</p> <p>Current condition</p>

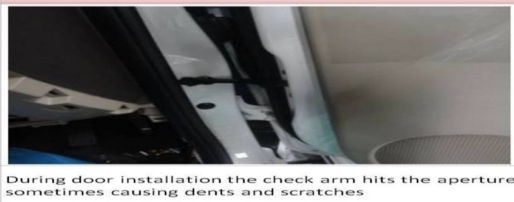
<p>During door installation the check arm hits the aperture sometimes causing dents and scratches</p> <p>Proposed : Plastic/rubber cap is provided on the checker arm head</p>

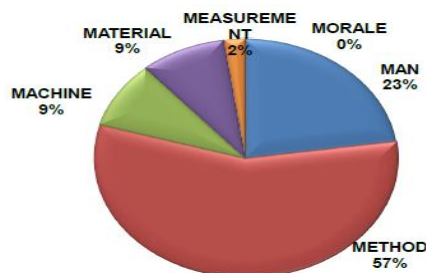
Figure 4 Chart representation of study result

Total number of observations made = 22

Total number of observations attributed to MAN = 5

Total number of observations attributed to METHOD = 13

Total number of observations attributed to MACHINE = 2

Total number of observations attributed to MATERIAL = 2

Total number of observations attributed to MORALE = 0

Total number of observations attributed to MEASUREMENT = 1
