Haunch Retrofitting of Exterior Beam-Column Connection

Babar Ilyas¹, Arif Ullah², Mian Asfahan Ali Gul³, Bawar Iftikhar⁴

Abstract: *Three beam-column joints sub-assemblies of 1/3rd reduced scale was tested under monotonic loading conditions. The beam-column connections were comprised of one control model having low concrete strength and having no joint ties, another similar model with diagonal hooks in the joint, and a retrofitted model using energy dissipating haunch. Haunch retrofitting of the deficient model was done to shift the damage from joint to beam and was connected through external anchors to avoid anchors failure. The haunch retrofitting substantially increased the strength of the model with some cracking/damage shift towards the beam but damage in the joint could not be prevented due to delayed action of the haunch that was due to lose attachment of the anchors.*

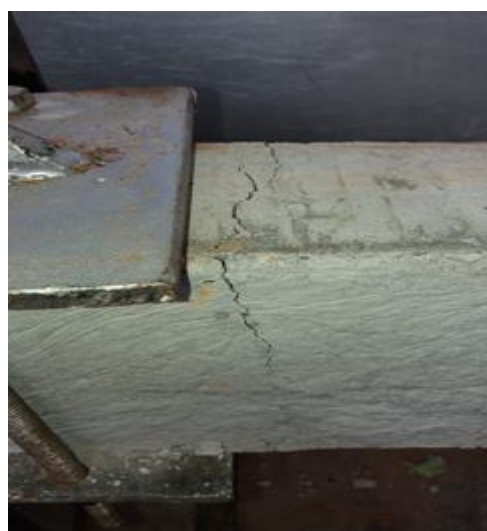
- 2) *Haunch Retrofitted Model*: Similar to the control model hairline cracking appears at the top side of the beam at beam-column interface due to the slippage of the beam top longitudinal reinforcement with a slight increase in stiffness and strength in the initial phase as compared to the control model. It was followed by joint shear cracking and the widening of the existing cracks. But after reaching the maximum in term of strength that is usually and, in the control, model followed by a drop in the strength, a rise in the strength is observed in the retrofitted model that gets steeper with further increase in the deformation as shown in the load deformation behaviour. This unique behaviour of the retrofitted model can be explained as, due to improper/loose attachment of the haunches to the model it influences the joint assembly by increasing the initial stiffness and strength by just a small margin, but as when the deformation increases and subsequently the haunch become more effective as its connection tightens due to the deformation in the model removing the free space the haunch takes the load and so transferring the stresses away from the joint towards the beam which the haunch was designed for. As the haunch diverts any further increase in stress in the joint with the increase in deformation towards the beam as intended a hairline flexure crack appear in the beam at the end of the haunch base plate that increase with further increase in the load and deformation up-to the maximum applied displacement.

Figure: (4) cracking in beam.
