# Haunch Retrofitting of Exterior Beam-Column Connection

Babar Ilyas<sup>1</sup>, Arif Ullah<sup>2</sup>, Mian Asfahan Ali Gul<sup>3</sup>, Bawar Iftikhar<sup>4</sup>

**Abstract:** *Three beam-column joints sub-assemblies of 1/3<sup>rd</sup> reduced scale was tested under monotonic loading conditions. The beam-column connections were comprised of one control model having low concrete strength and having no joint ties, another similar model with diagonal hooks in the joint, and a retrofitted model using energy dissipating haunch. Haunch retrofitting of the deficient model was done to shift the damage from joint to beam and was connected through external anchors to avoid anchors failure. The haunch retrofitting substantially increased the strength of the model with some cracking/damage shift towards the beam but damage in the joint could not be prevented due to delayed action of the haunch that was due to lose attachment of the anchors.*

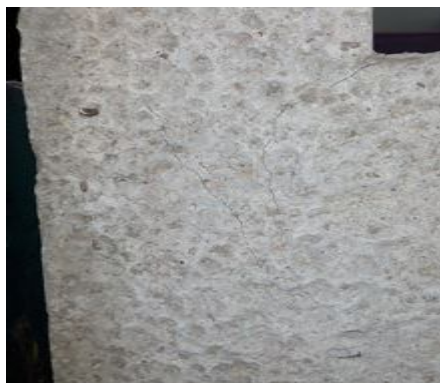
Figure; (1) Initiation of joint shear cracking.

- 1) *Control model*: By applying the load at the beam, a small hairline crack appears at the top side of the beam at beam-column interface due to the concrete reinforcement bond failure resulting into slippage of the beam top longitudinal reinforcement due to the lower concrete strength. By increasing the load further, a hairline diagonal crack appears at the joint as the principal tensile stresses surpasses the principle tensile strength of the joint core concrete due to the combine effect of concrete with lower compressive strength and no ties in the joint. By increasing the load further widening in the existing cracks is observed that is followed by the creation of a few smaller new cracks along the sides of the single major diagonal joint shear crack. This increase in the width of the diagonal cracks shows the development of strut mechanism in the joint due to exceedance of principle joint compressive stresses then the principle joint strength ultimately leading to spalling and showing clear joint shear failure.

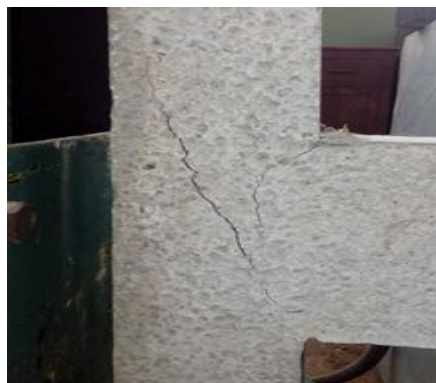
Figure; (2) Joint shear failure.

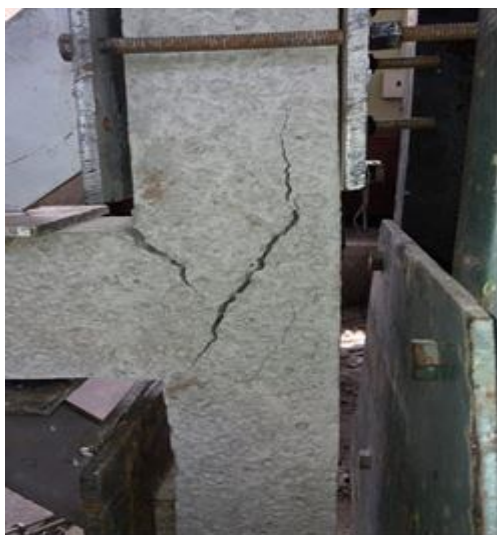
Figure: (3) cracking in joint.

- 2) *Haunch Retrofitted Model*: Similar to the control model hairline cracking appears at the top side of the beam at beam-column interface due to the slippage of the beam top longitudinal reinforcement with a slight increase in stiffness and strength in the initial phase as compared to the control model. It was followed by joint shear cracking and the widening of the existing cracks. But after reaching the maximum in term of strength that is usually and, in the control, model followed by a drop in the strength, a rise in the strength is observed in the retrofitted model that gets steeper with further increase in the deformation as shown in the load deformation behaviour. This unique behaviour of the retrofitted model can be explained as, due to improper/loose attachment of the haunches to the model it influences the joint assembly by increasing the initial stiffness and strength by just a small margin, but as when the deformation increases and subsequently the haunch become more effective as its connection tightens due to the deformation in the model removing the free space the haunch takes the load and so transferring the stresses away from the joint towards the beam which the haunch was designed for. As the haunch diverts any further increase in stress in the joint with the increase in deformation towards the beam as intended a hairline flexure crack appear in the beam at the end of the haunch base plate that increase with further increase in the load and deformation up-to the maximum applied displacement.

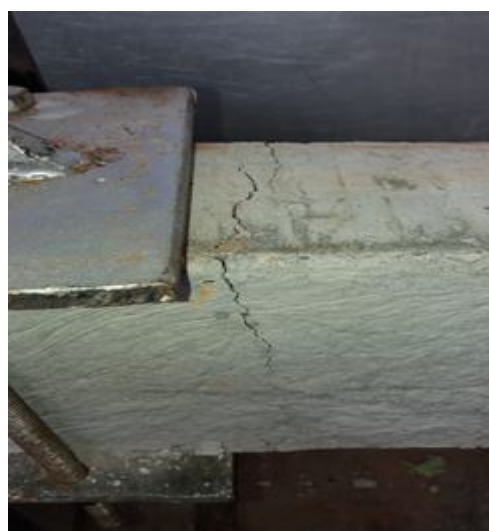
Figure: (4) cracking in beam.

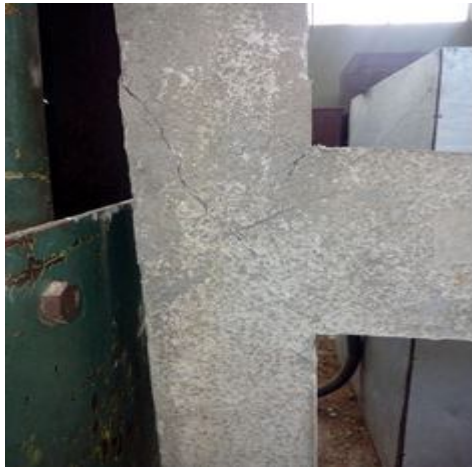
Figure: (5) Initiation of joint shear cracking.

- 3) *Diagonal/135 Hooks Model*: In the case of hooks bent diagonally making angle of  $135^\circ$  that position it transverse to the potential principal tensile cracks to help increase the joint principle tensile strength. After the application of load beam-column interface cracking was observed that widened reasonably before any diagonal joint shear crack was observed. The diagonal joint shear cracking started with multiple cracks showing compression strut failure due to principal compression stresses as opposed to the other models where cracking started with a single crack and converted to multiple cracks. This type of damage behaviour shows that the diagonal hooks increased the principal tensile strength of the joint thus delaying the occurrence of diagonal shear cracking and an overall increased strength of the joint assembly.

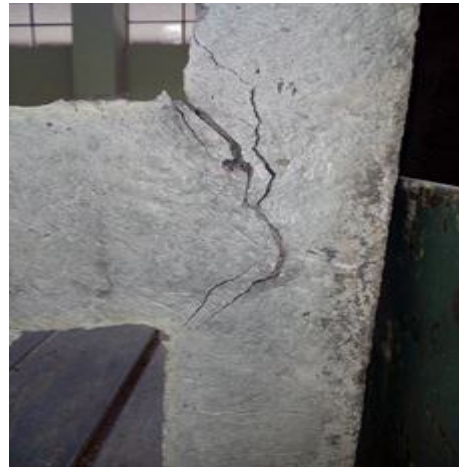
Figure: (6) Joint shear failure.

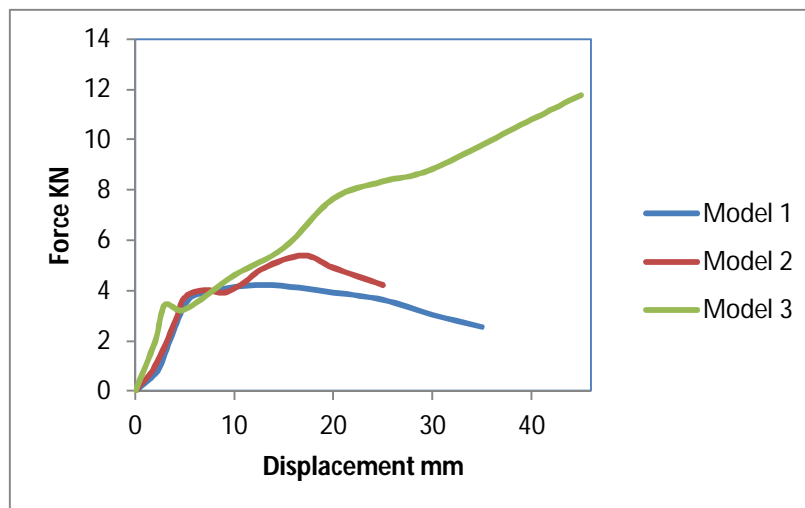
Figure (7); Load displacement behaviour.

In the case of control model yielding in the Load-displacement graph, starts at 3mm of applied displacement with applied load of 0.33 tons corresponding to the beam-column interface cracking in the joint assembly. Followed by the strain hardening region up-to a maximum load capacity of 0.43 tons corresponding to joint peak shear strength, where the joint fails under principal compressive stresses. After joint shear failure the strength degradation starts up-to the ultimate displacement of 35mm and load of 0.26 tons.

With the diagonal hooks in the joints a small increase in initial stiffness was observed. A little drop in the stiffness in the stiffness was observed due to the initial cracking at the beam-column interface but this drop was not substantial as in control model, as in this model interface cracking was not directly followed by initial joint shear cracking that in control model load-displacement graph could be seen in the form of clear yielding mechanism/drop usually followed by strain hardening. The joint assembly reaches to its maximum strength of 0.55 tons at 17mm of applied at the joint peak shear strength representing 22% of maximum strength increase, where the joint shear failure occurs in the form of joint core crushing due to principal compressive stresses. A 21% of strength drop was observed at the application of 25 mm of displacement

In case of the joint retrofitted with haunches a small increase in the initial stiffness and strength is observed as compared to the control model, otherwise a similar load-displacement behaviour was observed up-to applied displacement of 8mm. This small difference/behaviour can be attributed to less effectiveness of the haunch at smaller applied displacement due to the loose connection of the haunches to the joint assembly. As the applied displacement increases haunches become effective as the loose connection tightens, this can be observed in the clear increase in the strength and stiffness in the later stage of the load-displacement graph. More than 180% of strength increase was observed up-to the application of 45mm of displacement.
