Seismic Evaluation and Retrofitting of R.C. Building by using Pushover Analysis

A nonlinear static pushover analysis as described in ETAB2015 is carried out on an existing Biyani Science college, Amravati built in 2000. The subject college building is a G+2 story, irregularity structure. The building analysed for zone III.

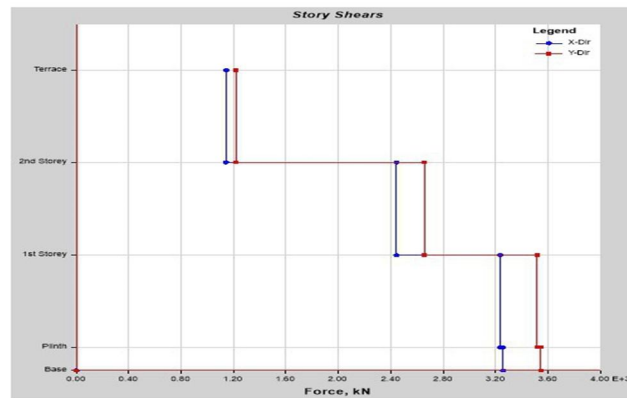
Figure 2. Maximum Storey Displacement

Pushover Analysis has been done for the G+2 Storey R.C building. The analysis was done in ETABS 2015 and the results are shown below. The maximum base shear for Zone 3 DBE is 3543 kN about Y axis and max. roof displacement is 20 mm in X-direction

Maximum storey displacement at one end 1.01 of the average displacement. Also the maximum drift is within limits laid by IS 1893: 2002.
