# Effect of Surface Textures on the Performance of Journal Bearings with Contaminated Oil

Vinay Kumar<sup>1</sup>, D. P. Vakharia<sup>1</sup>

**Abstract:** *The premature failure of journal bearings may be observed on account of lack of lubricating oil flow inside the bearing, misalignment on the shaft, surface irregularity on journal bearing and contamination blend with lubricating oil, etc., which may affect the production cost of the industry and also dangerous for human life. Sugar mill bearing is commonly known for operating with high load and low-speed conditions. The rise in temperature and wear of sugar mill bearing has been noticed in the sugar industry while working with contamination oil conditions. Hence the experimental investigation of the straight and spiral textured phosphorous bronze journal bearings lubricated with contamination oil has been conducted with a downsize of sugar mills. Dried and crushed bagasse of sugar cane is used as a contamination for entire experimental work. An internal knurling operation has been performed on the inner diameter of bearing through the lathe machine. The results of both textured bearings have been compared in the matter of tem

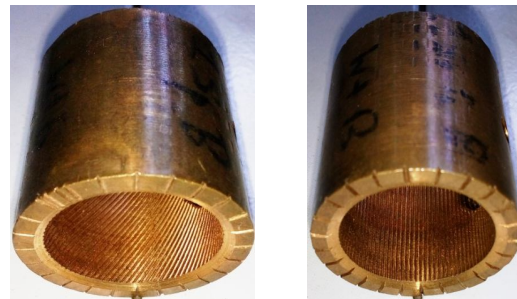
(a) (b)  
Fig. 1 Surface textured bearings (a) Spiral and (b) Straight

The experimental setup of journal bearing with downsizing has been designed and fabricated according to match the operating condition and environment of sugar mill bearing. The brass is commonly used as a bearing material for sugar mill bearing. In this analysis, EN8 and phosphorous bronze have been used as shaft and bearing materials, respectively. The size of the bagasse particle from sugar cane juice as a contaminant in oil is varied from 30 to 700  $\mu\text{m}$  and measured with SEM machine. An internal knurling tool is attached to the lathe machine to perform an internal knurling operation on the inner diameter of bearing. Two textured bearings like straight (St) and spiral (Sp) have been used for entire experimental work. The external diameter, internal diameter and length of bearings are 40 mm, 30 mm and 40 mm, respectively. The diameter and rotational speed of the shaft are 30 mm and from 500 to 800 RPM, respectively. The length of bearing to the diameter of the journal (shaft) ratio is 1.333:1. The kinematic viscosity of SAE 40 engine (Gulf) oil is approximate 16.34 cSt @ 100 °C . The total test run for two texture bearing is 40 hours (20 hours each) for 10 days. A capacity of 1.5 HP of AC electric motor with two pulleys and V-belt arrangement has been used to run (rotate) the shaft, which is subjected centrally with a constant load of 392.55 N. For varying speed of the shaft, a variable frequency drive (VFD) has been used. Wear analysis of the journal bearing is found by adding a deadweight load at the center of the span of the shaft. The shaft alignment has been maintained by double-row self-align deep grooved ball bearings (DGBB). The surface textured (spiral and straight knurled) bearings and test rig of journal bearing are shown in figures 1 and 2. The pitch diameter of 1 mm is the same for both straight and spiral knurled bearing. The pitch diameter of the 30° angle with the shaft axis is used for the spiral bearing.

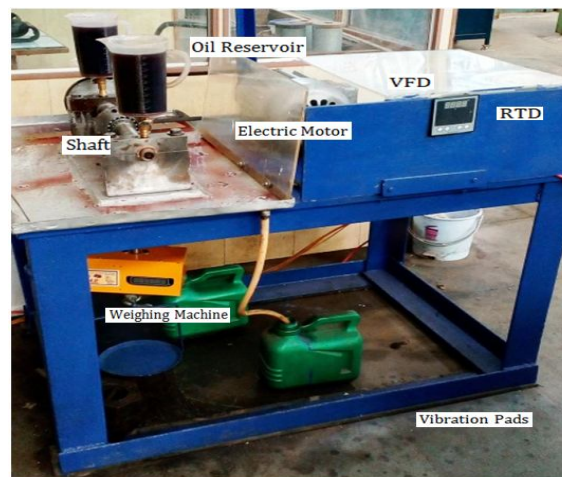
Fig. 2 Test rig of journal bearing

Two vibrations (rubber) pad of 6 mm thickness is required to keep at the bottom of the test rig, stabilize the vibration level of journal bearing. Two bearing housing is used to sustain the shaft and also restrict the movement of axial and rotation of bearings during the experimental work. The lubricating oil is flown inside the bearing through gravity. The internal diameter and temperature of all bearings have been measured by using coordinate measuring machine (CMM) with a least count of 0.005 mm and resistance thermometers (RTD) probe with a least count of  $\pm 1$  °C , respectively.

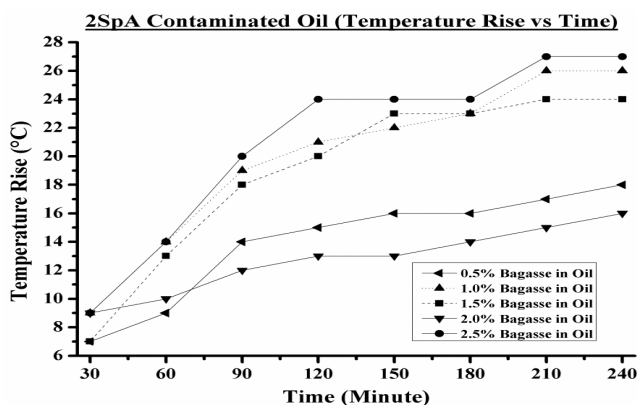
Fig. 3 Temperature of 2SpA bearing under various contaminated oil conditions

The temperature rise of 2SpA (spiral knurled) bearing with respect to time under various contamination (bagasse) oil conditions are shown in figure 3. The atmospheric temperature for each contamination oil condition was varied for the entire test run. The temperature of lubricating oil between the journal and bearing has been measured continuously after every 30 minutes of interval up to 240 minutes by RTD (resistance thermometer) PT 100 probe. The shaft is rotated at a speed of 500 RPM up to 60 minutes, 600 RPM for 60 to 120 minutes, 700 RPM for 120 to 180 minutes and 800 RPM for 180 to 240 minutes of the test run, respectively. The atmospheric temperature of 35 °C , 28 °C , 27 °C , 36 °C and 26 °C was measured at 0.5%, 1.0%, 1.5%, 2.0% and 2.5% of contaminated oil of the bearing, respectively. The maximum temperature rise of 27 °C and minimum temperature rise of 19 °C was recorded at 2.5% and 2.0% of the bearing, respectively. When contamination (sugar cane bagasse) is blended with operating oil, which may degrade the lubricating oil results affect the static characteristics of the journal bearing. The temperature rise of only 1 °C (approximate stable) has been observed at 0.5% and 2.0% of contaminated oil from 90 to 240 minutes of the test run, respectively. The temperature was close stable at 1.0% and 2.5% of contaminated oil from 120 to 180 minutes; it is increased 3 °C up to 240 minutes, respectively. The temperature rise of 2StB (straight knurled) bearing with respect to time under various contamination (bagasse) oil conditions are shown in figure 4. The atmospheric temperature of 37 °C , 29 °C , 40 °C , 30 °C and 38 °C was measured at 0.5%, 1.0%, 1.5%, 2.0% and 2.5% of contaminated oil of the bearing, respectively. The maximum temperature rise of 21 °C and minimum temperature rise of 10 °C was recorded at 1.0% and 1.5% of contaminated in lubricating oil of the bearing, respectively. The temperature rise has been found approximate similar at 0.5% and 2.0% of contaminated oil of the bearing. The temperature was increased up to 3 °C at 0.5%, 1.5% and 2.5% of contaminated oil of the bearing, from 90 to 240 minutes of test run.

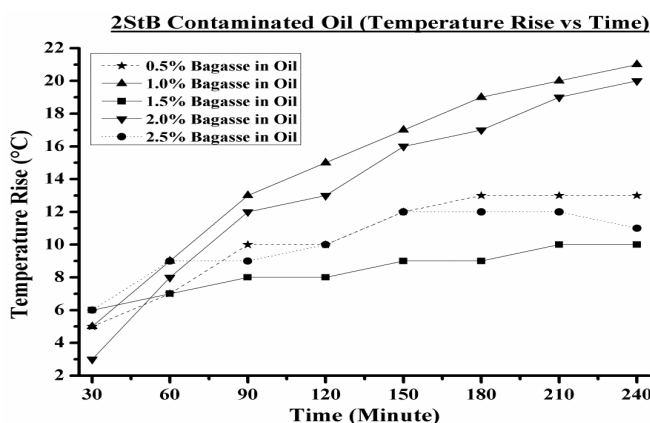
Fig. 4 Temperature of 2StB bearing under various contaminated oil conditions

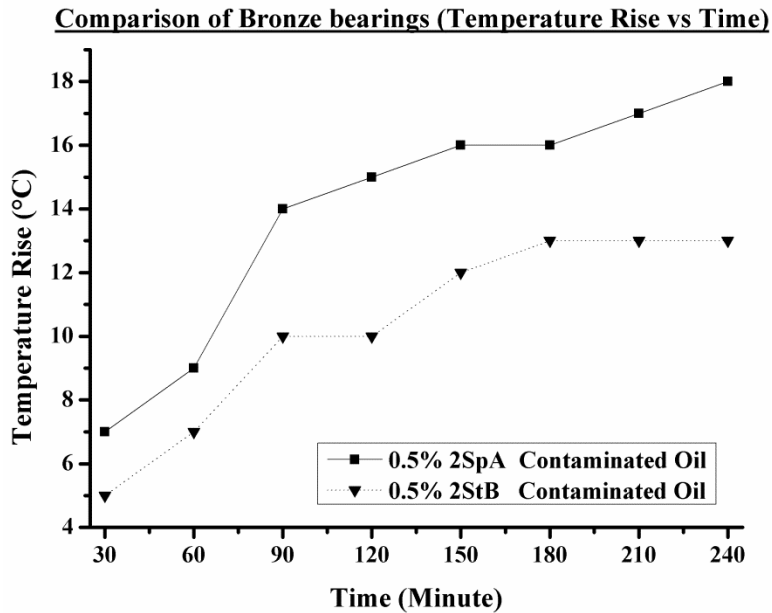
Fig. 5 Temperature of Phosphorous bronze bearings at 0.5% of contaminated oil

Comparison of the temperature of 2SpA and 2StB phosphor bearings as regards time under 0.5% of contaminated oil is shown in figure 5. Higher the temperature rise of 2SpA bearing has been noticed when comparing with 2StB bearings at 0.5% of contaminated oil. The temperature rise increases continuously up to 240 minutes of the test run in case of 2SpA bearing at 0.5% of contaminated oil. Only 3 °C of the temperature rise were marked on 2StB bearing between 90 to 240 minutes of test run.

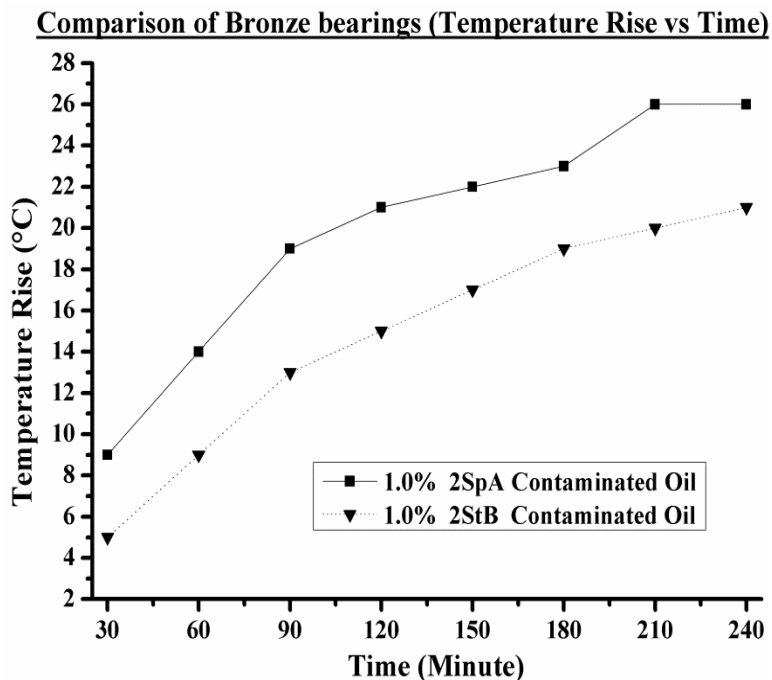
Fig. 6 Temperature of Phosphorous bronze bearings at 1.0% of contaminated oil

Comparison of the temperature of 2SpA and 2StB phosphor bearings with respect to time under 1.0% of contaminated oil is shown in figure 6. Higher the temperature rise of 2SpA bearing has been noticed when comparing with 2StB bearings with at 1.0% of contaminated oil. The temperature rise increases continuously up to 240 minutes of the test run in the case of 2SpA and 2StB bearing of 1.0% of contaminated oil.

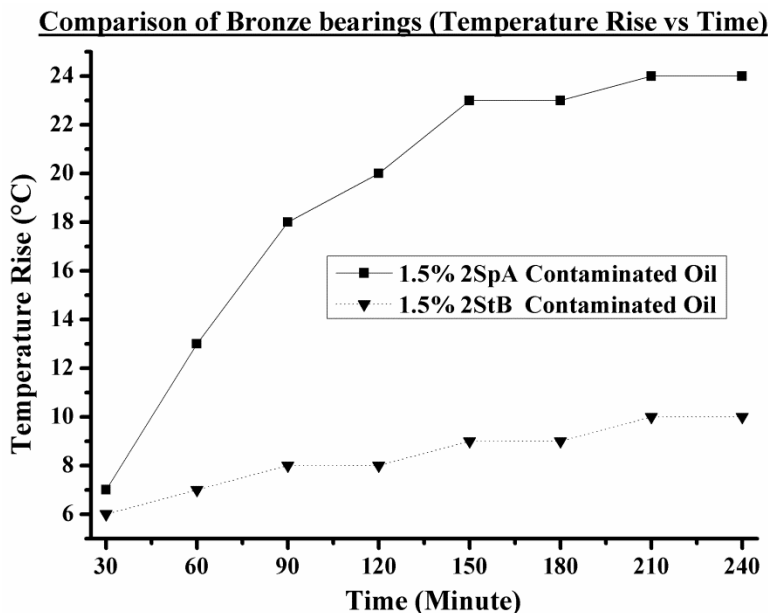
Fig. 7 Temperature of Phosphorous bronze bearings at 1.5% of contaminated oil

Comparison of the temperature of 2SpA and 2StB phosphor bearings with respect to time under 1.5% of contaminated oil is shown in figure 7. Higher the temperature rise of 2SpA bearing has been noticed when comparing with 2StB bearings with at 1.5% of contaminated oil. The temperature rise increases continuously up to 240 minutes of the test run in case of 2SpA bearing at 1.5% of contaminated oil. Only 4 °C of the temperature rise was marked on the 2StB bearing between 30 to 240 minutes of test run.

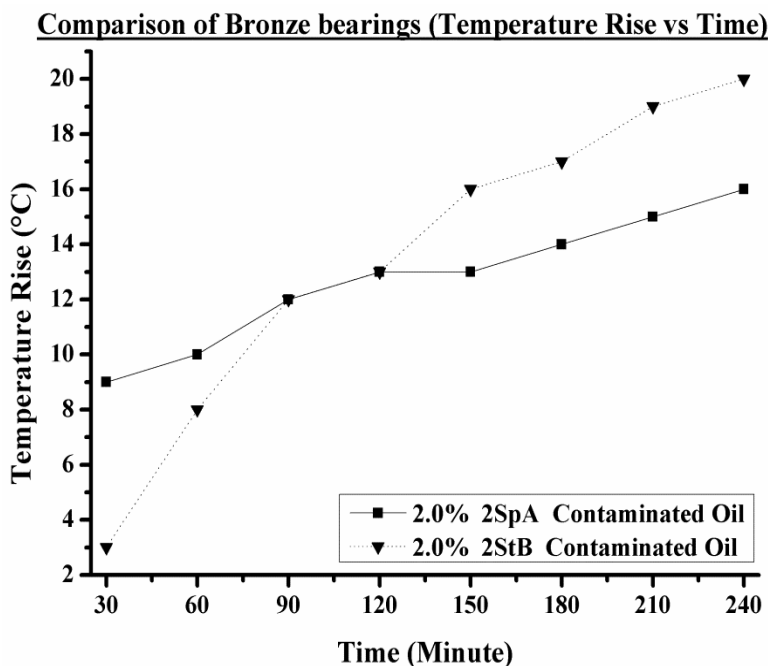
Fig. 8 Temperature of Phosphorous bronze bearings at 2.0% of contaminated oil

Comparison of the temperature of 2SpA and 2StB phosphor bearings with respect to time under 2.0% of contaminated oil is shown in figure 8. Higher the temperature rise of 2StB bearing has been noticed when comparing with 2SpA bearings with at 2.0% of contaminated oil. The temperature rise increases continuously up to 240 minutes of the test run in case of the 2SpA and 2StB bearing at 2.0% of contaminated oil.

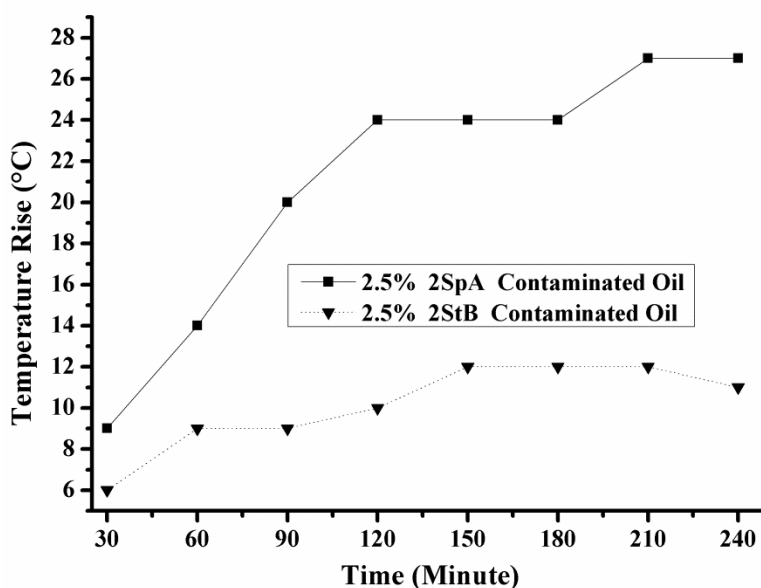
Fig. 9 Temperature of Phosphorous bronze bearings at 2.5% of contaminated oil

Comparison of the temperature of 2SpA and 2StB phosphor bearings with respect to time under 2.5% of contaminated oil is shown in figure 9. Higher the temperature rise of 2SpA bearing has been noticed when comparing with 2StB bearings with at 2.5% of contaminated oil. The temperature rise increases continuously up to 240 minutes of the test run in case of 2SpA bearing at 2.5% of contaminated oil. Only 3 °C of the temperature rise were marked on 2StB bearing between 60 to 240 minutes of test run.
