Effect of Surface Textures on the Performance of Journal Bearings with Contaminated Oil

Vinay Kumar¹, D. P. Vakharia¹

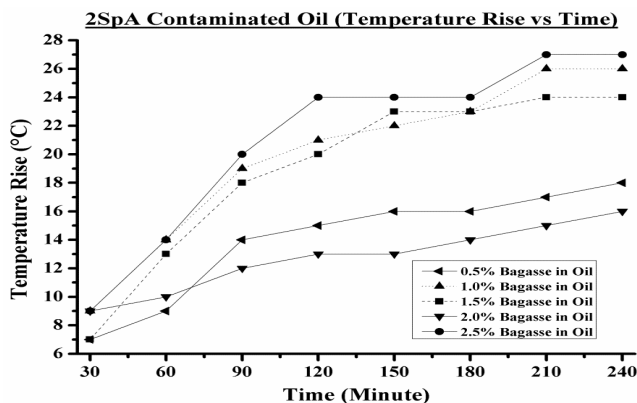
Fig. 3 Temperature of 2SpA bearing under various contaminated oil conditions

The temperature rise of 2SpA (spiral knurled) bearing with respect to time under various contamination (bagasse) oil conditions are shown in figure 3. The atmospheric temperature for each contamination oil condition was varied for the entire test run. The temperature of lubricating oil between the journal and bearing has been measured continuously after every 30 minutes of interval up to 240 minutes by RTD (resistance thermometer) PT 100 probe. The shaft is rotated at a speed of 500 RPM up to 60 minutes, 600 RPM for 60 to 120 minutes, 700 RPM for 120 to 180 minutes and 800 RPM for 180 to 240 minutes of the test run, respectively. The atmospheric temperature of 35 °C , 28 °C , 27 °C , 36 °C and 26 °C was measured at 0.5%, 1.0%, 1.5%, 2.0% and 2.5% of contaminated oil of the bearing, respectively. The maximum temperature rise of 27 °C and minimum temperature rise of 19 °C was recorded at 2.5% and 2.0% of the bearing, respectively. When contamination (sugar cane bagasse) is blended with operating oil, which may degrade the lubricating oil results affect the static characteristics of the journal bearing. The temperature rise of only 1 °C (approximate stable) has been observed at 0.5% and 2.0% of contaminated oil from 90 to 240 minutes of the test run, respectively. The temperature was close stable at 1.0% and 2.5% of contaminated oil from 120 to 180 minutes; it is increased 3 °C up to 240 minutes, respectively. The temperature rise of 2StB (straight knurled) bearing with respect to time under various contamination (bagasse) oil conditions are shown in figure 4. The atmospheric temperature of 37 °C , 29 °C , 40 °C , 30 °C and 38 °C was measured at 0.5%, 1.0%, 1.5%, 2.0% and 2.5% of contaminated oil of the bearing, respectively. The maximum temperature rise of 21 °C and minimum temperature rise of 10 °C was recorded at 1.0% and 1.5% of contaminated in lubricating oil of the bearing, respectively. The temperature rise has been found approximate similar at 0.5% and 2.0% of contaminated oil of the bearing. The temperature was increased up to 3 °C at 0.5%, 1.5% and 2.5% of contaminated oil of the bearing, from 90 to 240 minutes of test run.

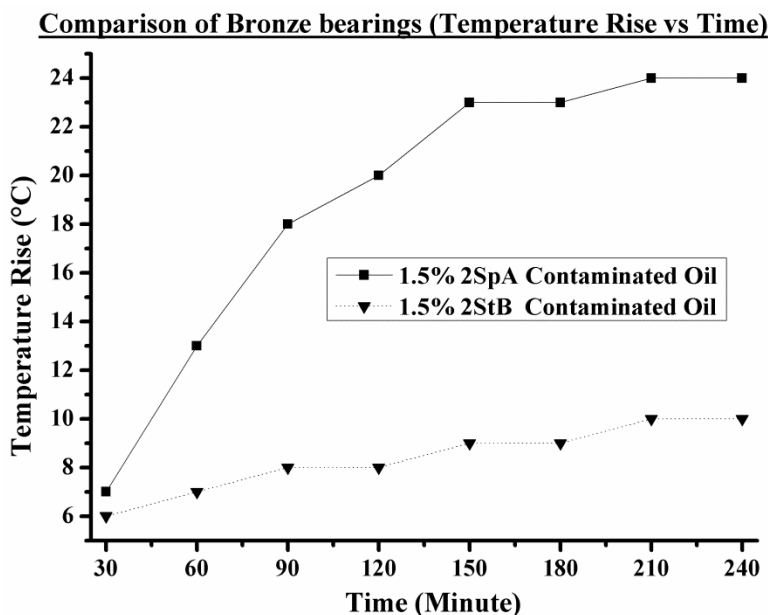
Fig. 7 Temperature of Phosphorous bronze bearings at 1.5% of contaminated oil

Comparison of the temperature of 2SpA and 2StB phosphor bearings with respect to time under 1.5% of contaminated oil is shown in figure 7. Higher the temperature rise of 2SpA bearing has been noticed when comparing with 2StB bearings with at 1.5% of contaminated oil. The temperature rise increases continuously up to 240 minutes of the test run in case of 2SpA bearing at 1.5% of contaminated oil. Only 4 °C of the temperature rise was marked on the 2StB bearing between 30 to 240 minutes of test run.

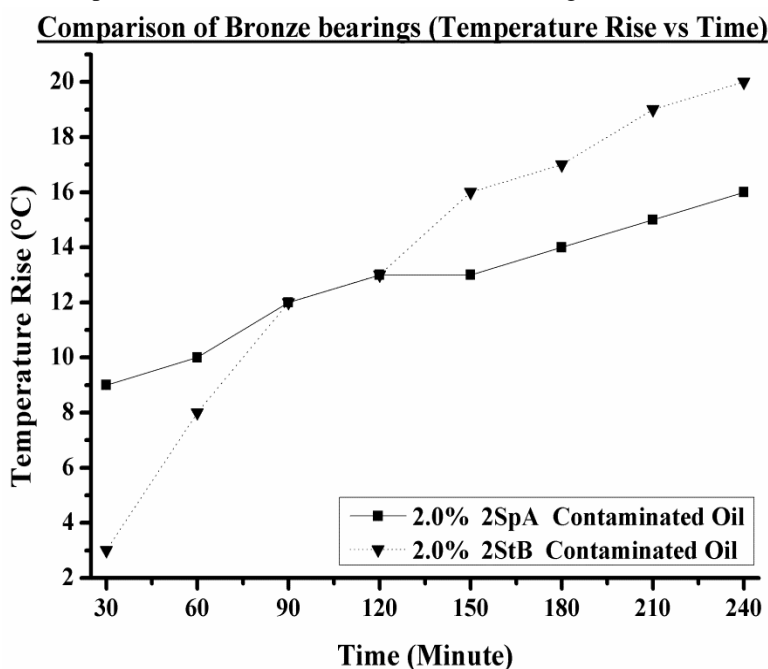
Fig. 8 Temperature of Phosphorous bronze bearings at 2.0% of contaminated oil

Comparison of the temperature of 2SpA and 2StB phosphor bearings with respect to time under 2.0% of contaminated oil is shown in figure 8. Higher the temperature rise of 2StB bearing has been noticed when comparing with 2SpA bearings with at 2.0% of contaminated oil. The temperature rise increases continuously up to 240 minutes of the test run in case of the 2SpA and 2StB bearing at 2.0% of contaminated oil.
