Seismic Vulnerability Assessment of RC Buildings of Nagpur (North-East) using Rapid Visual Screening

Shamshad Ali¹, S. S. Sanghai²

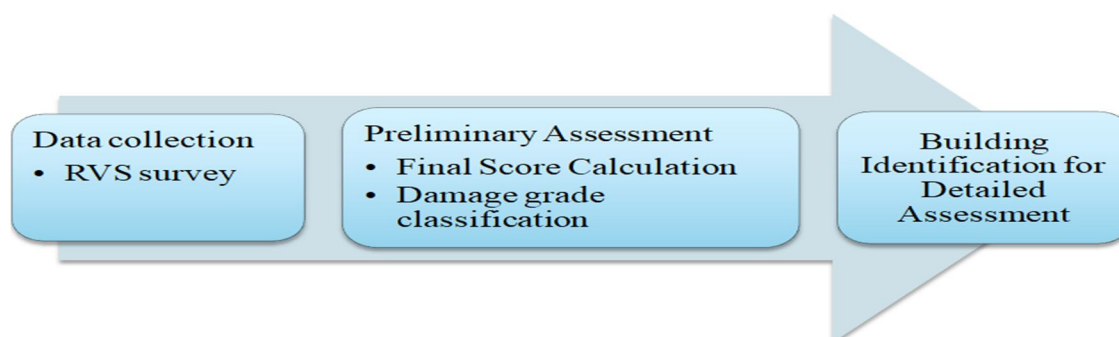
Fig. 1: Vulnerability Assessment Flow Chart

- 1) Selection of area of region of the city for Rapid Visual Screening.
- 2) Selection of two RVS forms proposed by Ningthaujam and Nanda [1] and FEMA.
- 3) Conduction of the RVS survey for the selected area by the two forms.
- 4) Calculation of Final Score using survey data by both the forms.
- 5) Categorization of damage grade of RC buildings as per final scores.
- 6) Comparison between the two RVS forms.
- 7) Identification of buildings requiring detailed seismic investigation.

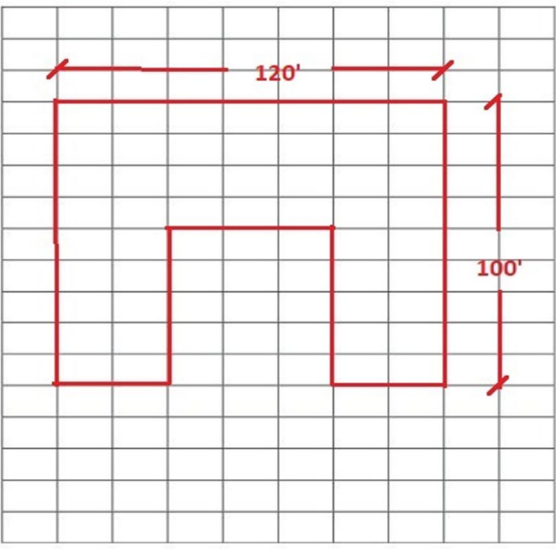
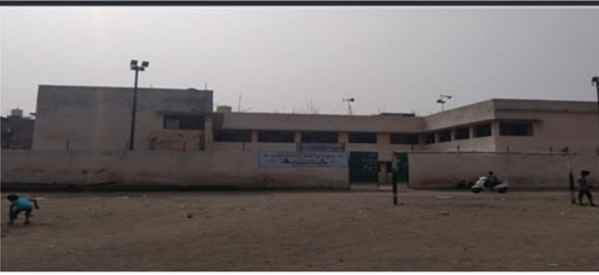
Fig. 3: RVS proposed by Ningthoujam and Nanda [1]

Building Name Azad Nagar Urdu High School Address Farooque Nagar Teka Nagpur Other Identifiers --- GPS Co-ordinates (If available) --- No. Stories 2 Year Built 1992 Total Floor Area (sq. Ft. /sq. m) 12000 sq.ft Seismic zone II Surveyor Shamshad Ali Date 15/12/2019

OCCUPANCY Commercial <input type="checkbox"/> Residential <input type="checkbox"/> Educational <input checked="" type="checkbox"/> Occupancy number 400		SOIL TYPE Type I Hard Type II Medium Type III Soft			
		Age of the building: Age of building (In years) 27			
BASIC SCORE, MODIFIERS, AND FINAL SCORE, S					
	Seismic zone	Zone II	Zone III	Zone IV	Zone V
	Basic scores	1.00	1.70	2.00	2.70
Basic score modifier	Substantial overhang	+0.41	+0.41	+0.41	+0.41
	Age of building : Increment per year	27x +0.02	+0.02	+0.02	+0.02
	Poor construction quality	+2.20	+2.20	+2.20	+2.20
	Moderate construction quality	+1.10	+1.10	+1.10	+1.10
	Poor Maintenance condition	+1.30	+1.30	+1.30	+1.30

Moderate Maintenance condition	+0.65	+0.65	+0.65	+0.65
	Type of soil:				
	Soil type-I	-4.86	-4.86	-4.86	-4.86
Soil type-II	-2.43	-2.43	-2.43	-2.43	
Soil type-III	0.00	0.00	0.00	0.00	
Number of stories: Increment per storey	2x +0.10	+0.10	+0.10	+0.10	
FINAL SCORE, S=		2.39			
Final score	S<1	1≤S<1.5	1.5≤S<2	2≤S<2.65	2.65<S
Assigned damage grade	Grade 1	Grade 2	Grade 3	Grade 4	Grade 5
RECOMMENDED ACTION FOR DIFFERENT DAMAGE GRADE:				Recommended action to be taken for the existing building:	
Grade 1/2: Seismically safe but non-structural damage can be harmful to occupants so repairing work is recommended for the building				Further re-evaluation is recommended.	
Grade 3/4/5: Seismically not safe as structural damage will occur so further re-evaluation and retrofitting is recommended for the building

An educational building of G+1 is taken for the case study from the surveyed buildings. Scores are calculated based on the two methodologies as presented in Fig: 1 and Fig: 2. As per Ningthoujam and Nanda [1], the building will face grade 4 damage and need further detailed evaluation, whereas the school building will face grade 2 damage as per FEMA and need not further re-evaluation for the seismic event.

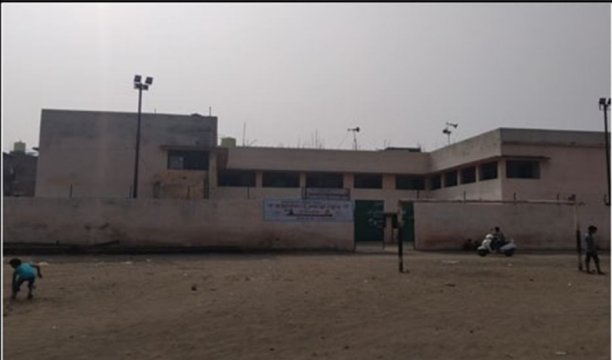
Fig. 4: RVS sheet by FEMA [9]

<p>Plan and Elevation Scale:</p>	<p>Address: <u>Farooque Nagar Teka</u> <u>Nagpur</u> Pin <u>440017</u></p> <p>Other Identifiers <u>---</u></p> <p>GPS Co-ordinates (If available) <u>---</u></p> <p>No. Stories <u>2</u> Year Built <u>1992</u></p> <p>Surveyor <u>Shamshad Ali</u> Date <u>15/12/2019</u></p> <p>Total Floor Area(sq. Ft./sq. m) <u>12000 sq. ft</u></p> <p>Building Name <u>Azad Nagar Urdu High School</u></p> <p>Use <u>Educational</u></p>

OCCUPANCY		SOIL TYPE		FALLING HAZARDS						
Assembly	Govt.	Office	Max. No. Of persons 0-10 11-100 <u>101-1000</u> 1000+	Type I Hard	Type II Medium	Type III Soft	Chimneys Cladding	Parapets Others.		
Commercial	Historic	Residential							School	
Emer. Service	Industrial	School								
BASIC SCORE, MODIFIERS, AND FINAL SCORE, S										
BUILDING TYPE	Wood	S1 (FRAME)	S2 (LM)	C1 (MRF)	C2 (SW)	C3 (INF)	RM1 (BAND+RD)	RM2 (BAND+FD)	URM3	URM4
Basic Score	6.0	4.6	4.6	<u>4.4</u>	4.8	4.4	4.6	4.8	4.6	3.6

Mid Rise (4 to 7 stories)	N/A	+0.2	N/A	+0.4	-0.2	-0.4	-0.2	-0.4	-0.6	-0.6
High Rise (>7 stories)	N/A	+1.0	N/A	+1.0	0.0	-0.4	N/A	N/A	N/A	N/A
Vertical Irregularity	-3.0	-2.0	N/A	-1.5	-2.0	-2.0	-1.5	-2.0	-1.5	-1.5
Plan Irregularity	-0.8	-0.8	-0.8	<u>-0.8</u>	-0.8	-0.8	-0.8	-0.8	-0.8	-0.8
Poor Condition	-0.5	-0.5	-0.5	-0.5	-0.5	-0.5	-0.5	-0.5	-0.5	-0.5
Code Detailing	N/A	+0.4	N/A	+0.6	+0.4	N/A	N/A	N/A	N/A	N/A
Soil Type II	-0.4	-0.8	-0.4	-0.6	-0.4	-0.4	-0.2	-0.4	-0.4	-0.4
Soil Type III	-0.8	-1.4	-1.0	<u>-1.4</u>	-0.8	-0.8	-0.8	-0.8	-0.8	-0.8
Liquefiable Soil	-2.0	-2.0	-2.0	-2.0	-2.0	-2.0	-1.6	-1.4	-1.4	-1.4
FINAL SCORE, S = 2.2										
Comments								Further Evaluation Recommended		
As per the Score, further re-evaluation is not recommended as it is of more than the cut off score of 2.								YES NO

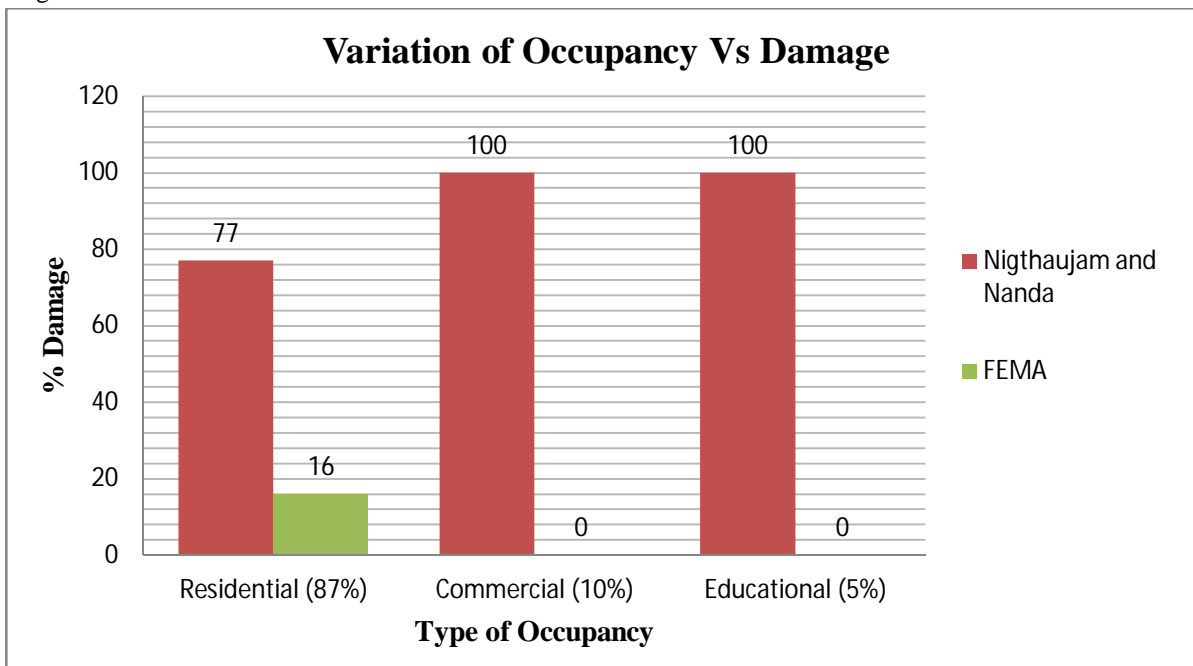
Fig. 5: Distribution of types of occupancy

The interpretation of the survey data has been represented in the form of bar charts. Figure 5 represents the variation in the occupancy type within the sample surveyed. 87% of the buildings are residential, 10% are commercial and 5% are the educational buildings. The vertical axis shows the % of damage calculated by both the methodologies that needs details evaluation (above grade 2). Forms proposed by Ningthoujam and Nanda shows high level of damage whereas FEMA shows only few residential buildings of getting damage.

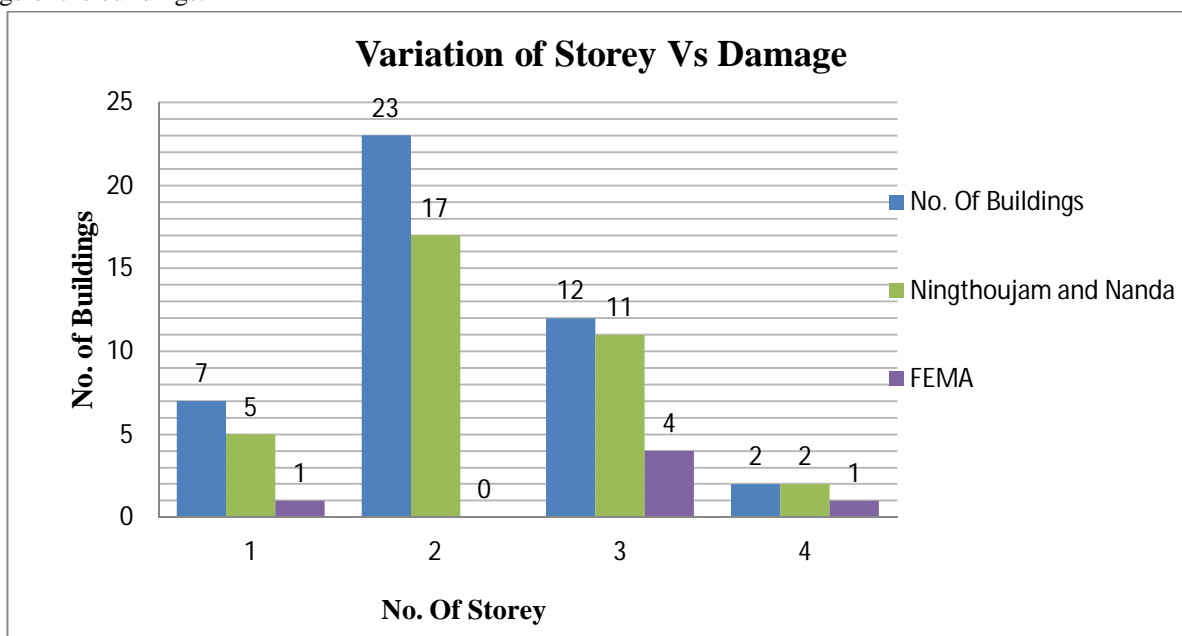
Fig. 6: Distribution of Storey of the buildings

Figure 6 represents the distribution of the storeys of the buildings surveyed. Maximum storey of the building is 4 within the vicinity and most of the buildings are of 2-3 storeys. Ningthoujam and Nanda, FEMA indicates the number of buildings getting the grade above 2 that emphasizes the heavy damage. Here also more damage prediction is made by the first form whereas FEMA shows very less damage of the buildings.

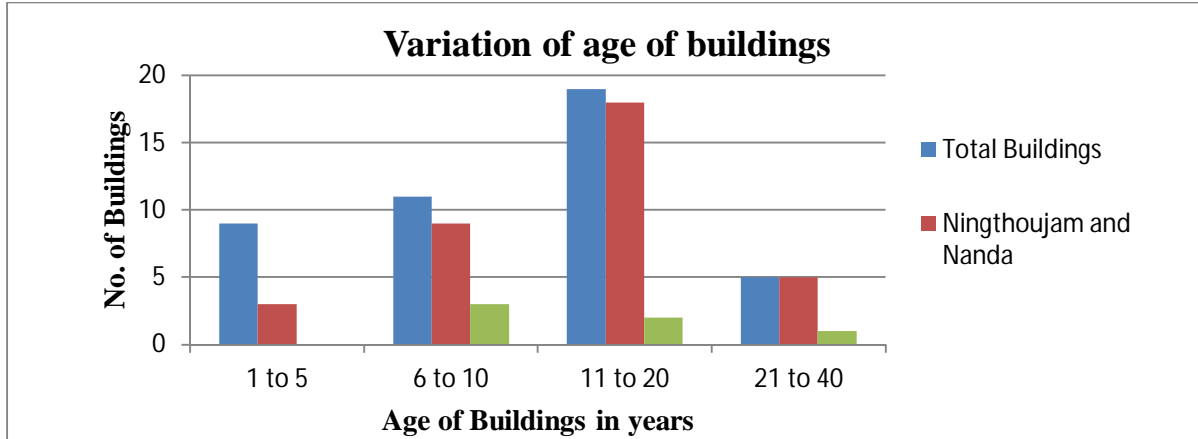
Fig. 7: Distribution of age of the buildings

Variation in the age of the RC buildings surveyed is represented in figure 7. In the selected region, most of the buildings are of 10 to 20 years and few of more than 20 years. In this chart, Ningthoujam and Nanda and FEMA indicate the number of buildings that require more detailed assessment as per the score calculated by the RVS forms. It can be seen that with increase of age of the buildings, damage also increases in the first case because the first form uses the age of building to calculate the RVS score, on the other hand FEMA recommended form doesn't contain the age in the calculation of score.

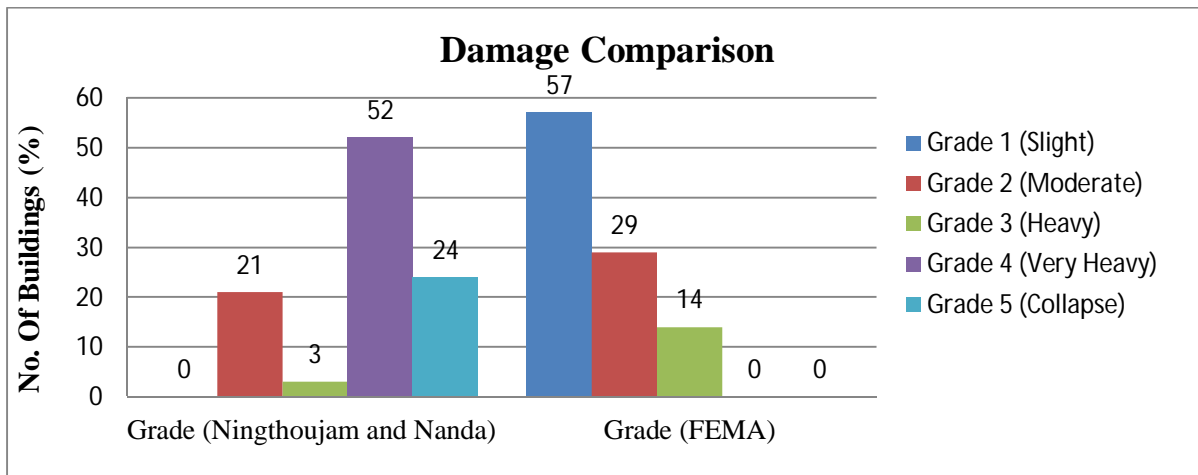
Fig. 8: Damage assigned by the two forms

The detailed comparison of all the grades calculated by the two methodologies within the selected area is represented in figure 8. It can be noted that only 21% (sum of grade 1 and grade 2) of buildings lie between slight to moderate damage calculated by Ningthoujam and Nanda whereas 86% of the buildings lie in the same range by FEMA. Ningthoujam and Nanda suggested screening form shows higher % of buildings fall under grade 4 and grade 5. FEMA recommended screening form illustrates only 14% of grade 3 damage of the buildings of none of grade 4 and grade 5.
