Seismic Vulnerability Assessment of RC Buildings of Nagpur (North-East) using Rapid Visual Screening

Shamshad Ali¹, S. S. Sanghai²

Abstract: Earthquake phenomenon as a natural hazard is causing high levels of damages to the structures around the world. The damages and losses caused by recent earthquakes have increased. The damage and loss caused by recent earthquakes has increased. Most of the existing buildings in Nagpur (India) are designed to withstand gravity loads only without the provision of earthquakes. It is therefore necessary to study the vulnerability of reinforced concrete structures to avoid high risk. The north-east region of the city is surveyed through rapid visual screening methodology using two different screening forms. Two different forms are selected to choose better form for Indian context. The damage grade is assigned to the buildings from 1 to 5 as per the European Macroseismic Scale-1998 for both the methodology independently. According to the grading systems buildings are identified for the further detailed evaluation.

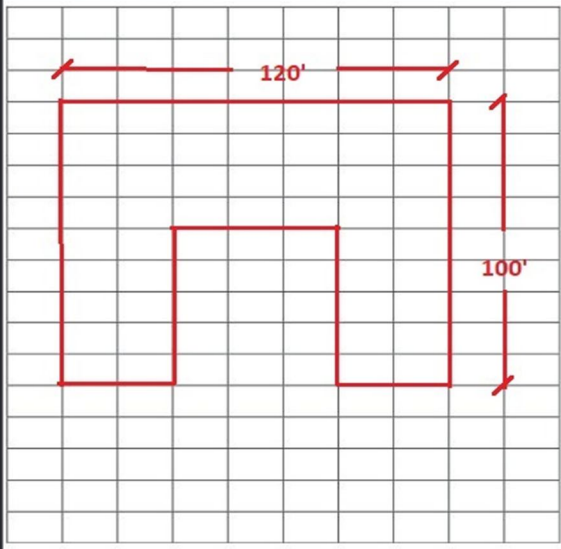
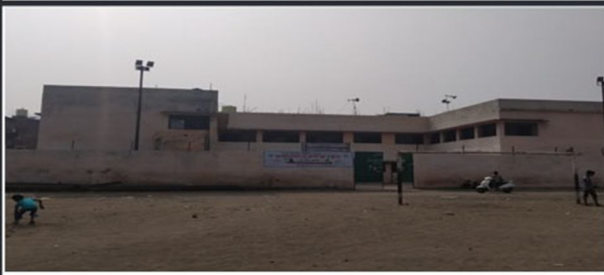
Fig. 3: RVS proposed by Ningthoujam and Nanda [1]

Building Name Azad Nagar Urdu High School Address Farooque Nagar Teka Nagpur Other Identifiers --- GPS Co-ordinates (If available) --- No. Stories 2 Year Built 1992 Total Floor Area (sq. Ft. /sq. m) 12000 sq.ft Seismic zone II Surveyor Shamshad Ali Date 15/12/2019

OCCUPANCY Commercial <input type="checkbox"/> Residential <input type="checkbox"/> Educational <input checked="" type="checkbox"/> Occupancy number 400		SOIL TYPE Type I Hard Type II Medium Type III Soft	Age of the building: Age of building (In years) 27		
BASIC SCORE, MODIFIERS, AND FINAL SCORE, S					
	Seismic zone	Zone II	Zone III	Zone IV	Zone V
	Basic scores	1.00	1.70	2.00	2.70
Basic score modifier	Substantial overhang	+0.41	+0.41	+0.41	+0.41
	Age of building : Increment per year	27x +0.02	+0.02	+0.02	+0.02
	Poor construction quality	+2.20	+2.20	+2.20	+2.20
	Moderate construction quality	+1.10	+1.10	+1.10	+1.10
	Poor Maintenance condition	+1.30	+1.30	+1.30	+1.30

Moderate Maintenance condition	+0.65	+0.65	+0.65	+0.65
	Type of soil:				
	Soil type-I	-4.86	-4.86	-4.86	-4.86
Soil type-II	-2.43	-2.43	-2.43	-2.43	
Soil type-III	0.00	0.00	0.00	0.00	
Number of stories: Increment per storey	2x +0.10	+0.10	+0.10	+0.10	
FINAL SCORE, S=		2.39			
Final score	S<1	1≤S<1.5	1.5≤S<2	2≤S<2.65	2.65<S
Assigned damage grade	Grade 1	Grade 2	Grade 3	Grade 4	Grade 5
RECOMMENDED ACTION FOR DIFFERENT DAMAGE GRADE:				Recommended action to be taken for the existing building:	
Grade 1/2: Seismically safe but non-structural damage can be harmful to occupants so repairing work is recommended for the building				Further re-evaluation is recommended.	
Grade 3/4/5: Seismically not safe as structural damage will occur so further re-evaluation and retrofitting is recommended for the building

An educational building of G+1 is taken for the case study from the surveyed buildings. Scores are calculated based on the two methodologies as presented in Fig: 1 and Fig: 2. As per Ningthoujam and Nanda [1], the building will face grade 4 damage and need further detailed evaluation, whereas the school building will face grade 2 damage as per FEMA and need not further re-evaluation for the seismic event.

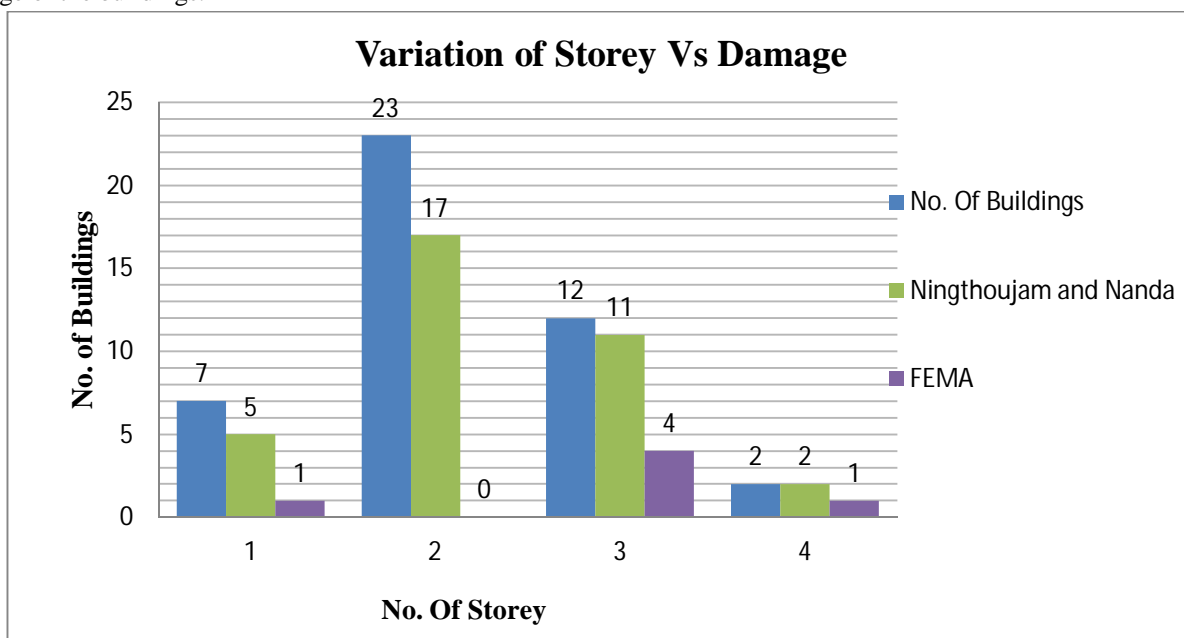
Fig. 6: Distribution of Storey of the buildings

Figure 6 represents the distribution of the storeys of the buildings surveyed. Maximum storey of the building is 4 within the vicinity and most of the buildings are of 2-3 storeys. Ningthoujam and Nanda, FEMA indicates the number of buildings getting the grade above 2 that emphasizes the heavy damage. Here also more damage prediction is made by the first form whereas FEMA shows very less damage of the buildings.
