# Mitigation of Salt-Induced Corrosion of Reinforcing Steel in Concrete using Rebar-Coating Technique

MS. Phan Văn Chương<sup>1</sup>, Dr. Phạm Văn Khoan<sup>2</sup>, Dr. Nguyễn Nam Thắng<sup>3</sup>

<sup>1</sup>Vietnam Institute for Building Science and Technology, Ministry of construction

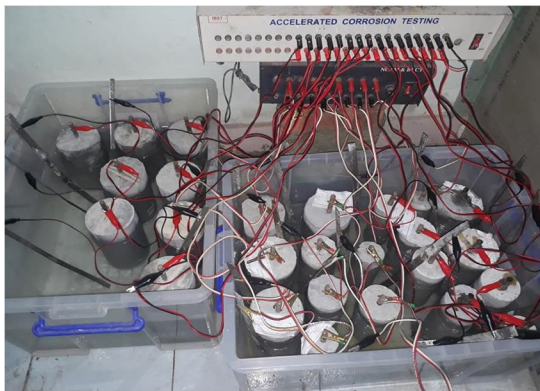
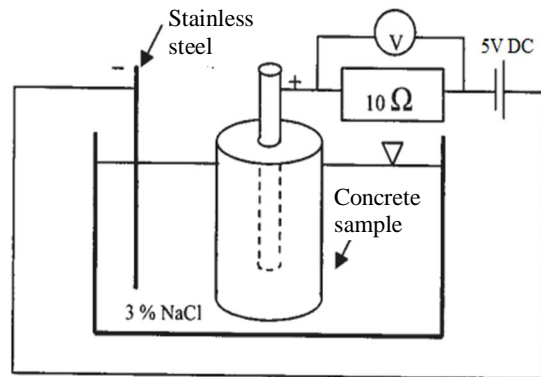
Figure 1. Sample composition and testing diagram

The technique of accelerated corrosion of reinforcing steel in concrete was adopted in the study. The reinforced concrete samples was cured for 28 days, then, put into the accelerated corrosion test. The samples were immersed in 3% NaCl solution so that water level was always 3cm away from the top of each sample. A rebar was connected to the anode of a 5V DC power supply while the cathode was connected to another stainless steel electrode immersed in a solution. Under the influence of the current, the diffusion rate of  $\text{Cl}^-$  ion into concrete increased sharply whilst the rebar corrosion accelerated; as a result, rust appeared and initiated the cracks in each sample. The amperage was measured regularly every 24 hours; at the same time, the surface state of the samples was observed. At the time of a surge in amperage, cracks together with rust appeared on the surface along the length of the rebar. The stronger the corrosion was, the less time it took from the starting time of the test to the time of current surge. The data of time served as a basis to clarify the difference in the corrosion levels of reinforcing steel in different types of concrete affected by different salinity levels and having the various types of rebar coatings. The testing diagram and samples are shown in Figure 1. Concrete aggregates used in the study are shown in Table 1.

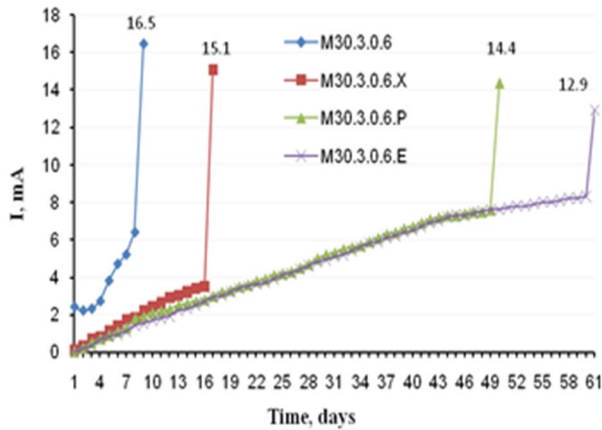
Figure 3. Effect of coating of rebar in concrete with  $Cl^- = 1.2$  kg/m<sup>3</sup> on time to crack initiation in sample

The data in both Tables 2 to 4 and Figures 2 to 6 showed the states of samples with differently coated rebars as follows:

- 2) *Concrete with salinity of  $1.2 \text{ kg/m}^3$* : M30.3.1.2.P, M30.3.1.2.E, M30.3.1.2.X samples had times to crack initiation of 47, 58 and 15 days, equal to 522%, 644% and 167%, respectively of that of M30.3.0.6 reference sample.

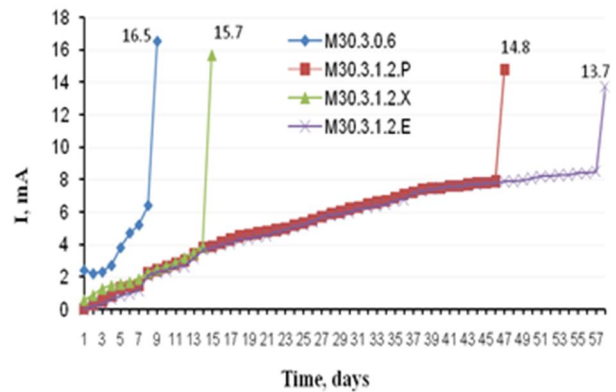
Figure 4. Effect of coating of rebar in concrete with  $Cl^- = 1.8$  kg/m<sup>3</sup> on time to crack initiation in sample

- 3) *Concrete with salinity of  $1.8 \text{ kg/m}^3$* : M30.3.1.8.P, M30.3.1.8.E, M30.3.1.8.X samples had times to crack initiation of 45, 54 and 11 days, equal to 500%, 600% and 122%, respectively of that of M30.3.0.6 reference sample.

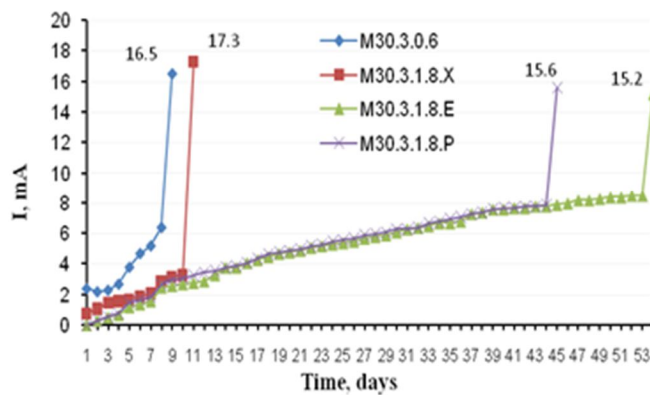
Figure 5. Effect of coating of rebar in concrete with  $Cl^- = 2.4$  kg/m<sup>3</sup> on time to crack initiation in sample

- 4) *Concrete with salinity of  $2.4 \text{ kg/m}^3$* : M30.3.2.4.P, M30.3.2.4.E, M30.3.2.4.X samples had times to crack initiation of 42, 52 and 8 days, equal to 467%; 578% and 89%, respectively of that of M30.3.0.6 reference sample.

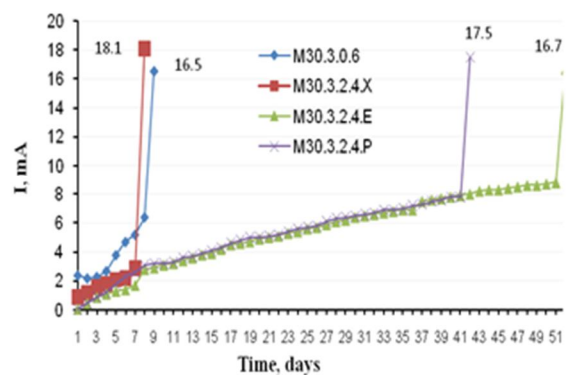
Figure 6 Comparison of cracking time of concrete with waterproofing B10 (M300), steel reinforcement paint with different salinity levels

To assess the rebar corrosion resistance on a type-to-type basis, M30.3.0.6 concrete with salinity of  $0.6 \text{ kg/m}^3$ , cover thickness of 30mm and 9-day time to crack initiation was taken as reference sample. The reinforced concrete samples, suffering from the salinity of 1.2, 1.8 and  $2.4 \text{ kg/m}^3$  and having differently coated rebars, were compared with the reference sample in terms of times to crack initiation. The comparison results was as follows:

- 1) *Concrete with salinity of  $0.6 \text{ kg/m}^3$* : M30.3.0.6.P, M30.3.0.6.E, M30.3.0.6.X samples had times to crack initiation of 50, 61 and 17 days, equal to 556%, 678% and 189%, respectively of that of M30.3.0.6 reference sample.
