# Inspection and Service Life Prediction of ZP School Buildings in Shahuwadi Region

**Abstract:** This paper presents a specific case study for estimating the service life of ZP school buildings in the Shahuwadi region of Maharashtra, India. Prediction of building components is evaluated by calculation of 'Condition Indices' followed by the 'Factor method'. For planning maintenance of any building it is necessary to have good information about building components and durability of materials. The construction works have to be maintained during their whole service life. Service life's knowledge becomes very important input data to guide designers, manufacturers and real estate owners in contributing for sustainability of whole building process. The case in consideration was applied to the data collected for a project to assess the condition of 30 schools that belong to selected study area.

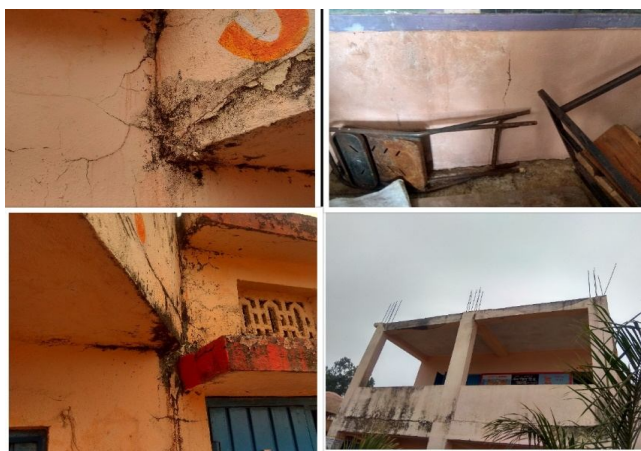
Fig.1 Defects in Jivan Salashi

Defects observed: Here Defective concrete as a result of ageing is most commonly found in such old buildings. There is formation of shear cracks at the joints due to load. When two materials have widely different elastic properties and are built side by side, under the effects of load, shear stress is set up at the interface of the two materials, resulting in formation of crack at the junction. Vertical crack is observed in the wall which is a common sign of structural instability. A chajja which is a projecting eave or a covering of a roof is absent in the above building and this may expose to the building to rainfall and allow seepage of water from roof and gliding downwards.

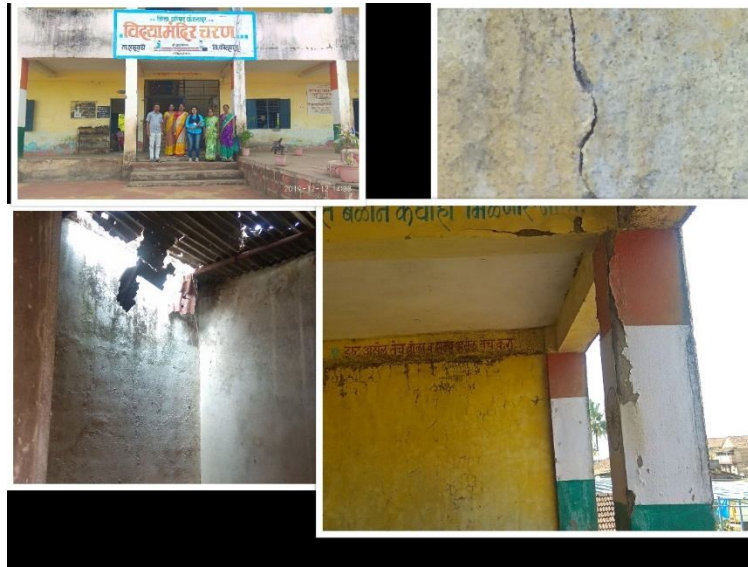
Fig.2 Defects in Charan

Defects observed: Cut edges on a steel roof will experience edge creep, which is minimal rusting occurring at the cut edge. Many details in a standing seam metal roof have folds or hemmed edges that conceal the cut edge of the metal. Vertical and diagonal cracks in concrete walls typically indicate foundation movement. If a vertical crack widens at the top or bottom, the wall is either settling or gradually heaving, which may present serious issues. Spalling of the mortar and brick will occur due to the expansive nature of water. This happens when excessive moisture enters the walls.

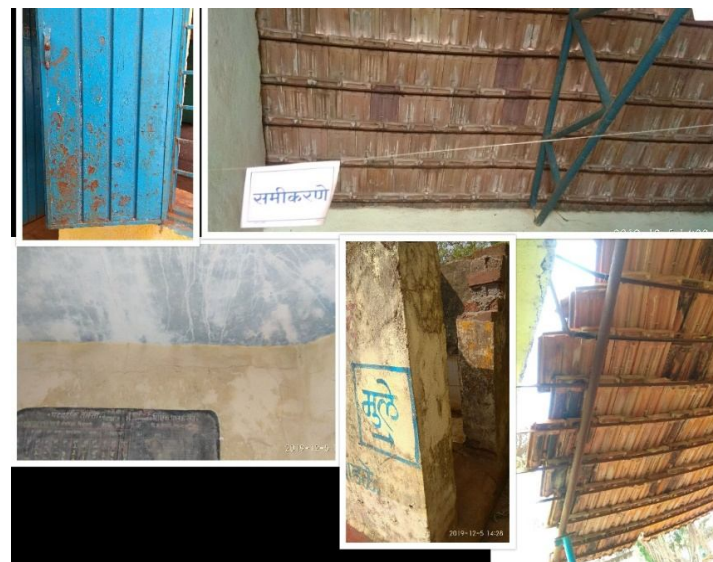
Fig.3 Defects in Bhadale

a) *Defects Observed:* The metal windows have been rusted to some extent and it is form of surface rusting. Without the required servicing and maintenance, hinges may become too tight to operate, rivets may loosen up and screws may be corroded that shorten their life-span. The purlins under the manglorian roof tiles have been eroded which may lead to service failure. The W.C are not in proper condition due to falling off of bricks from the walls. Also the roof has been subjected to dampness and can be a serious matter, particularly to buildings located near water sources. Dampness led to deterioration of building structures and also damage to the furnishings.

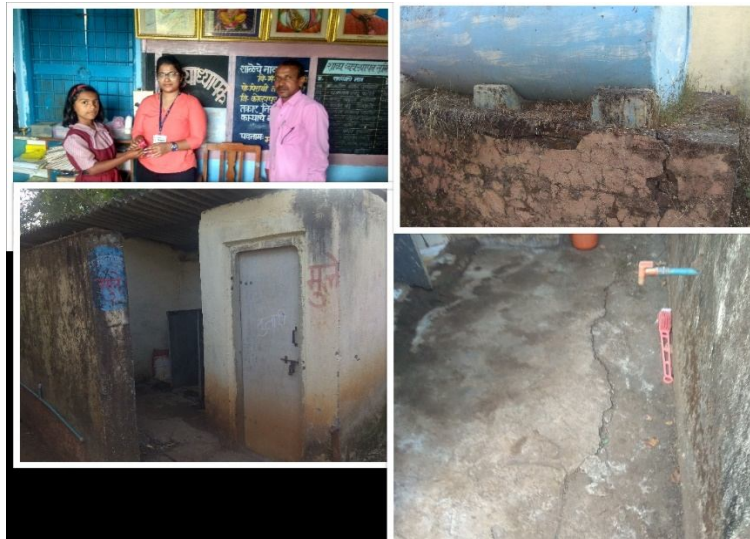
Fig.4 Defects in Vhanagdewadi

- a) *Defects Observed:* Mold and fungi are found everywhere either both indoors and outdoors all the year round. Mold is a type of fungi and it seems likely to grow and become bigger threat when there is water damage, high humidity or dampness. The growth of unwanted vegetation below the eater tank has led to loss in strength of concrete base. Exposure to sever changes in temperature may cause cracking of concrete flooring as we can see above image. Again, in most cases, hairline cracks are harmless and don't compromise the strength of the floor. Deeper cracks can cause a few other problems, however.

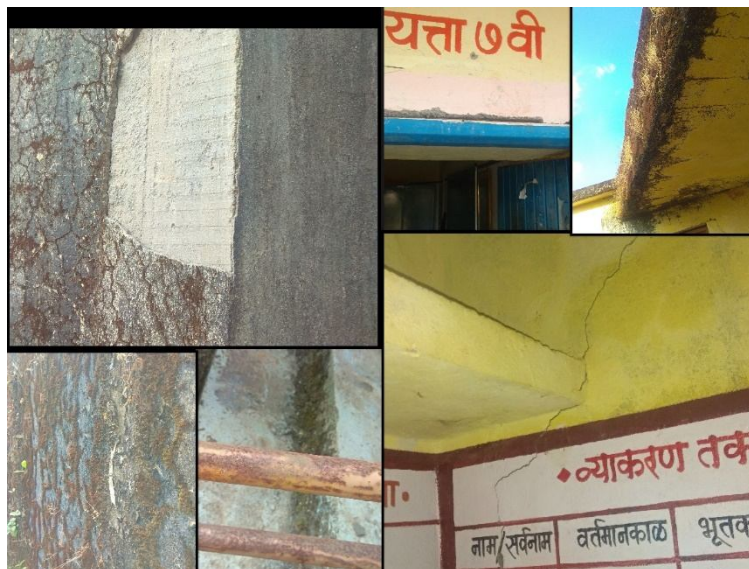
Fig.5 Defects in Warewadi

Defects observed: Here we observe falling off of concrete patches due to defective concrete or spalling of concrete. Dismantling of door frame is also observed here. Diagonal cracks are visible If there isn't a sufficient number of vertical expansion joints along the length of the wall, the unrelieved horizontal movement will cause diagonal cracks to occur at openings and, in some cases, at building corners. Spores of mold are observed on external walls. When these spores land on a moist surface that is suitable for life, they begin to grow. *Rust* is the cancer of the metal world. It eats away at the material from the inside. Many *railing* manufactures do not galvanize their railings which leads to such failure.
