A Study on Earthquake Resistant Construction in Nepal

Abstract-Nepal has a long history of earthquake activities due to its position. Recently the devastating earthquake occurred in Nepal touched 7.9 Magnitude at the Richter scale. Almost 8,673 people lost their lives and 21,954 injured, approximately 4,89,500 buildings were completely destroyed and near about 2,62,600 were partially destroyed in Lumjung-Kathmandu-Nepal. Many roads damaged including ring road in the capital city. Also 78 people lost their lives in INDIA and at least 25 people in CHINA and many more were injured. The earthquake occurred at the hypocentre of 15 km and the epicentre was Lumjung, Kathmandu. The main cause of this earthquake was the movement of INDIAN Tectonic Plate going under the Eurasian Plate. The purpose of this research paper is how to save lives at the low cost of construction through use of horizontal bands and proper seismic knowledge and also use of principles of earthquake resistant design.

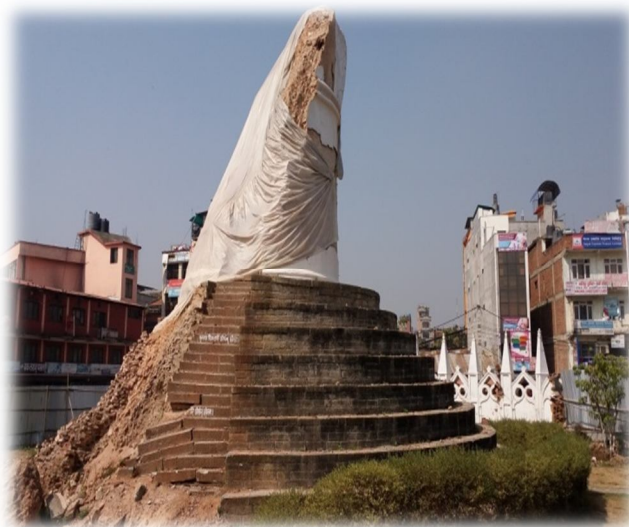
Figure 1: damaged dharahara tower, kathmandu

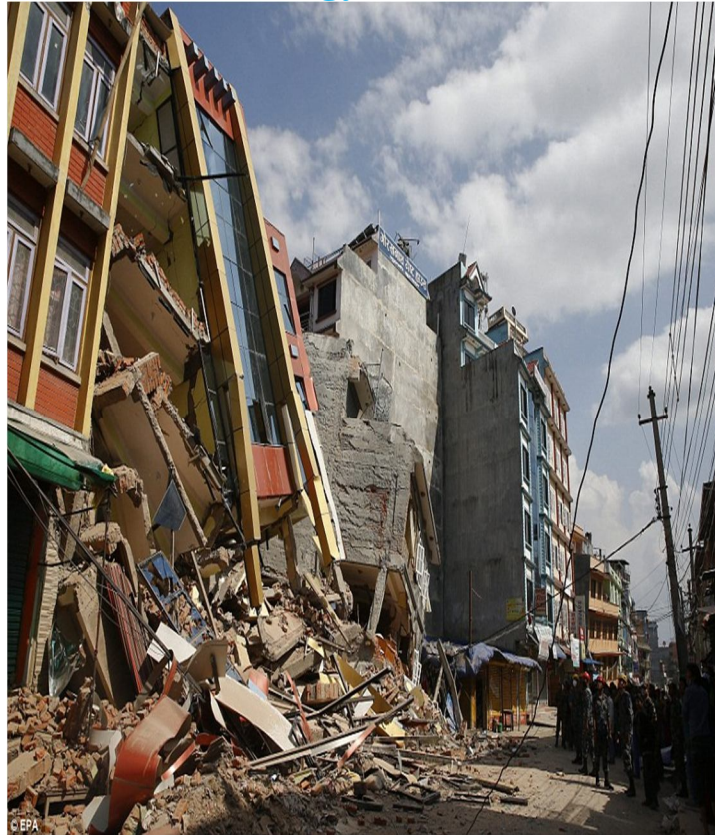
Figure 2: column, joints fail

There were almost 5 lack houses were collapsed in the Lumjung-Kathmandu-Nepal on the devastating quake occurred April 25, 2015 at 11:56AM. I vested all the affected places in Kathmandu valley and collect all the data which is required to prepare this paper. I have to discuss some points regarding failure of buildings during earthquake such as unreinforced masonry buildings, soft story effects, in adequate confinement of steel in RCC structure, soil liquefaction, poor detailing of reinforcement, seismically weak sot story at the first floor, insufficient shear reinforcement.

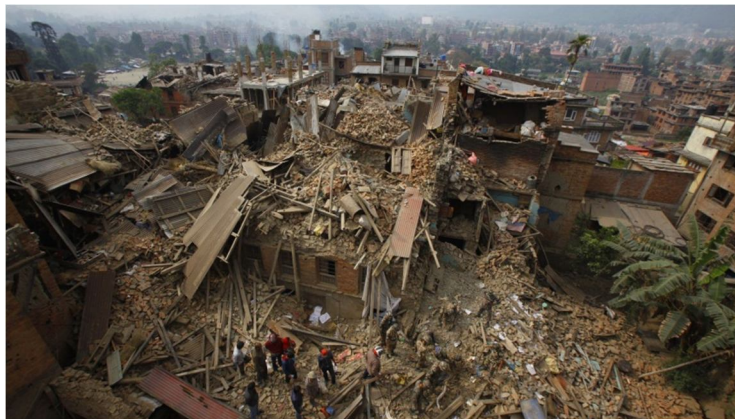
Figure 3: total house collapsed
