Effect of Post Weld Heat Treatment on Properties of ACTIG Welded Aa6063 Aluminium Alloy Joint

Sandeep Verma¹, H.K.Arya², Pankaj Kumar³

^{1, 2, 3}Department of Mechanical Engineering, SLIET, Longowal, Punjab, India

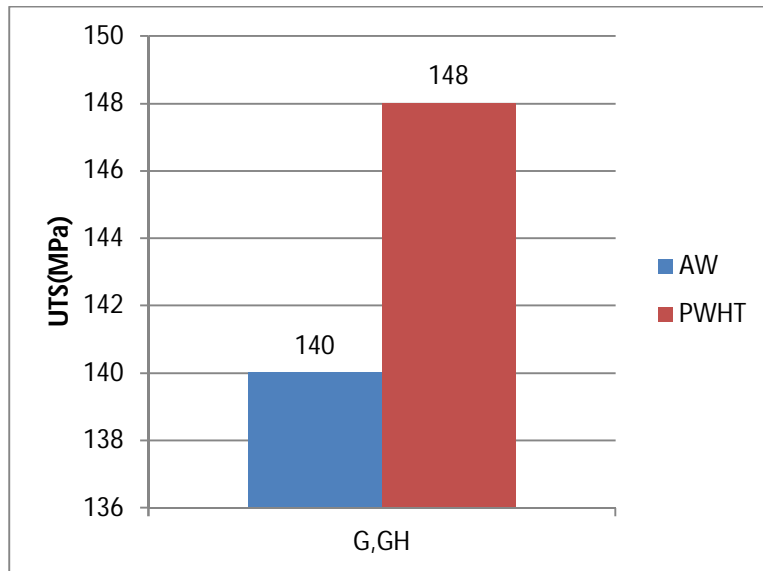
Fig 4 Graphical representation of variation in ultimate tensile strength values of welded specimen

The tensile strength of the joints made using different conditions in as welded as well as in post weld heat treatment has been evaluated. In each condition the corresponding ultimate tensile strength, peak load and total elongation are mentioned in Table 4.

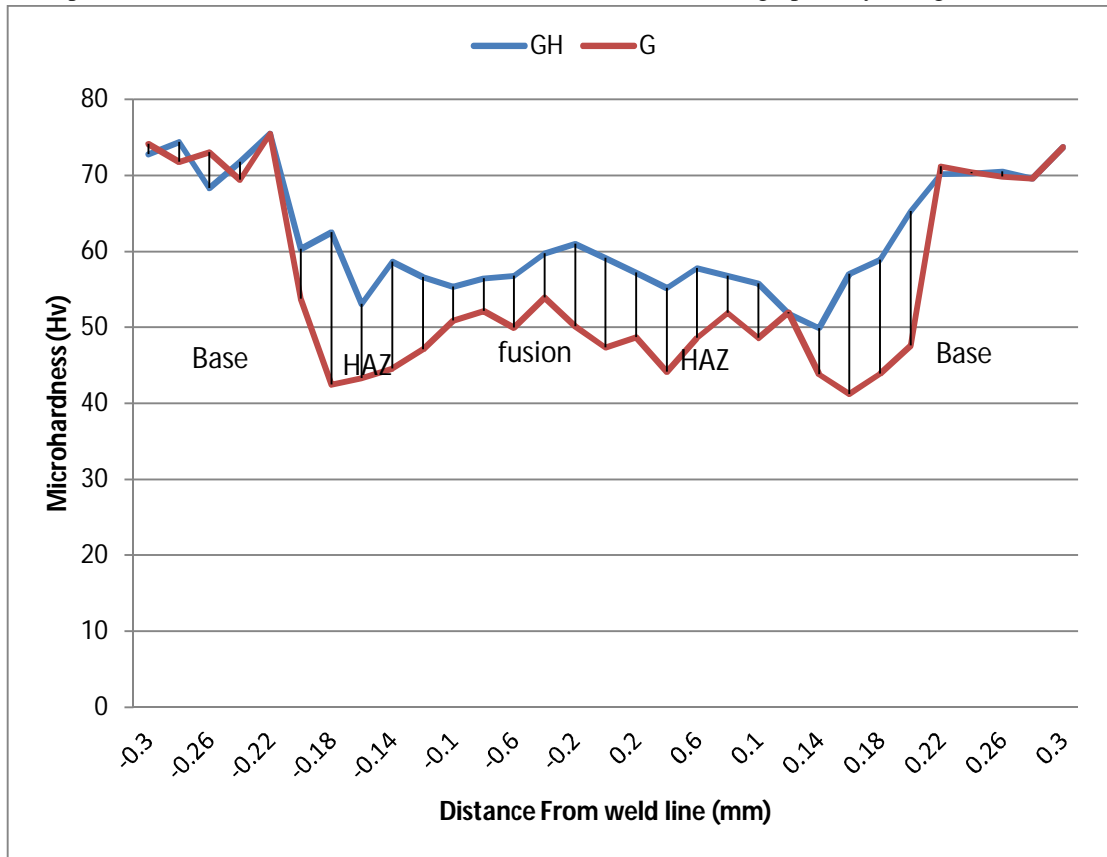
Fig. 6 Microhardness variation

Micro-indentation testing, more commonly called microhardness testing, is widely used to study fine scale changes in hardness. Microhardness examinations were carried out in a direction perpendicular to the weld bead in same plane. The comparison in the microhardness of the specimen in as welded as well as in heat treated condition shown graphically in Fig 6.

- C. The fractography of specimen GH joint revealed fine dimples which shows that GH joints have higher ductility compared to TIG joints.
- D. Micro hardness tests confirm the general decay of mechanical properties induced by higher temperature experienced by material in case of TIG joint but post weld heat treated specimen (GH) much harder than as welded specimen (G).
