Seismic Evaluation and Retrofitting of R.C. Building by using Pushover Analysis

Dnyaneshwri A. Hatwar[1], Prof. V. M. Sapate[2]
[1]PG Student, [2]Professor, Department of civil engineering, G.H. Raisoni University, Amravati.

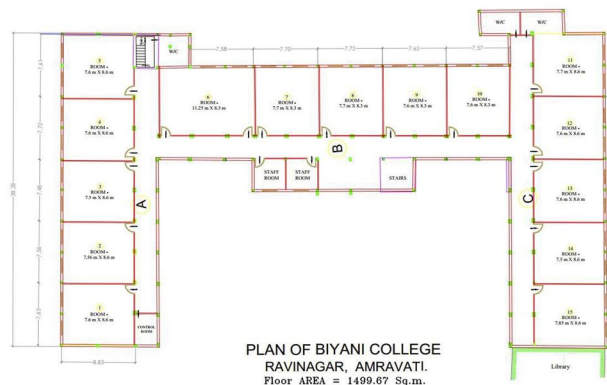
Figure .1 Typical Floor Plan of Biyani College and ETABS Model for Biyani College

PLAN OF BIYANI COLLEGE
RAVINAGAR, AMRAVATI.

Floor AREA = 1499.67 Sq.m.
