Prevention of Damages & Accidents in PSC I-Girders during Stressing & Erection Works

Abhijit Mangaraj¹, Nitin Bobade², Ananya P. Parida³

Department of Civil Engineering, Gandhi Institute For Technology Autonomous

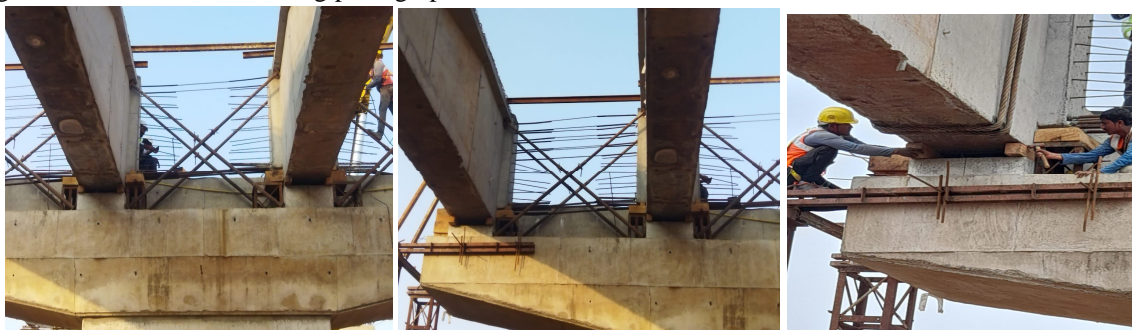
Fig 1.3:- Supporting arrangement of PSC Girdes (3 Photos)

Above arrangement are shown in following photographs:

- a) All supporting work shall be carried out under strict supervision and control of experienced Engineers, Supervisors.
- b) Not a single support shall be removed or relocate, unless the permission granted by Engineer-in-Charge. This is one of the main cause of girder toppling.

- k) No vehicular movement and pedestrian movement shall be permitted below the girders till casting of permanent diaphragm by concreting.
- l) After casting of diaphragm by concreting, all supports and wooden blocks shall be carefully removed. Except wooden blocks below diaphragms.
