Volume: 7 Issue: VIII Month of publication: August 2019 DOI: http://doi.org/10.22214/ijraset.2019.8124

## Haunch Retrofitting of Exterior Beam-Column Connection

Abstract: Three beam-column joints sub-assemblies of  $1/3^{rd}$  reduced scale was tested under monotonic loading conditions. The beam-column connections were comprised of one control model having low concrete strength and having no joint ties, another similar model with diagonal hooks in the joint, and a retrofitted model using energy dissipating haunch. Haunch retrofitting of the deficient model was done to shift the damage from joint to beam and was connected through external anchors to avoid anchors failure. The haunch retrofitting substantially increased the strength of the model with some cracking/damage shift towards the beam but damage in the joint could not be prevented due to delayed action of the haunch that was due to lose attachment of the anchors.

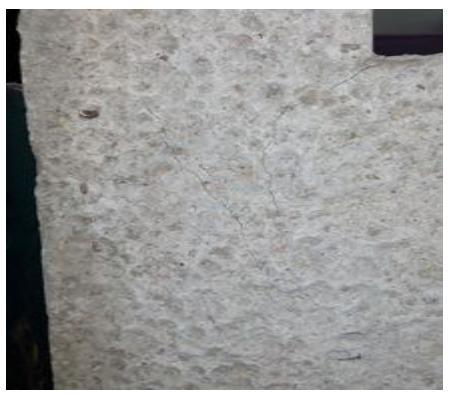
Figure; (1) Initiation of joint shear cracking.

1) Control model: By applying the load at the beam, a small hairline crack appears at the top side of the beam at beam-column interface due to the concrete reinforcement bond failure resulting into slippage of the beam top longitudinal reinforcement due to the lower concrete strength. By increasing the load further, a hairline diagonal crack appears at the joint as the principal tensile stresses surpasses the principle tensile strength of the joint core concrete due to the combine effect of concrete with lower compressive strength and no ties in the joint. By increasing the load further widening in the existing cracks is observed that is followed by the creation of a few smaller new cracks along the sides of the single major diagonal joint shear crack. This increase in the width of the diagonal crakes shows the development of strut mechanism in the joint due to exceedance of principle joint compressive stresses then the principle joint strength ultimately leading to spalling and showing clear joint shear failure.

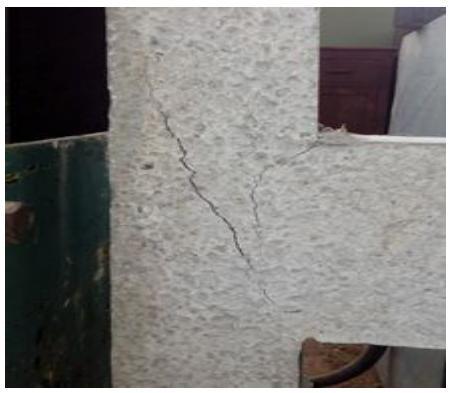
Figure; (2) Joint shear failure.

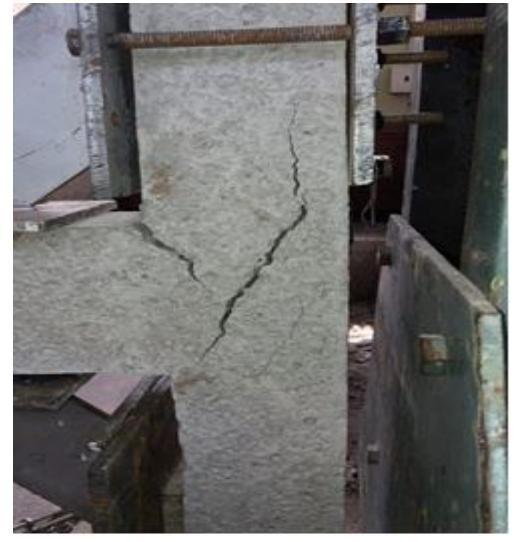
Figure: (3) cracking in joint.

2) Haunch Retrofitted Model: Similar to the control model hairline cracking appears at the top side of the beam at beam-column interface due to the slippage of the beam top longitudinal reinforcement with a slight increase in stiffness and strength in the initial phase as compared to the control model. It was followed by joint shear cracking and the widening of the existing cracks. But after reaching the maximum in term of strength that is usually and, in the control, model followed by a drop in the strength, a rise in the strength is observed in the retrofitted model that gets stepper with further increase in the deformation as shown in the load deformation behaviour. This unique behaviour of the retrofitted model can be explained as, due to improper/loose attachment of the haunches to the model it influences the joint assembly by increasing the initial stiffness and strength by just a small margin, but as when the deformation increases and subsequently the haunch become more effective as its connection tightens due to the deformation in the model removing the free space the haunch diverts any further increase in stress in the joint towards the beam which the haunch was designed for. As the haunch diverts any further increase in stress in the joint with the increase in deformation towards the beam as intended a hairline flexure crake appear in the beam at the end of the haunch base plate that increase with further increase in the load and deformation up-to the maximum applied displacement.

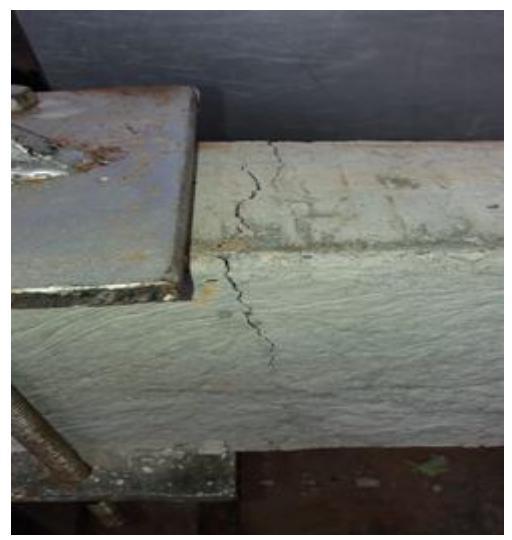
Figure: (4) cracking in beam.

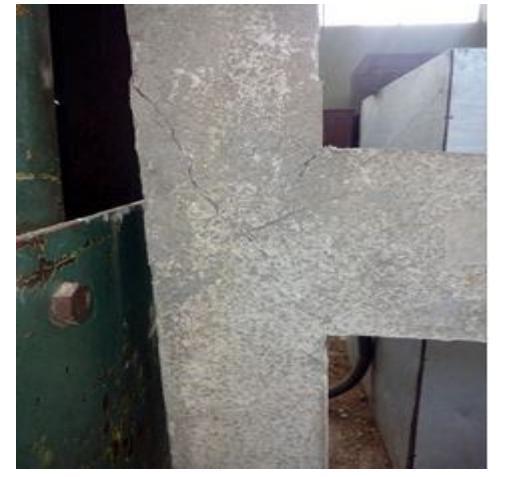
Figure: (5) Initiation of joint shear cracking.

3) Diagonal/135 Hooks Model: In the case of hooks bent diagonally making angle of 135<sup>^</sup> that position it transverse to the potential principal tensile crakes to help increase the joint principle tensile strength. After the application of load beam-column interface cracking was observed that widened reasonably before any diagonal joint shear crack was observed. The diagonal joint shear cracking started with multiple cracks showing compression strut failure due to principal compression stresses as opposed to the other models where cracking started with a single crack and converted to multiple cracks. This type of damage behaviour shows that the diagonal hooks increased the principal tensile strength of the joint thus delaying the occurrence of diagonal shear cracking and an overall increased strength of the joint assembly.

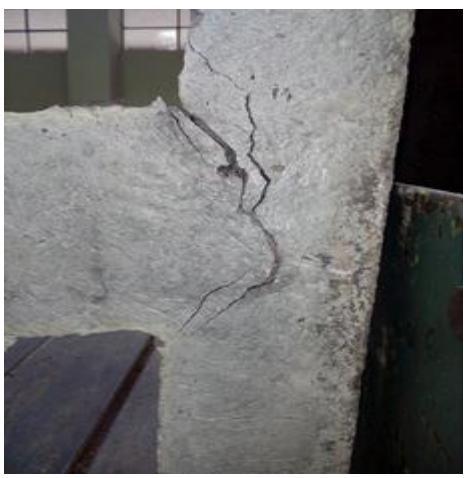
Figure: (6) Joint shear failure.

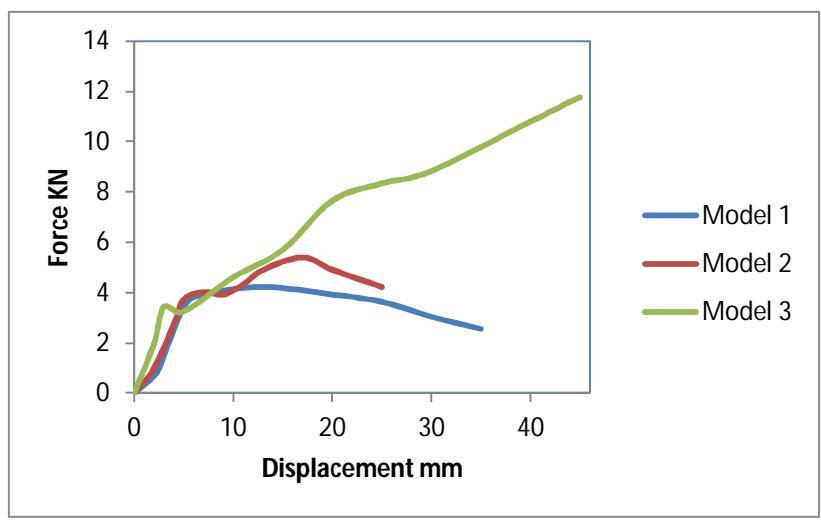
Figure (7); Load displacement behaviour.

In the case of control model yielding in the Load-displacement graph, starts at 3mm of applied displacement with applied load of 0.33 tons corresponding to the beam-column interface cracking in the joint assembly. Followed by the strain hardening region up-to a maximum load capacity of 0.43 tons corresponding to joint peak shear strength, where the joint fails under principal compressive stresses. After joint shear failure the strength degradation starts up-to the ultimate displacement of 35mm and load of 0.26 tons.

With the diagonal hooks in the joints a small increase in initial stiffness was observed. A little drop in the stiffness in the stiffness was observed due to the initial cracking at the beam-column interface but this drop was not substantial as in control model, as in this model interface cracking was not directly followed by initial joint shear cracking that in control model load-displacement graph could be seen in the form of clear yielding mechanism/drop usually followed by strain hardening. The joint assembly reaches to its maximum strength of 0.55 tons at 17mm of applied at the joint peak shear strength representing 22% of maximum strength increase, where the joint shear failure occurs in the form of joint core crushing due to principal compressive stresses. A 21% of strength drop was observed at the application of 25 mm of displacement

In case of the joint retrofitted with haunches a small increase in the initial stiffness and strength is observed as compared to the control model, otherwise a similar load-displacement behaviour was observed up-to applied displacement of 8mm. This small difference/behaviour can be attributed to less effectiveness of the haunch at smaller applied displacement due to the loose connection of the haunches to the joint assembly. As the applied displacement increases haunches become effective as the loose connection tightens, this can be observed in the clear increase in the strength and stiffness in the later stage of the load-displacement graph. More than 180% of strength increase was observed up-to the application of 45mm of displacement.
