International Journal for Research in Applied Science & Engineering Technology (IJRASET)

Investigation of Tribological Behaviour Properties in Coated Carbide Tools for Steels Turning Operation

D. Venkatesa Prabu¹, R. Nandhakumar², A. Sathishkumar³, R. Chandiran⁴

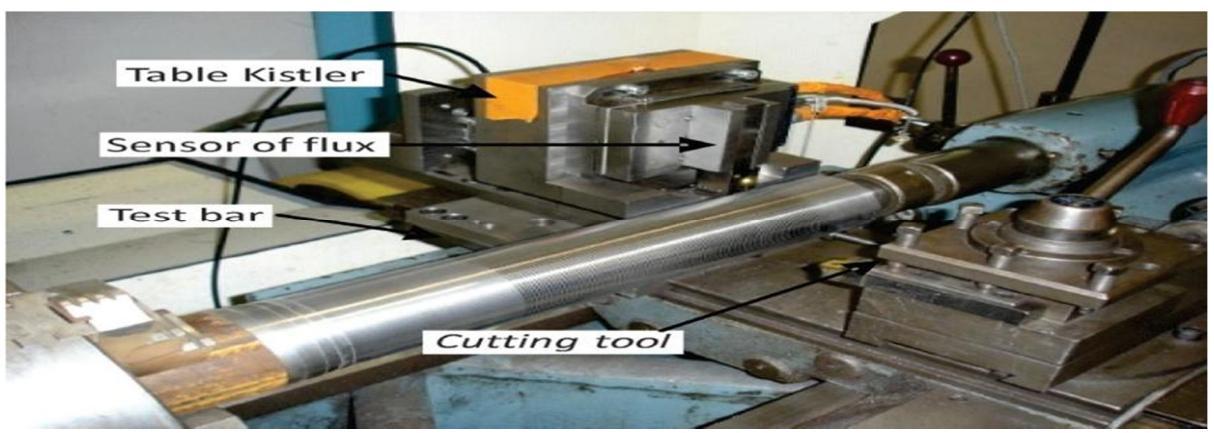
The tests were performed in the Laboratory of Tribology and System Dynamics (LTDS) Saint Etienne, France, using round bars made of 42CrMo4 and 27MnCr5 steels with 80 mm diameter and 600 mm length with improved machinability. The longitudinal turning and tribological cutting operations (in orthogonal cutting), were performed on conventional lathe (Gazeneuve). The chemical composition of the material to be tested is given in Table 1. The machine being used is Gazneuve lathe (Figs. 1 and 2), equipped with KISTLER 9257B standard dynamometer with the objective to measure in real time the three force components along x, y, z.

Fig. 1. Cutting test and machining on an instrumented Gazeneuve lathe installation

During longitudinal turning and in order to prepare the next test, it is of importance to measure the wear of TiN coated carbide inserts as shown in Fig. 1 and meanwhile searching the interaction between the two forms of wear (flank VB and crater KT) as function of time of cutting. It can be noticed from Fig. 6 that the curves are continuous.

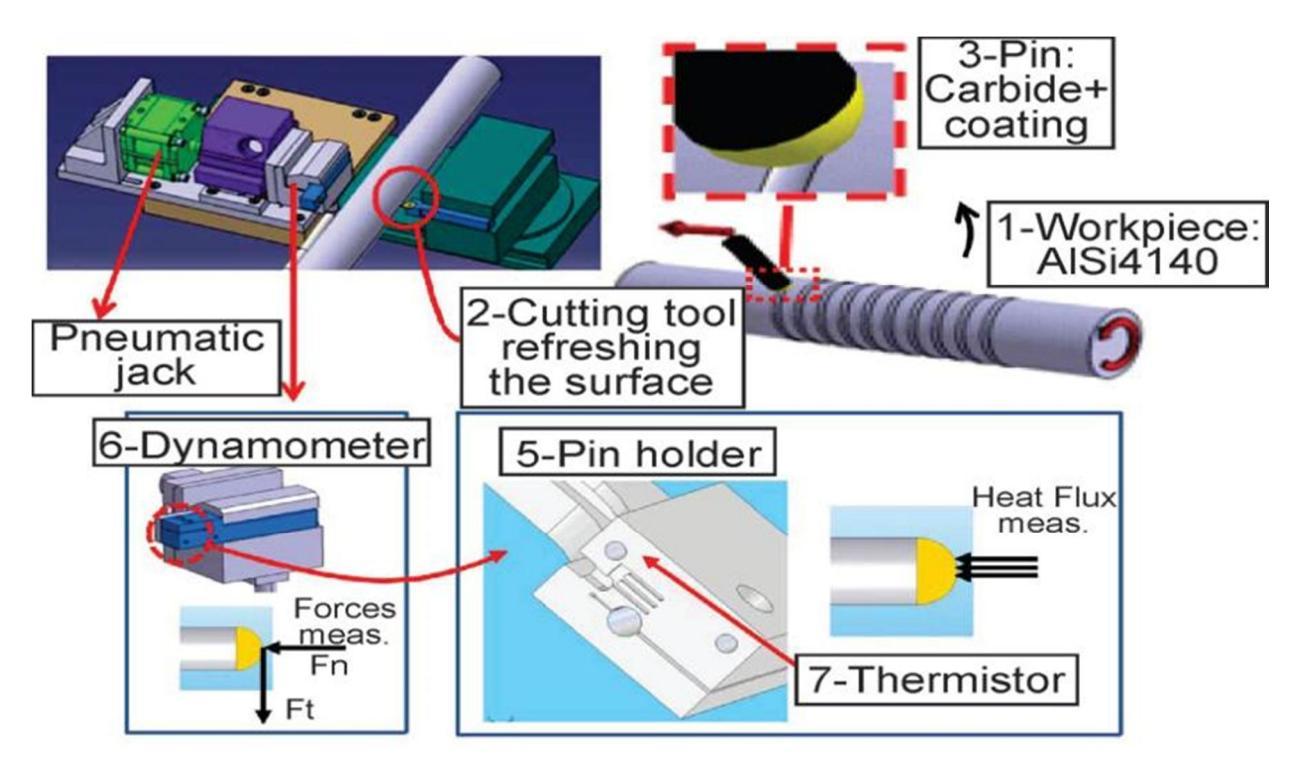
Fig. 2. Measure principles on a tribometer intended to acquire the efforts and the heat flow

An interface for acquisition of heat flow is directly connected to the pin holder whose principle is based on thermistor transducers

(Fig. 2). The tests have been carried out in a dry environment without lubrication. Wear has been investigated taking into consideration the following parameters: feed rate, f, 0.8 mm/rev for cutting and 2 mm/rev for scratching, cut depth, ap of 2 mm and cutting speed Vc between 20 and 180 m/min.

The test bench can generate furrows along the specimen as shown in (Fig. 2). It has been noticed that the coefficient of friction decreases considerably when increasing the cutting speed. For the TiN pin, the fall is precipitous until a speed of 60 m/min is

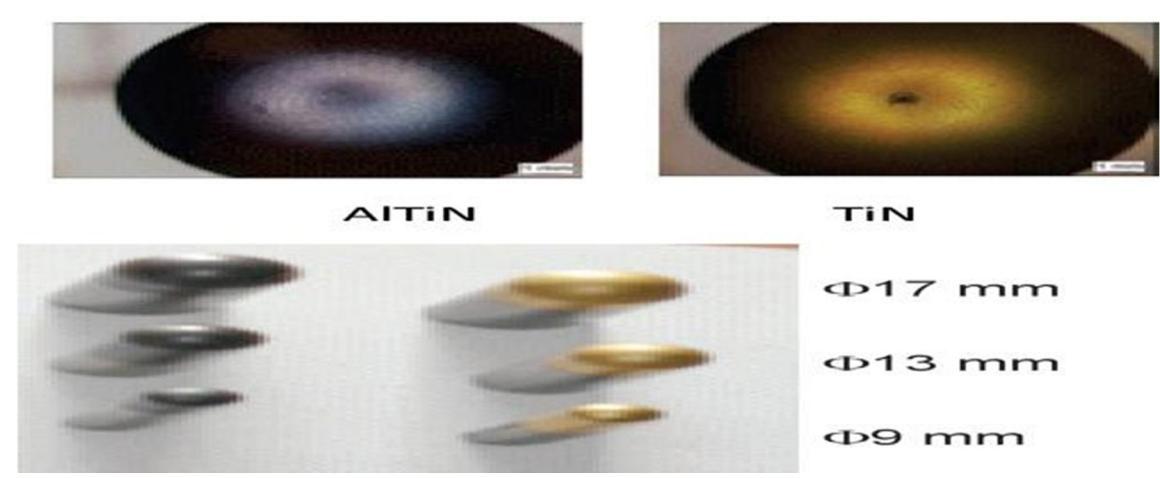
Fig. 3. The different colors of pins coated and their diameter F17, 13 and 9 mm

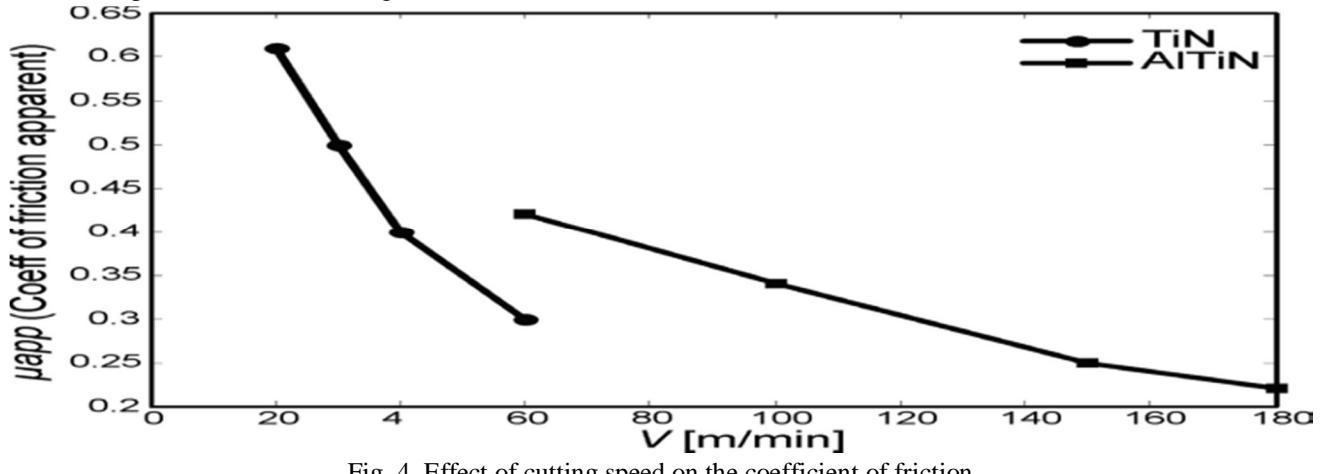
The tribological cutting tests on 42CrMo4 steel with a hardness (HB 290), using TiN and TiAlN pins of diameter 13 obtained by PVD at different speeds, are shown in (Fig. 4).

achieved. The AlTiN pin behaves otherwise by falling steadily until 0.23 to a speed of 180 m/min. Here, the apparent friction coefficient which is calculated through the measure of the effort using the following equation, should be mentioned: $\mu macr = FT / FN$. (1)

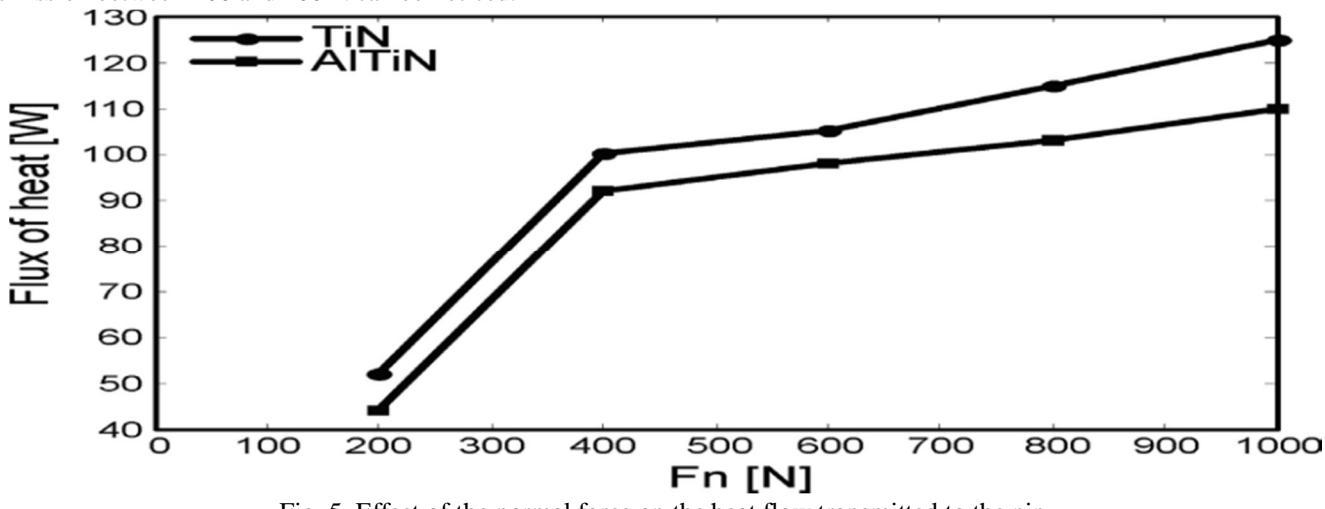
Fig. 5 shows the heat flow evolution transmitted to the pin. Beyond this value, the slope of the flow growth decreases. In fact, and during the contact pin / work piece at a cutting speed of 120 m/min, intense heat is created and increase steadily as the normal stress increases. At 600 N value, the transmitted heat flow to the pin becomes regular and linear. A rapid growth of the heat flow transmission between 200 and 400 N can be noticed.

Fig. 5. Effect of the normal force on the heat flow transmitted to the pin

It is noticed that at 400 N, the appearance of theheat flow changes significantly. This can be explained by the effect of heat diffusion across the pin.

The heat flow transmitted to the TiN pin at high pressure (for an applied force greater than 400 N) is more important for TiN pin than for AlTiN pin.

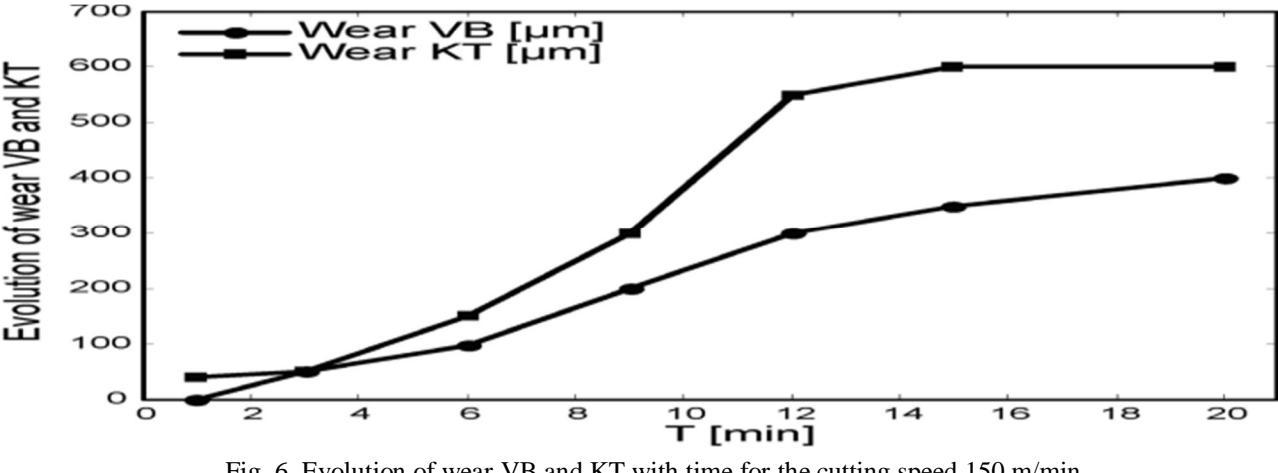
Fig. 6. Evolution of wear VB and KT with time for the cutting speed 150 m/min

After a rapid wear at the beginning of the test, the shape of frontal wear VB becomes almost linear. Beyond 0.4 mm the crater wear rate (KT) increases quickly. For finish operations (following ISO standard ISO 3685-1977 (F) 0.3 mm wear finish and 0.6 mm for draft), which is the case, the flank wear VB which is more representative it is then taken into account. Both wear VB and KT

During the tests, it could be noticed that the flank wear VB and crater wear KT become more and more important, especially at high cutting speeds (more than 150 m/min). They often result in the breakdown of the tool nose and then they result in the inaccuracy of the tolerances of the workpiece.

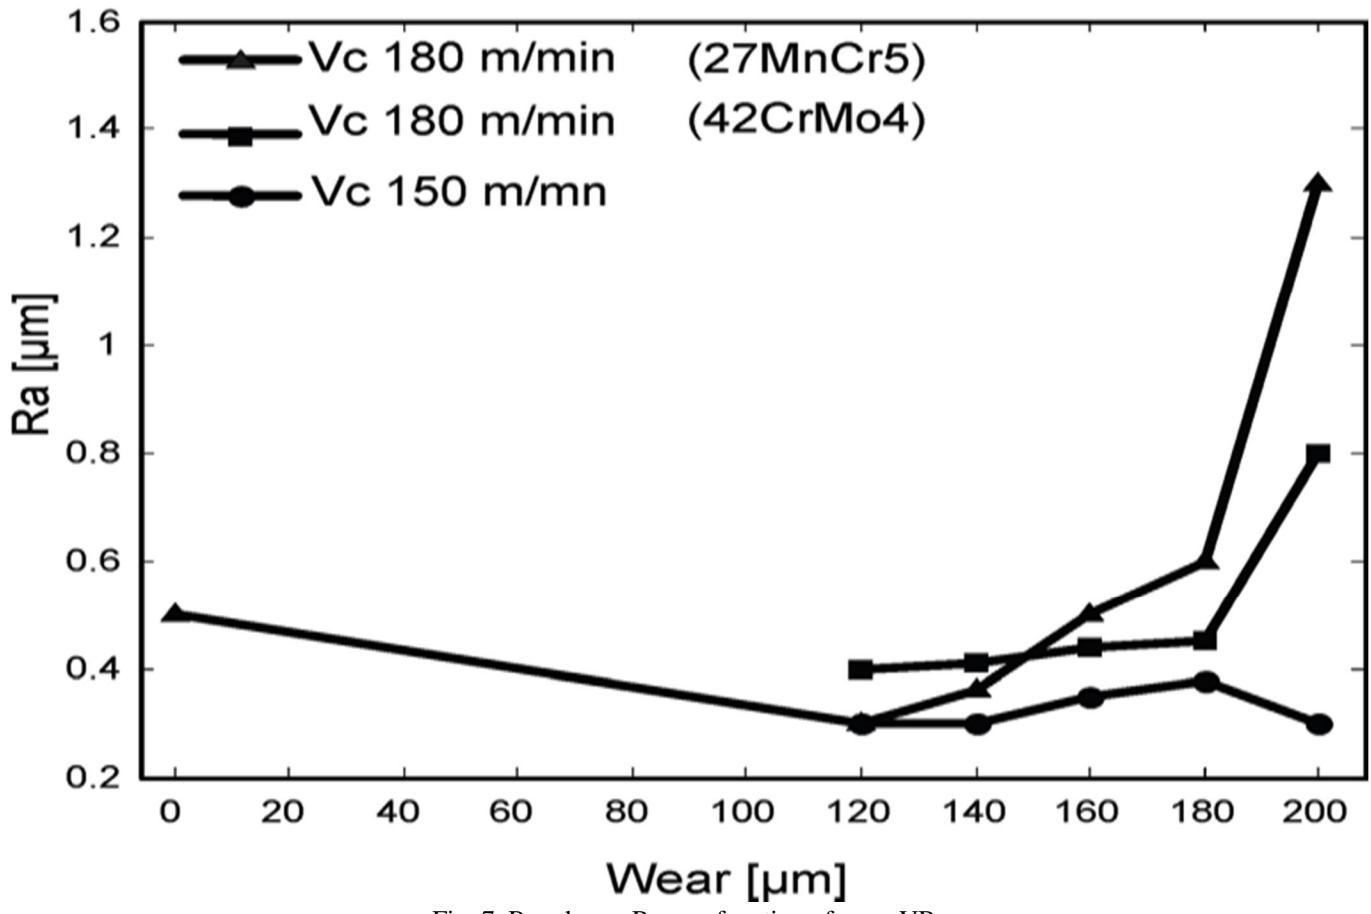
As can be seen from the three curves in Fig.7 and different speeds, it can be noticed that the surface finish obtained (work piece) with unworn tools is almost regular (near 0.4 μ m). Gradual damage of the surfaces corresponding to the increased wear can also be noticed. In the case where $VB = 300 \,\mu$ m is taken as a wear criterion, a significant degradation of the surface which results in an increase in the value of *Ra* can be noticed. In fact, for fixed upper limit of roughness to *Ra* = 0.6 μ m, it has been observed that the lifetime of the plate is significantly reached.

The surface quality is better for low rate of wear VB (lower than 200 mm); beyond this value the roughness Ra increases as function of the cutting speed Vc.

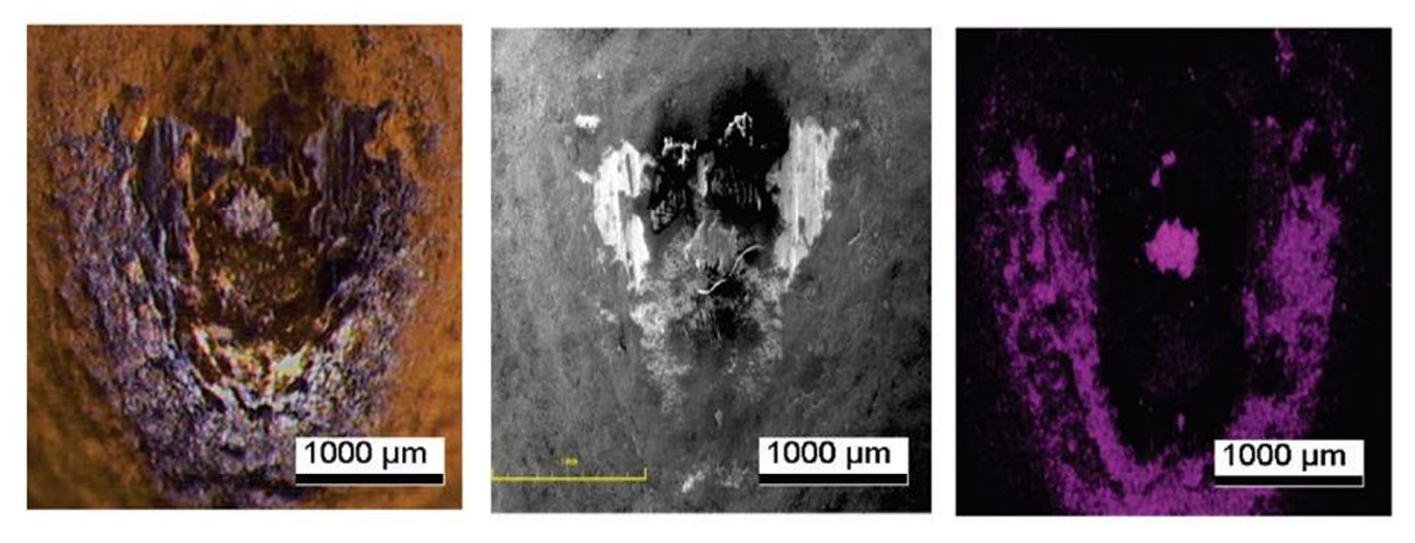
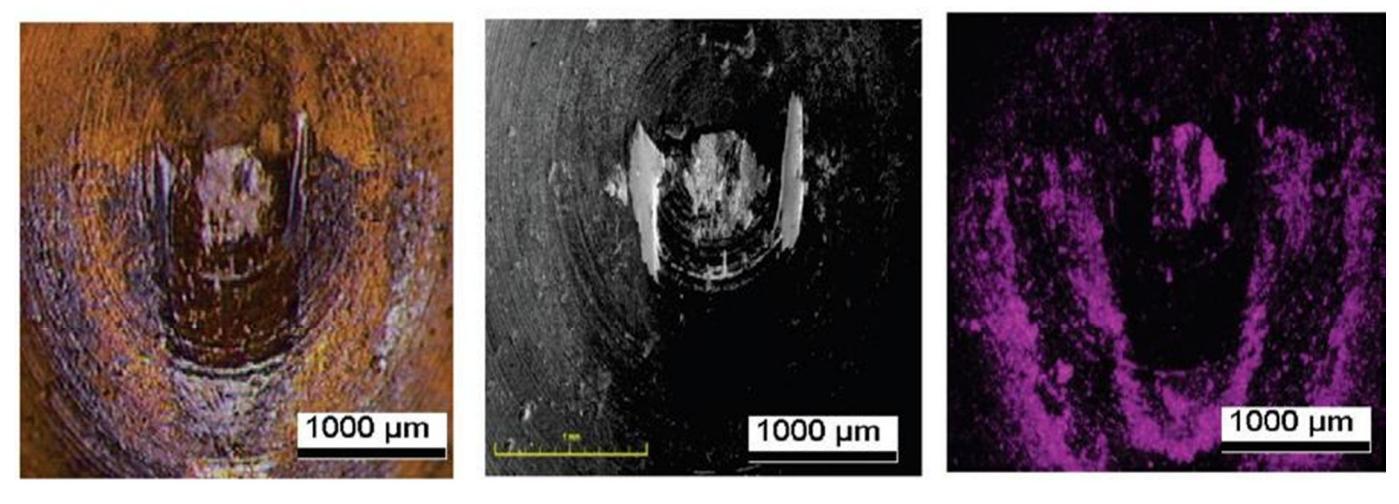
Observation of friction pins allows us to reinforce the assumptions made when interpreting friction measurements. It articularly expresses the respective behavior of materials towards adhesion, diffusion or other tribological phenomena of the contact couple materials (workpiece-pin). At the end of the experimental test, the optical and electronic micrographes of the pin show that the damaged surface is very torn. This is due to severe adhesive wear. This result is confirmed by the adhesion of iron deposits detached from the piece (Fig. 8).

Three different types of observation have been performed: on a binocular microscope, on a scanning electron microscope (SEM), and finally an EDS (Energy-dispersive X-ray spectroscopy) chemical analysis of elements found on the surface of the pins. The SEM technique is based on the principle of electron-matter interactions. It is therefore sufficient to scan the electron beam over its entire surface. Moreover, the SEM used in the laboratory can also analyze the spectrum of X- ray by dispersive energy using a microprobe EDS or EDX (energy dispersive X-ray spectroscopy). The analyses of structure and composition are performed in a single step, which has the advantage of a fast data acquisition. The observation of pins with a binocular microscope gives little information about their wear. It is quite difficult to distinguish between areas where the coating has been damaged and areas that

Fig. 8. Observation and analysis of the wear of the pins to after 30 min of different friction types of observation Vc = 80 m/min, f = 2 mm/rev

The resulting images show the existence of two types of alteration of the coating depending on the type of the material used. The pin being rubbed against 27MnCr5 rods shows an adhesive wear, with a tearing of two plates at the ends of the contact zone. The center of this same zone is protected by adhesive deposits which are shown in black. For the 42CrMo4 material pin, there is a clear presence of two trenches left by the edges of the grooves. Here one can talk about an abrasive wear, since such marks are parallel to the direction of motionThe existence of these two types of wear which are specific to each material is common in the tribological behavior when a couple of materials is used. The adhesive regime often leads to sudden changes of wear which can be due to simple modifications of friction parameters. EDS analyses do not provide further information. Only deposits of the Iron element in the case

of 42CrMo4 confirmed by the density of the alloy, the net propensity to adhere more firmly to the friction surface of the pins compared to 27MnCr5 alloy.

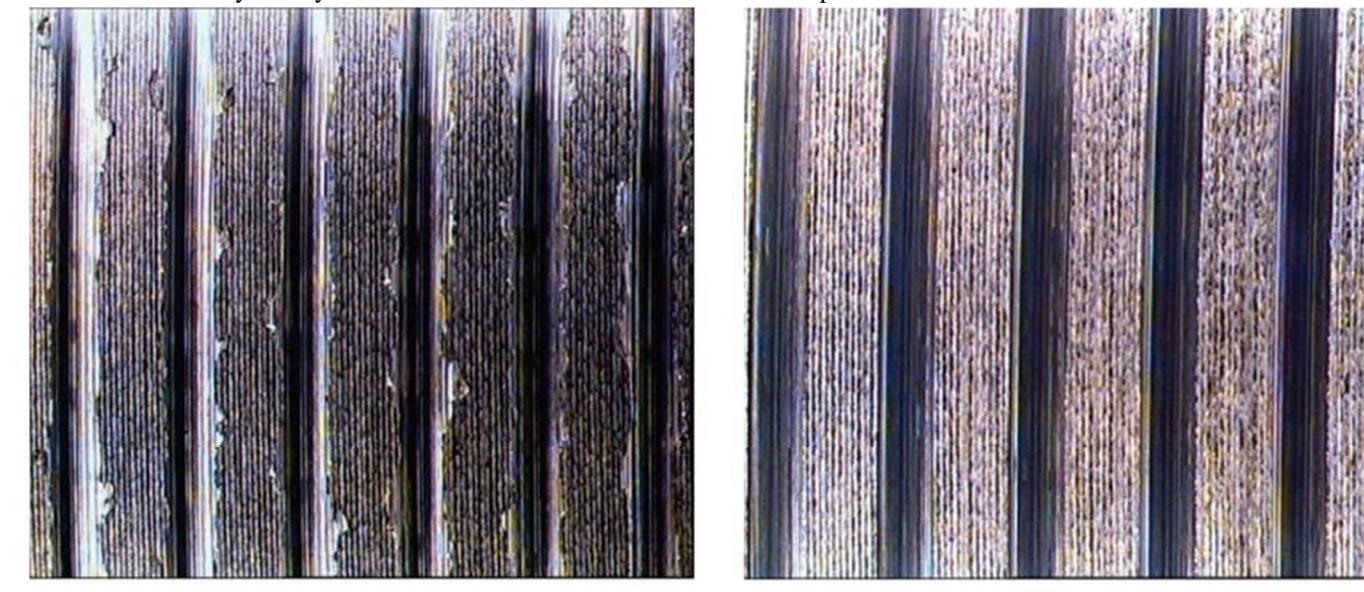
It is well noticed the existence of striations which are parallel to the pin sliding direction, which qualify this kind of wear as soft abrasion wear. This observation seems consistent with the difference between the two materials in contact. In addition, there is a discharge of matter towards the edges of tracks (groove), a sign of ploughing, due to the steel ductility. The observation of the pin at the end of the test very clearly shows a non-uniform wear of the head of the pin.

Fig. 9. Comparison of scratches obtained after scratching using pins Ø13 mm and diameters Ø17 mm; 42CrMo4 - magnification $\times 1$ - Vc = 80 m/min

The widths of scratches observed on 27MnCr5 bars remain relatively constant (Fig. 9), during testing. Only those left by the pins in the bars of standard material, increase furtively after the first twenty minutes of friction. This seems to confirm the destabilizing of the recorded coefficients of friction. Therefore, there is a slight difference in behavior on the friction with time between the two alloys. The scratches left in the 27MnCr5 alloy are in fact much larger than those left on of 42CrMo4 alloy (about 1.8 mm) showing a more pronounced wear of the pin associated with the 27MnCr5 alloy (about 1.25 mm). After each friction testing, the used piece is removed from the lathe to take measurements of scratch widths left by the pin on it. Measurements are performed in the middle of the specimen (and therefore at the middle of the experiment). These data will enable us to assess the contact local pressure, to express the densities flow, and to evaluate the speed impact on the sliding conditions of the pin.
