A Study on Earthquake Resistant Construction in Nepal

Department of Civil Engineering, Madan Mohan Malaviya University of Technology, Gorakhpur, INDIA

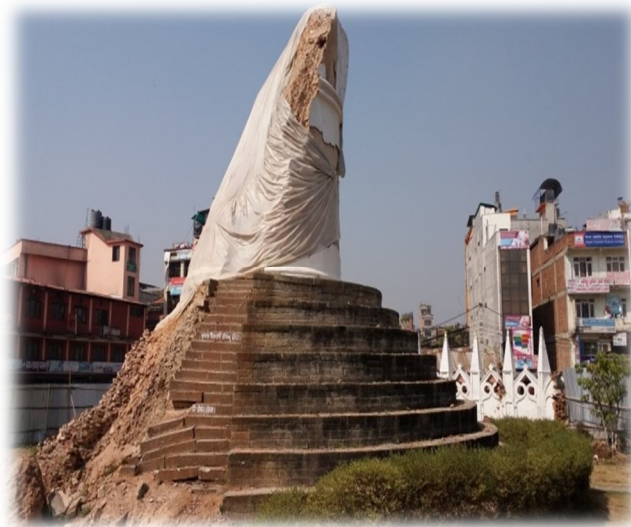
Figure 1: damaged dharahara tower, kathmandu

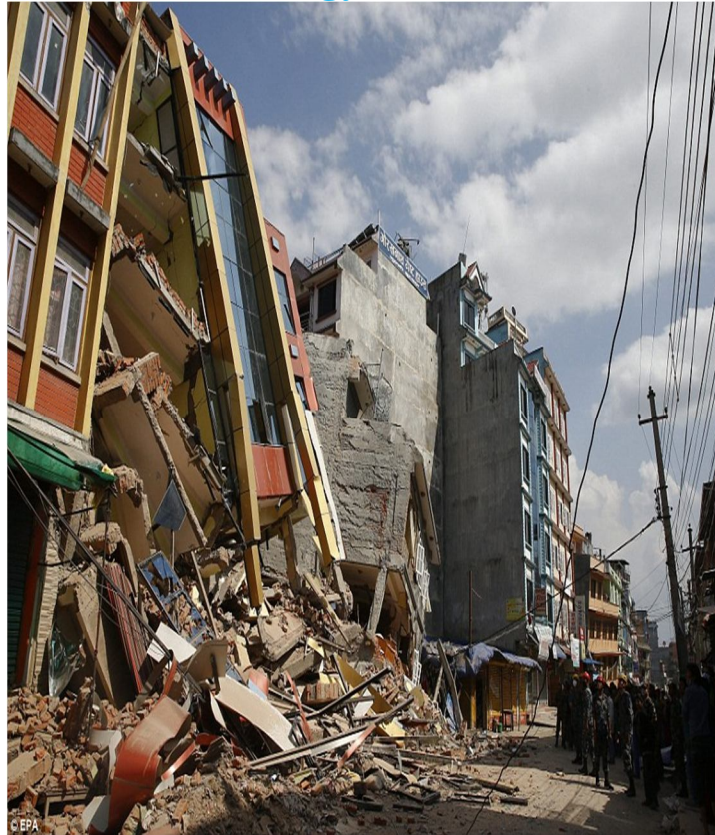
Figure 2: column, joints fail

There were almost 5 lack houses were collapsed in the Lumjung-Kathmandu-Nepal on the devastating quake occurred April 25, 2015 at 11:56AM. I vested all the affected places in Kathmandu valley and collect all the data which is required to prepare this paper. I have to discuss some points regarding failure of buildings during earthquake such as unreinforced masonry buildings, soft story effects, in adequate confinement of steel in RCC structure, soil liquefaction, poor detailing of reinforcement, seismically weak sot story at the first floor, insufficient shear reinforcement.

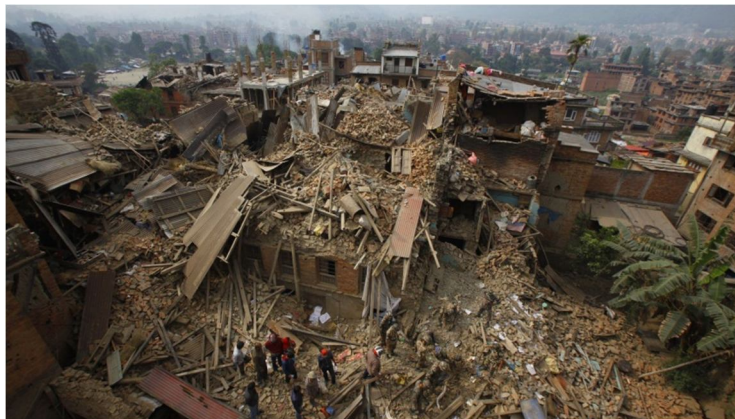
Figure 3: total house collapsed
