# Abrasive Wear in Ground Engaging Tools and Its Remedial Measures

Pankaj Dhiman<sup>1</sup>, Dushyant Kaistha<sup>2</sup>, Shabnam Dhiman<sup>3</sup>, Swati Kaistha<sup>4</sup>

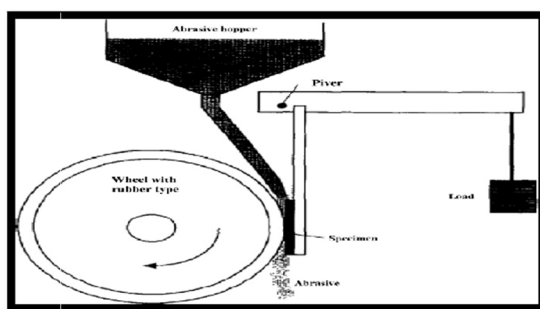
Figure 1 Schematic diagram of the rubber wheel abrasion tester

(Hosseini and Radziszewski, 2011). The 3-body abrasion phenomenon, is generally classified in two classifications “low stress abrasive wear” and “high stress abrasive wear” depending on the type of experimental apparatus used. For example a rubber wheel used to simulate the 3-body testing is more representative for “low stress abrasive wear” and the steel wheel testing is more representative for “high stress abrasive wear”. Steel wheel abrasion test which can be conducted to study the wear and abrasive breakage of grains which can be useful to consider as it is seen in ball mills and other industrial applications (Hosseini and Radziszewski, 2011). Steel wheel abrasion test is also useful for mining industry devices, as it provides similar working conditions (Radziszewski, 2002). (Haworth, 1949) used rubber to maintain the contact pressure as the specimen wore, because it was noted that the pistons of slurry pumps were made from rubber in order to maintain pressure as the liner wore. The apparatus of RWAT is shown schematically in Fig. 1 (Hosseneni and Radziszewski, 2011).
