Analysis of Multistorey RCC Frame subjected to Mainshock and Aftershock Earthquake

We compare the seismic behaviour of G+9 multi-story buildings during Mainshock and Aftershock earthquakes individually in this work, and we assess seismic metrics including story displacement, story drift, story shears, and story stiffness for suggested structural models[10]. Additionally, we will investigate the seismic properties of the same building using Time history analysis using unscaled data from the Centre for Engineering Strong Motion Research Ground Motion Database. March 29, 1999, GOPESHWAR STATION (Latitude & Longitude: 30'24"N - 79'20"E), CHAMOLI (NW HIMALAYA) EARTHQUAKE

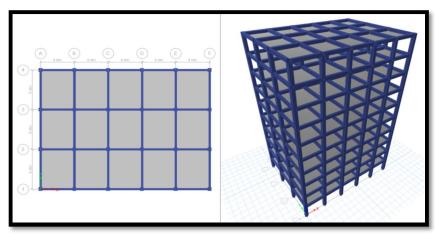
Plan and 3D view

A G+9 building is represented in ETABS v16 with a storey height of 3.1m, a structure's length of 20m in one direction and 15m in the other, and member sizes that vary depending on the building's design specifications. The slab measures 150 centimetres in thickness. As per IS 456-2000 and IS 1893-2016, the model is evaluated and created.

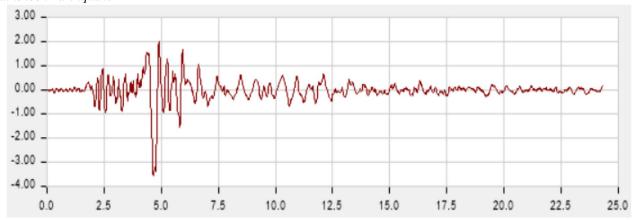
Acceleration vs Time data along Horizontal N-E Direction

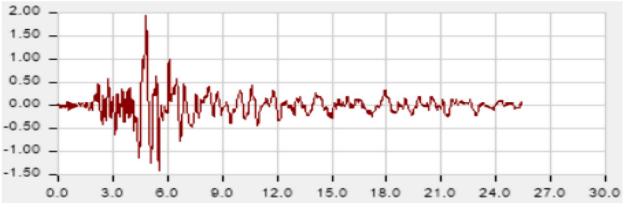
Acceleration vs Time data along Horizontal N-W Direction

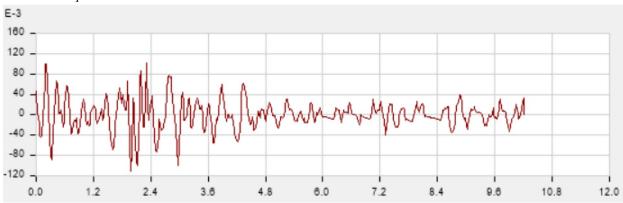
Acceleration vs Time data along Horizontal N-E Direction

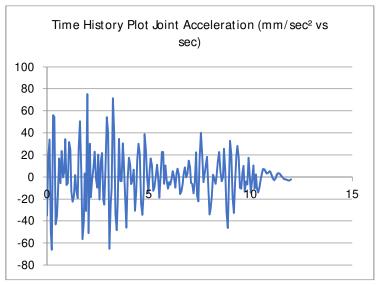
Aftershock

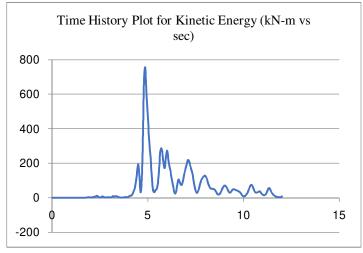
C. Kinetic Energy Stored during Earthquake

Mainshock

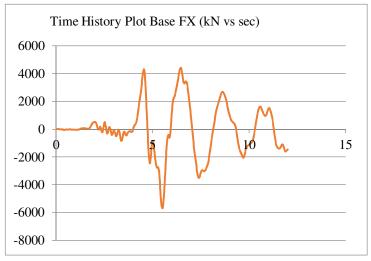
D. Base Shear

Mainshock
