Analysis of Multistorey RCC Frame subjected to Mainshock and Aftershock Earthquake

Sharad Srivastava¹, Ganesh Jaiswal²

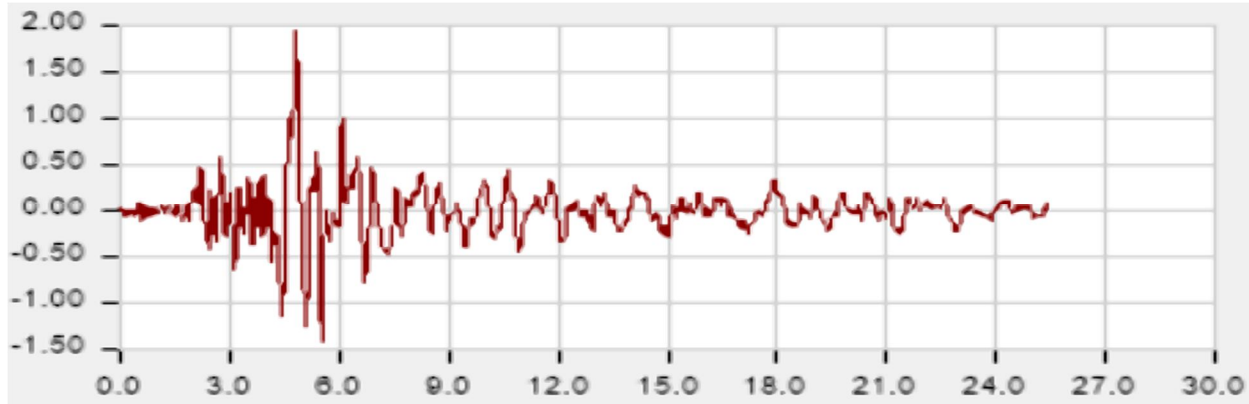
Acceleration vs Time data along Horizontal **N-W** Direction

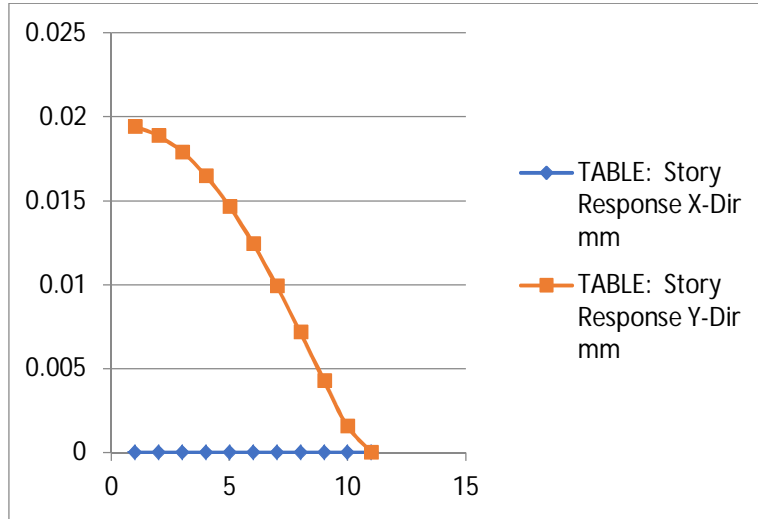
A. Storey Displacement of the RC Building

- 1) According to IS 1893 (part 1): 2002 Cl. 7.11. 3, any storey's storey drift caused by the specified minimum design lateral force, with a partial load factor of 1.0, may not be greater than 0.004 times the storey height. The maximum drift calculated from the graphs is 0.019418 and is within the permitted range.
- 2) Joint acceleration and base shear occur more frequently during aftershocks than during mainshocks.
- 3) The Storey 10 joint's maximum joint acceleration after the aftershock is approximately 2% of the joint acceleration during the mainshock.
- 4) Approximately 11.52 percent of the maximum energy which is stored during the mainshock is added during the aftershock.
- 5) Storey drifts, storey displacement, and stiffness are seen to be within acceptable ranges as advised by the IS 1893 code.
