Analysis of Multistorey RCC Frame subjected to Mainshock and Aftershock Earthquake

Sharad Srivastava¹, Ganesh Jaiswal²

¹PG Student (M.Tech. Structural Eng.), ²Assistant Professor, Civil Engineering Department, Institute of Engineering and Technology, Lucknow

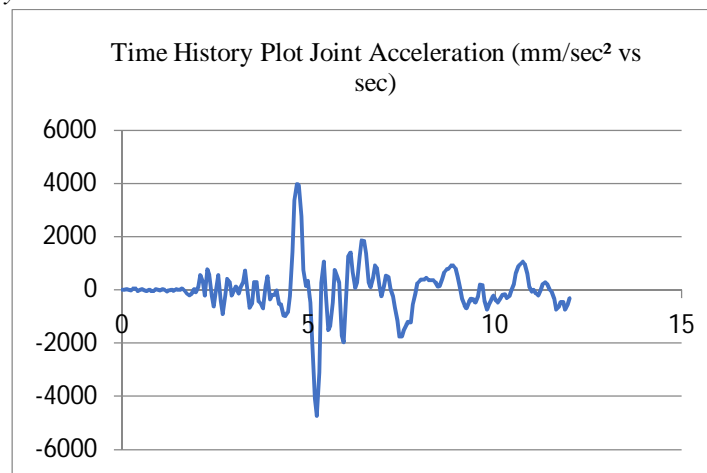
B. Joint Acceleration for Storey 10

Mainshock

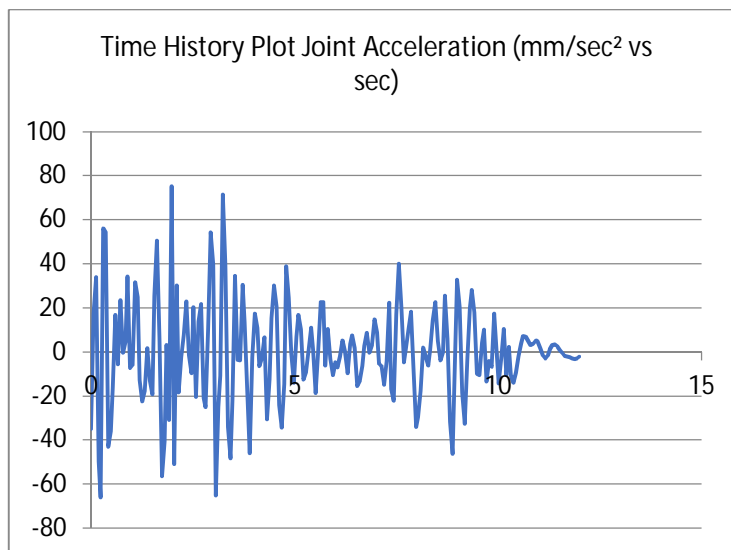
Aftershock
