# Comparative Analysis of Traditional and Contemporary Architecture in Context to Sustainable Characteristics and its Construction Techniques: A Case of Kumaon Region

Ar. Nitika Ranjan Rao<sup>1</sup>, Ar. Saurabh Saxena<sup>2</sup>

<sup>1</sup>Student, M.Arch, <sup>2</sup>Professor, School of Architecture & Planning, Babu Banarasi Das University, Lucknow

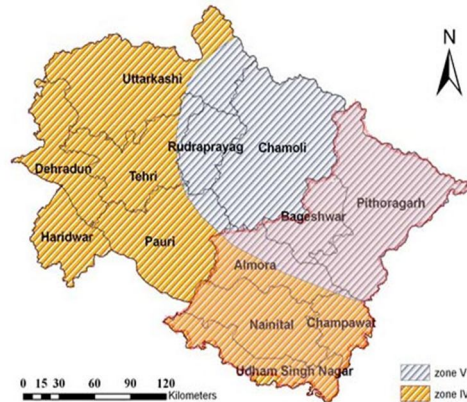
Fig 1. Uttarakhand earthquake hazard zonation (source: Uttarakhand State Disaster Management Authority)

Uttarakhand state is located in seismically highly sensitive zone. It is categorised under zones IV and V of the earthquake risk map of India (Figure 1). Kumaon architecture exemplifies the region's richness of art. Kumaon has a distinct sense of style when it comes to art and architecture. Despite being disaster prone region, few traditional buildings have proved to be disaster-resilient.

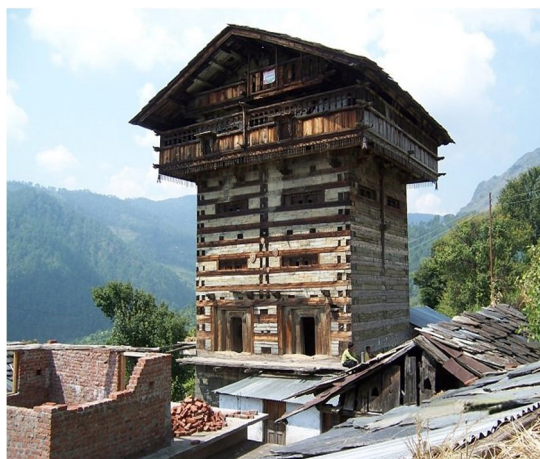
Fig.02 Koti Banal House (Source: <https://madhusudanks.wordpress.com/2015/11/07/koti-banal/>)

Koti Banal style, found in Uttarakhand, is one of the oldest architectural forms. It exhibits in-depth understanding of indigenous materials. Investigations revealed that it was an earthquake-resistant wooden and stone construction that was developed 1000 years ago. The buildings are constructed using the locally available building materials such as long thick wooden logs, stones, and slates. This architectural style is one of the most suitable for building in these regions. This style is proven to have minimal environmental impact and maximum earthquake resistance.

The Uttarakhand region has witnessed some of the catastrophic earthquakes in the past. Kumaon earthquake of year 1720 and Garhwal earthquake of 1803 are termed as two of the great earthquakes (magnitude > 8) that shook the region, yet this type of construction has survived major earthquake resistant properties. The following are major earthquake-resistant characteristics noticed in Koti Banal architecture:

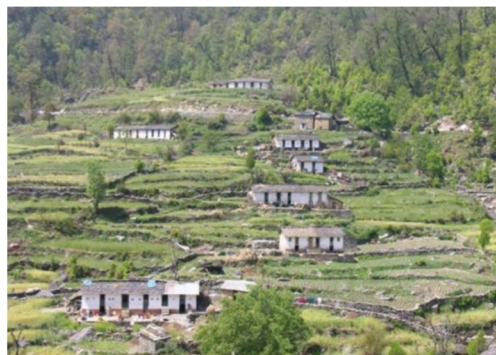
Fig.8 Barakot village in Almora (source: okuttarakhand.com)

Barakot village is situated on the top of the hills in Almora. The entire settlement is planned in a linear manner with street in centre and houses on its side. It is a mix of row houses and single houses. Row houses are planned in a straight manner with houses on both side of the road.

- 1) Houses in this village are mainly placed along the contours and have agricultural field. Terrace farming is adopted in most parts of Kumaon because of sloppy terrain.
- 2) Main buildings are placed on the first floor which comprise of a fore-court, kitchen, living room, and bedroom. The kitchen is mostly placed at the end of the unit.

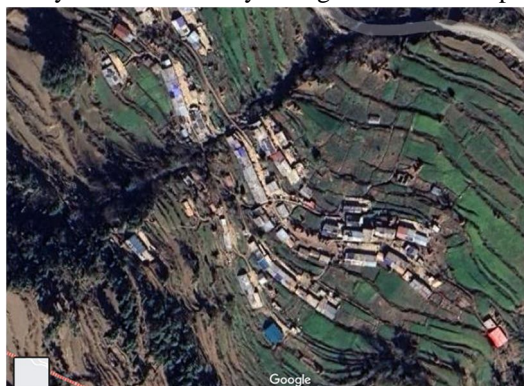
Fig 10. conceptual sketch of Harkot village and its setting (Source: <https://villageinfo.in/uttarakhand/pithoragarh/munsiari/harkot.html>)

- 1) Villages are always sited on the sunniest slopes.
- 2) Stepped terraces are usually cut into the mountain slopes and then carefully dammed with stone walls and vegetation as reinforcement to prevent erosion.
