Comparative Analysis of Traditional and Contemporary Architecture in Context to Sustainable Characteristics and its Construction Techniques: A Case of Kumaon Region

Ar. Nitika Ranjan Rao¹, Ar. Saurabh Saxena²

¹Student, M.Arch, ²Professor, School of Architecture & Planning, Babu Banarasi Das University, Lucknow

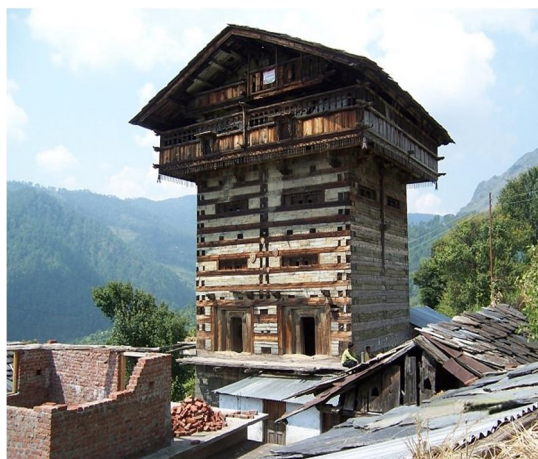
Fig.02 Koti Banal House (Source: <https://madhusudanks.wordpress.com/2015/11/07/koti-banal/>)

Koti Banal style, found in Uttarakhand, is one of the oldest architectural forms. It exhibits in-depth understanding of indigenous materials. Investigations revealed that it was an earthquake-resistant wooden and stone construction that was developed 1000 years ago. The buildings are constructed using the locally available building materials such as long thick wooden logs, stones, and slates. This architectural style is one of the most suitable for building in these regions. This style is proven to have minimal environmental impact and maximum earthquake resistance.

The Uttarakhand region has witnessed some of the catastrophic earthquakes in the past. Kumaon earthquake of year 1720 and Garhwal earthquake of 1803 are termed as two of the great earthquakes (magnitude > 8) that shook the region, yet this type of construction has survived major earthquake resistant properties. The following are major earthquake-resistant characteristics noticed in Koti Banal architecture:

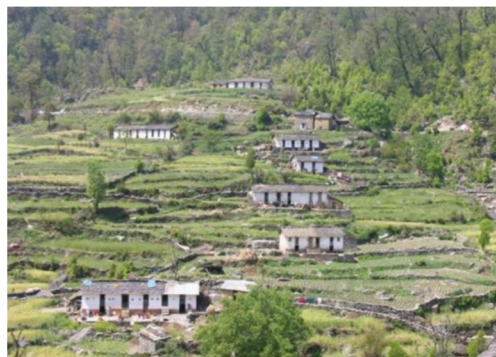
Fig.8 Barakot village in Almora (source: okuttarakhand.com)

Barakot village is situated on the top of the hills in Almora. The entire settlement is planned in a linear manner with street in centre and houses on its side. It is a mix of row houses and single houses. Row houses are planned in a straight manner with houses on both side of the road.

- 1) Houses in this village are mainly placed along the contours and have agricultural field. Terrace farming is adopted in most parts of Kumaon because of sloppy terrain.
- 2) Main buildings are placed on the first floor which comprise of a fore-court, kitchen, living room, and bedroom. The kitchen is mostly placed at the end of the unit.
