# Comparative Study of G+6 Irregular Multistoreyed Building of Different Shape of Diaphragm

Ritik Saxena<sup>1</sup>, Kavita Golghate<sup>2</sup>

<sup>1</sup>PG Scholar, <sup>2</sup>Professor, Civil Engineering Department, SDBCE College, Indore, India

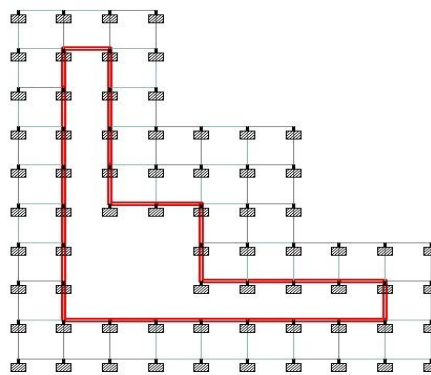
Fig.4 Plan of G+6 Irregular Structural Model M4 with 30% Diaphragm Discontinuity in L- Shape in Centre

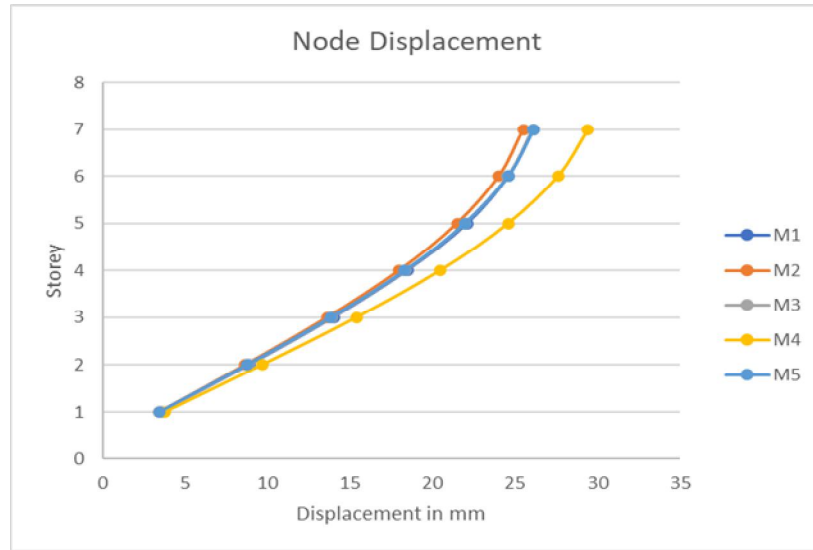
Graph No.1 Resultant Node Displacement for All Model

Considering the data available, it is evident that Model M2 consistently exhibits higher stress levels, larger node displacements, and higher storey shear values, indicating that it might be more susceptible to structural deformation and less stable under lateral loads. Model M3, (Re-entrant Plan irregular Building with 17% Diaphragm Discontinuity) on the other hand, consistently displays better overall performance in terms of lower node displacements and stress values.

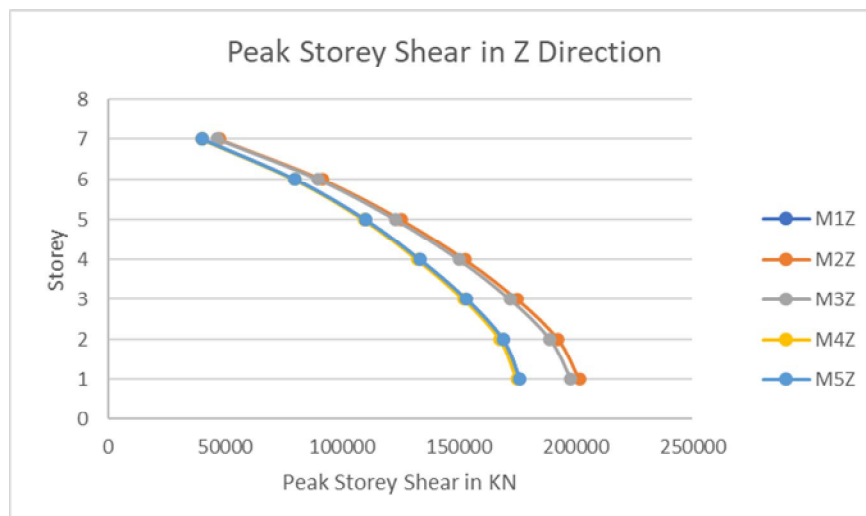
Graph No.3 Peak Storey Shear in all model in Z direction
