# Condition Monitoring of Spur Gear Box based on Acoustic Emission Signal Analysis

Vikas. G. N<sup>1</sup>, V. C. Chandra shekara<sup>2</sup>, Madhusudana C. K<sup>3</sup>, Srinivasa. M. R<sup>4</sup>

<sup>1, 2, 3, 4</sup>Department of Mechanical Engineering, PES College of Engineering, Mandya-571401

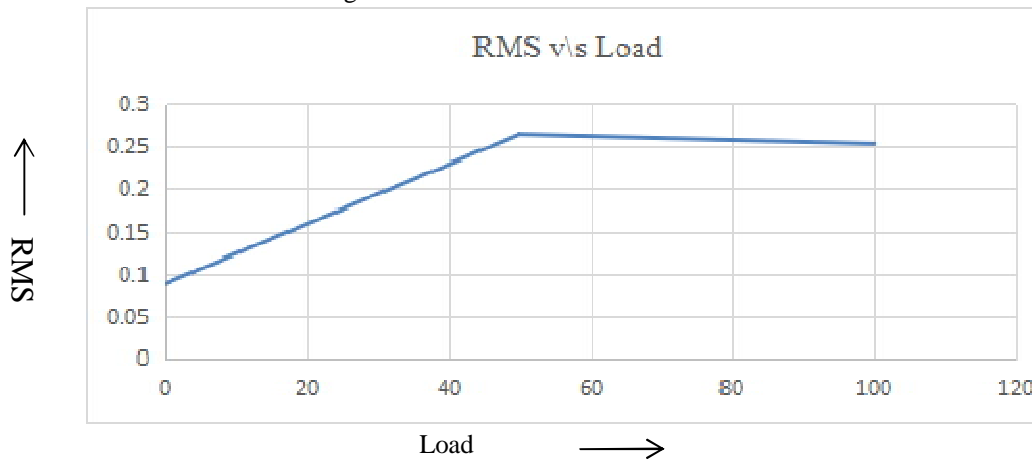
Figure 5:-RMS versus Load

In the above diagram shows that the effects of load deviation on RMS value. The RMS value is increased up to 0.2643v at loading condition compared to the RMS value about 0.0884v at initial(no load) condition. This variation in value of AE rms clearly shows the change in condition of gear. The variation of rise time with respect to load as shown in figure 6.
